LAC+USC TUNNEL STRUCTURAL AND MECHANICAL ASSESSMENT  
AND ASBESTOS SURVEY,  
1200 NORTH STATE STREET, LOS ANGELES, CALIFORNIA

LAC USC TUNNEL  
Structural and Mechanical  
Assessment and Asbestos Survey

January 30, 2013

**Structural Assessment & Corrosion Evaluation Of  
LAC+USC Medical Center/Utility Tunnel (Juvenile Hall)  
Los Angeles, California**

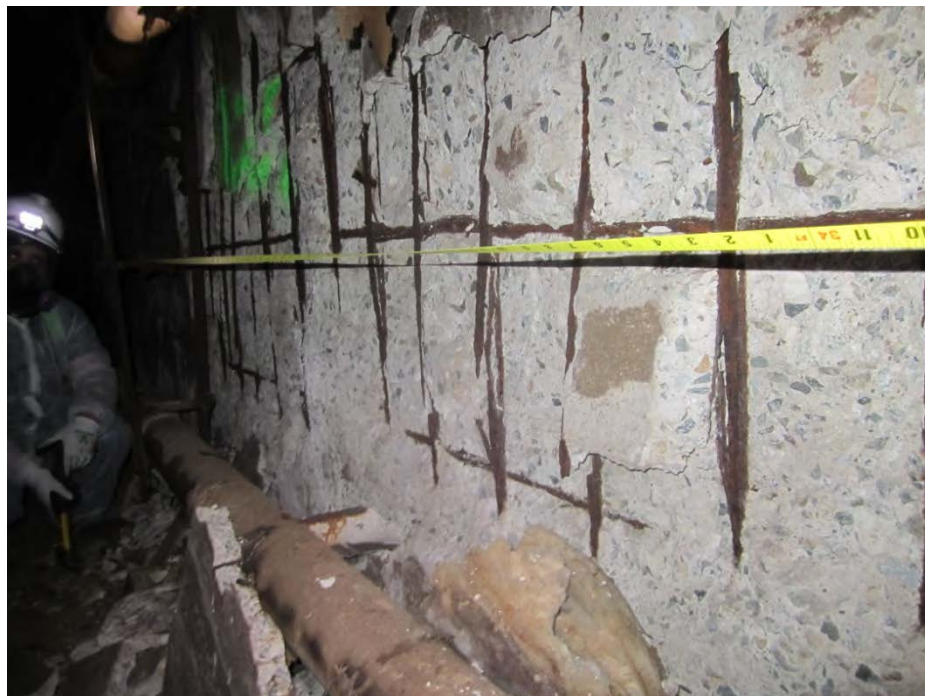
**Figure 1 - Severely corroded reinforcing in spall at Station 21-22**

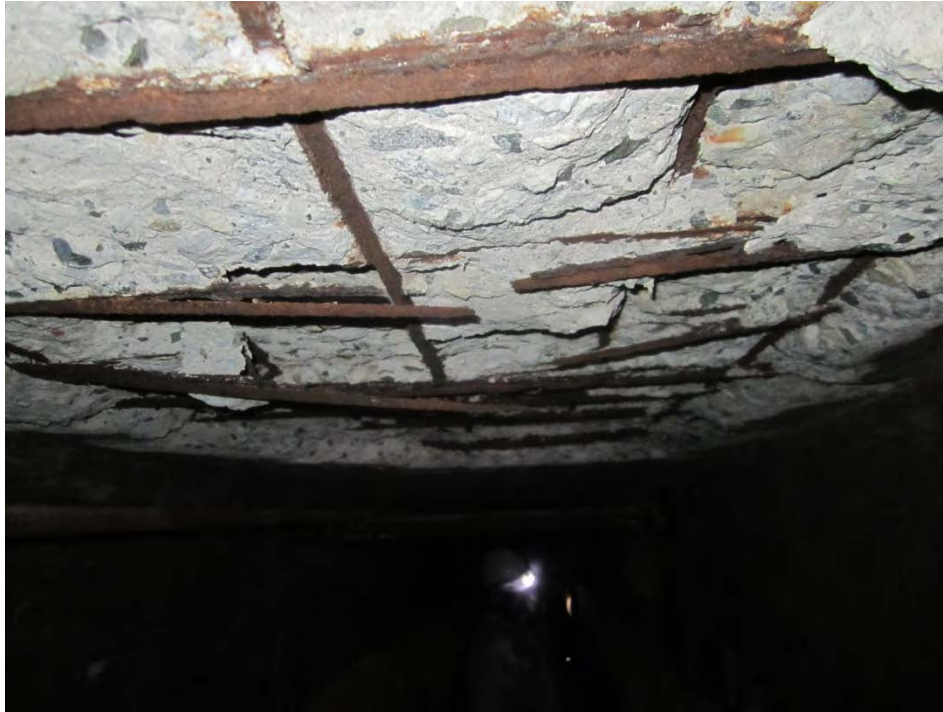
**Figure 2 - Severely corroded tunnel ceiling slab reinforcement**

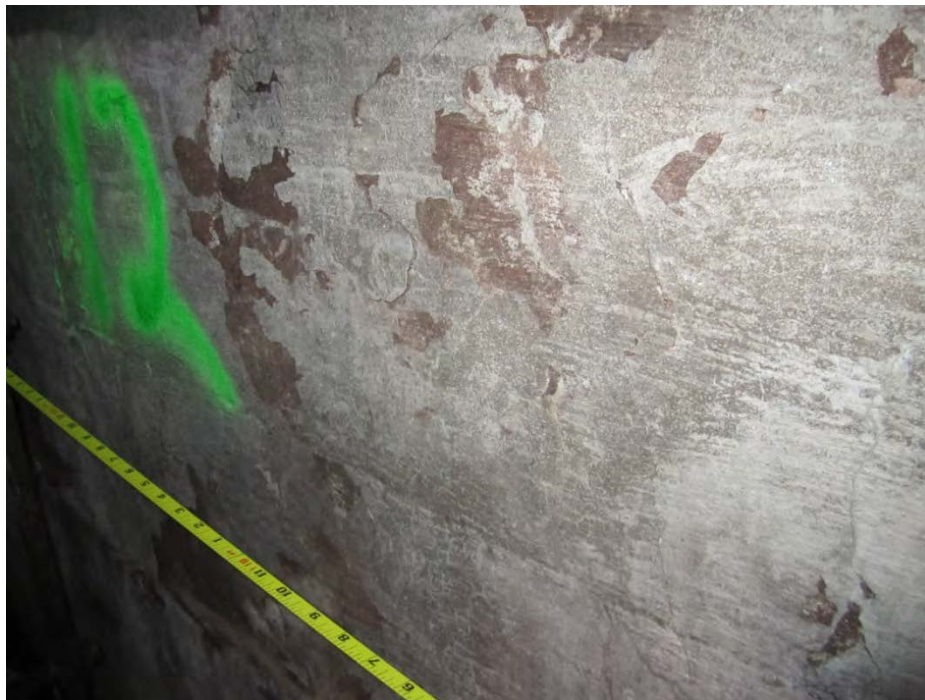
Picture #4- Soft concrete with small cracks in Section 11-12

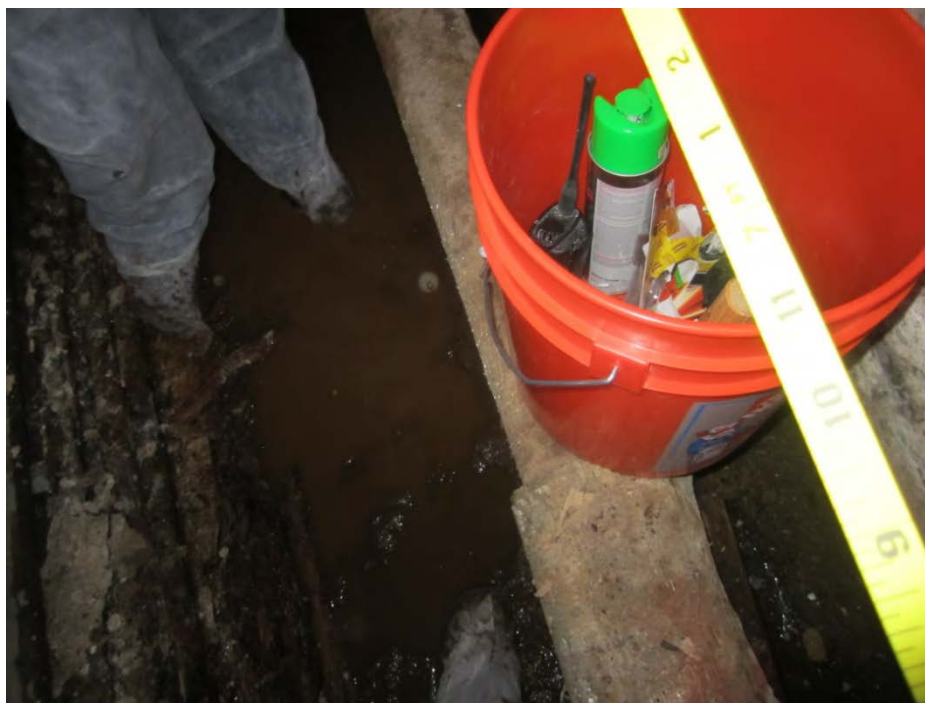
Picture #6- Water covering the tunnel floor in Section 12-13

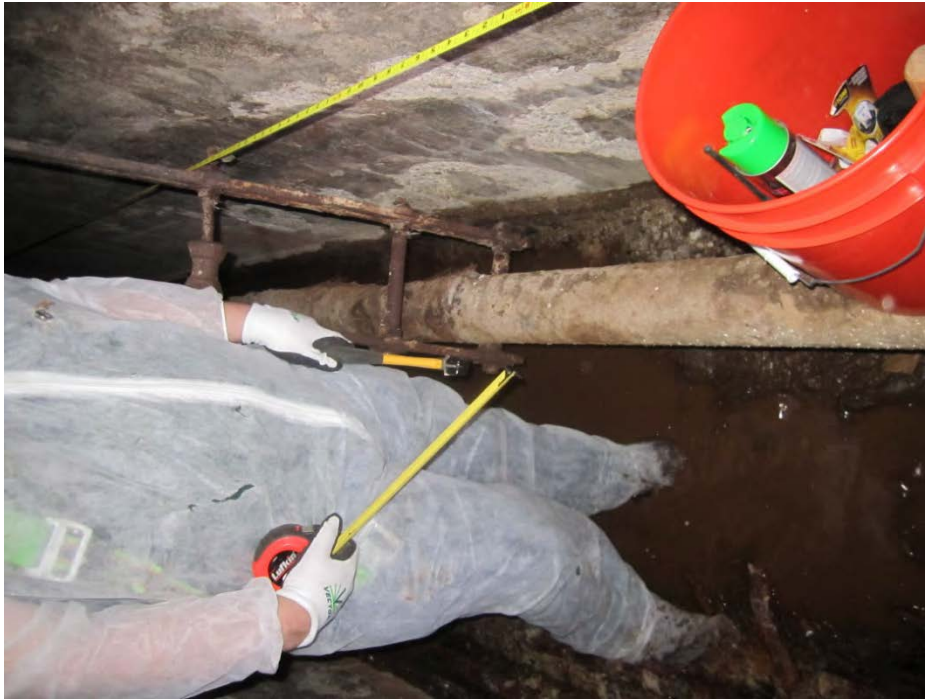
Picture #7- Water covered floor and soft concrete with shallow spalls Section 12-13

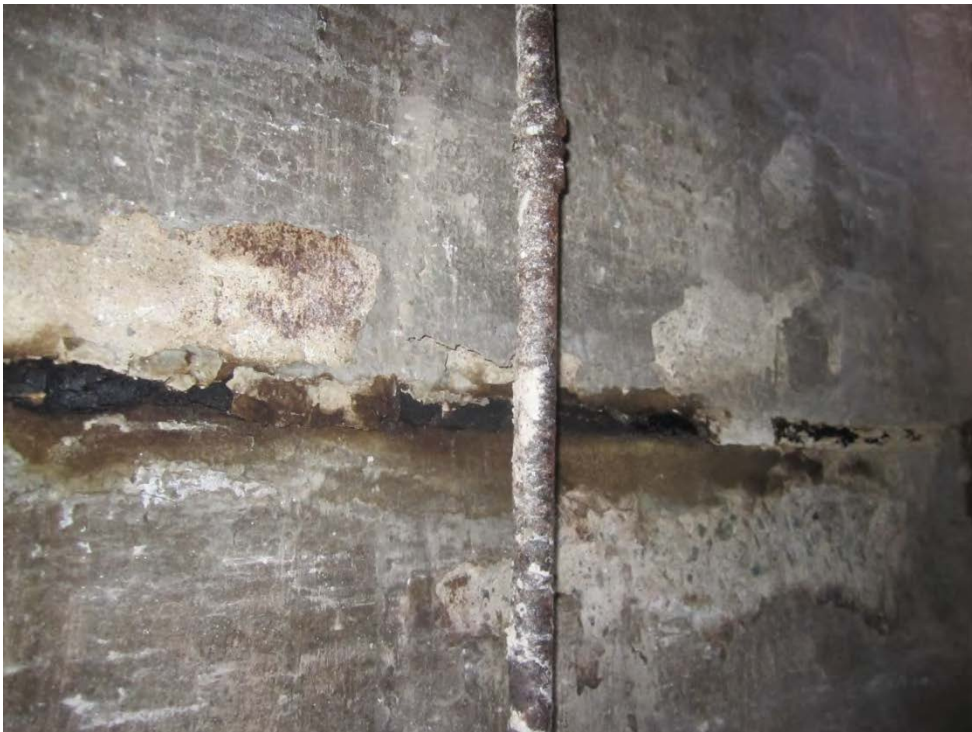
Picture #22- Deteriorated joint near Station 6

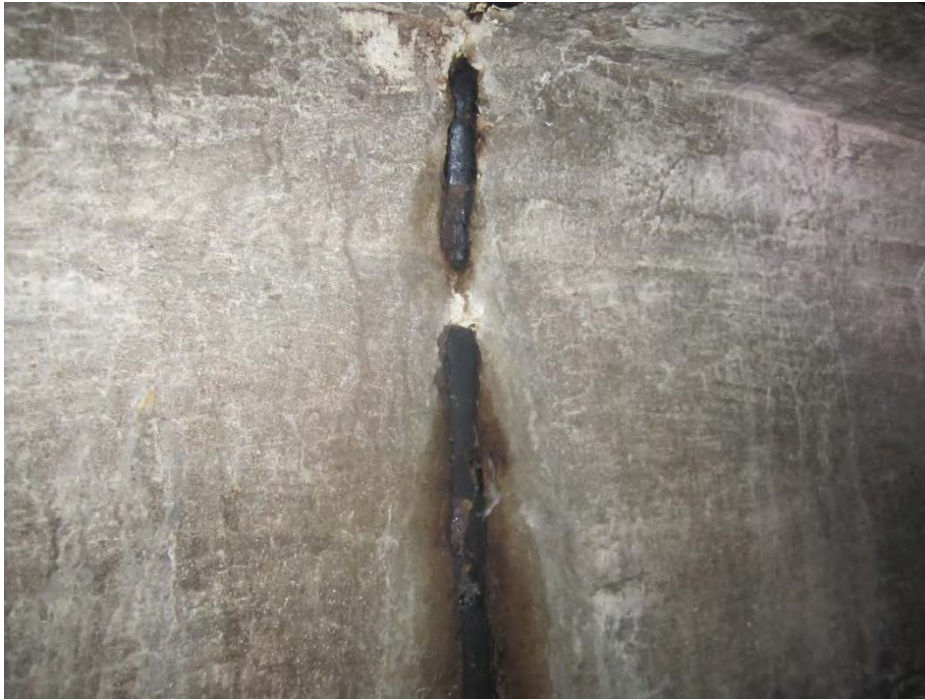
Picture #23- Deteriorated joint near Station 6

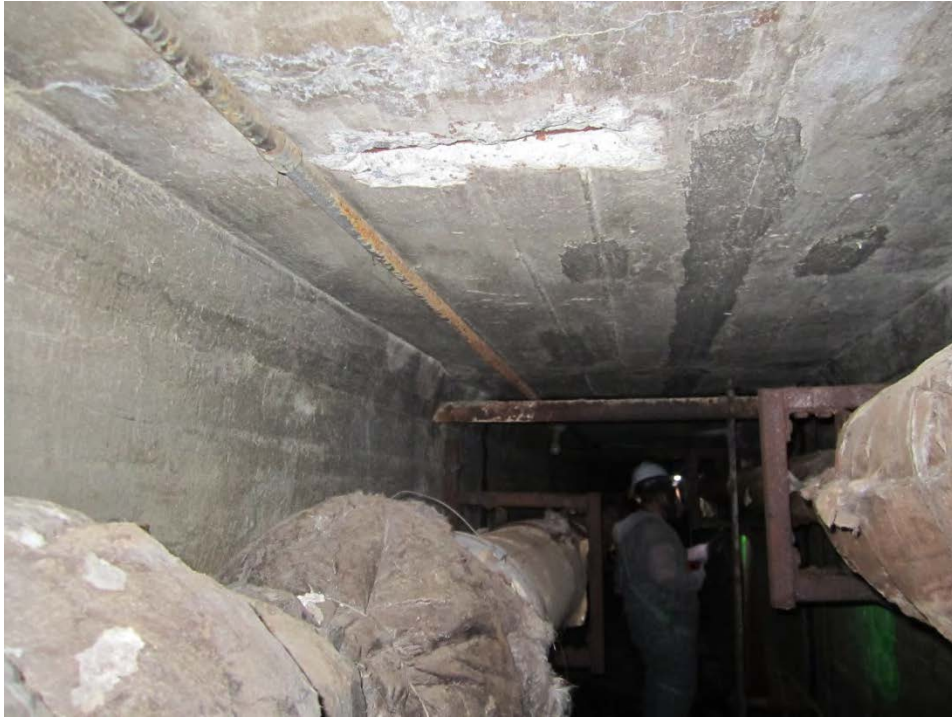
Picture #25- Ceiling spall Section 7-8

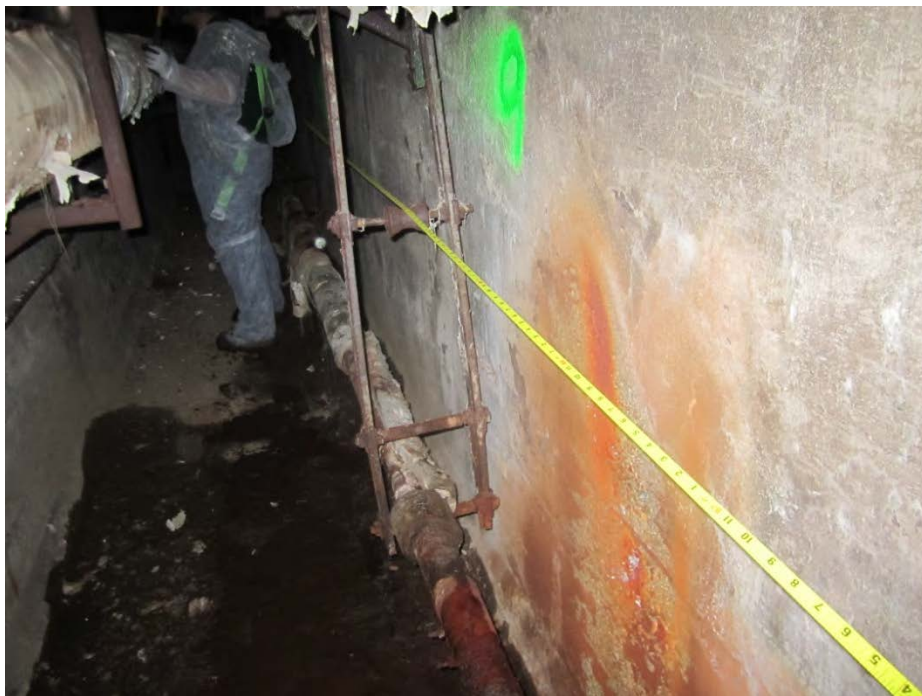
Picture #26- Damage from steam leak Section 8-9

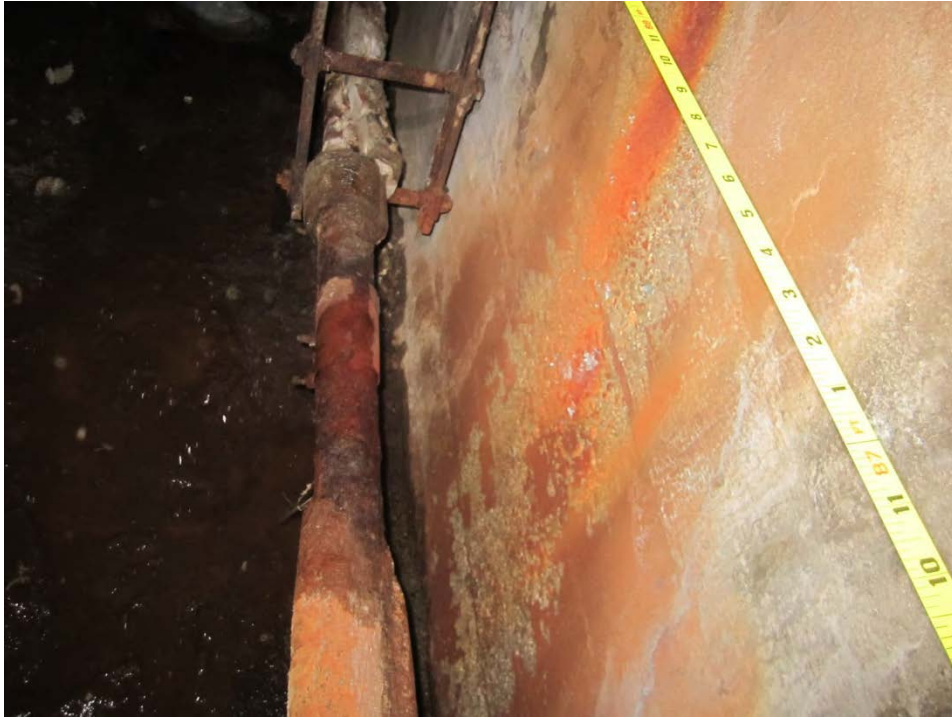
Picture #27- Damage from steam leak Section 8-9

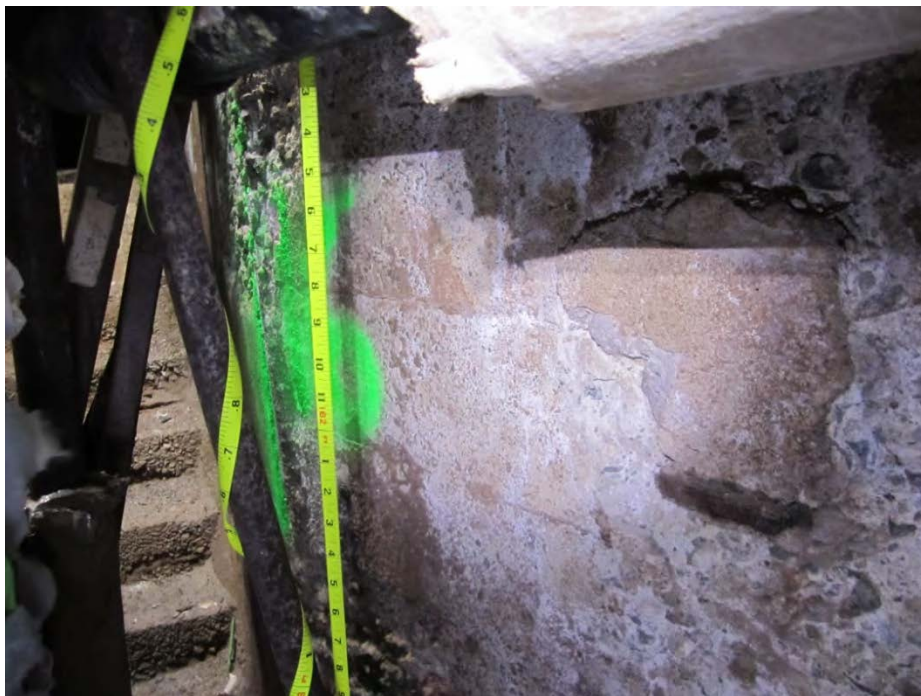
Picture #28- Soft concrete Section 15-16

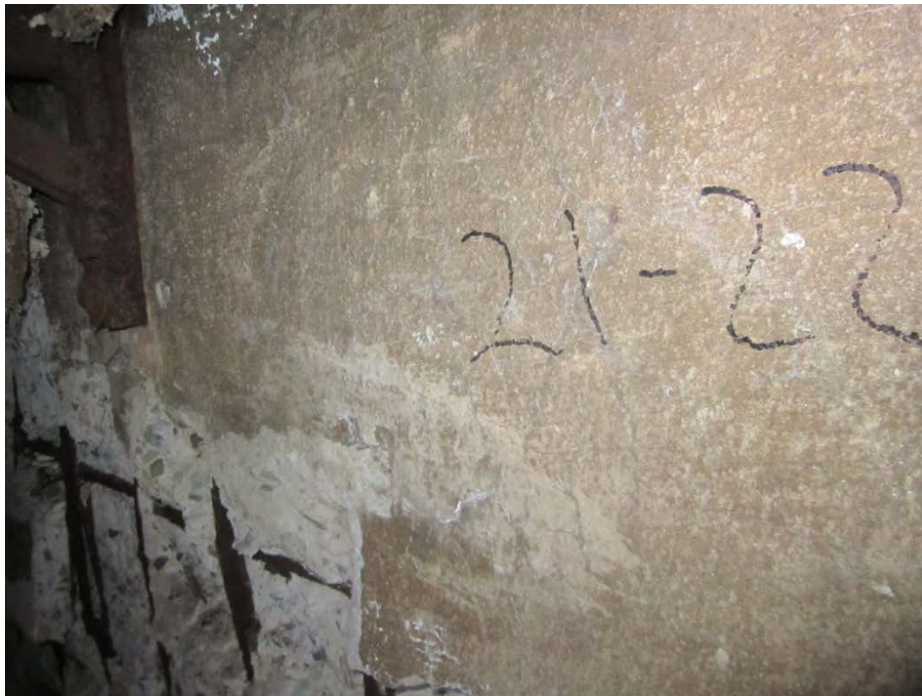
Picture #30- Spall with exposed corroded reinforcing steel Section 21-22

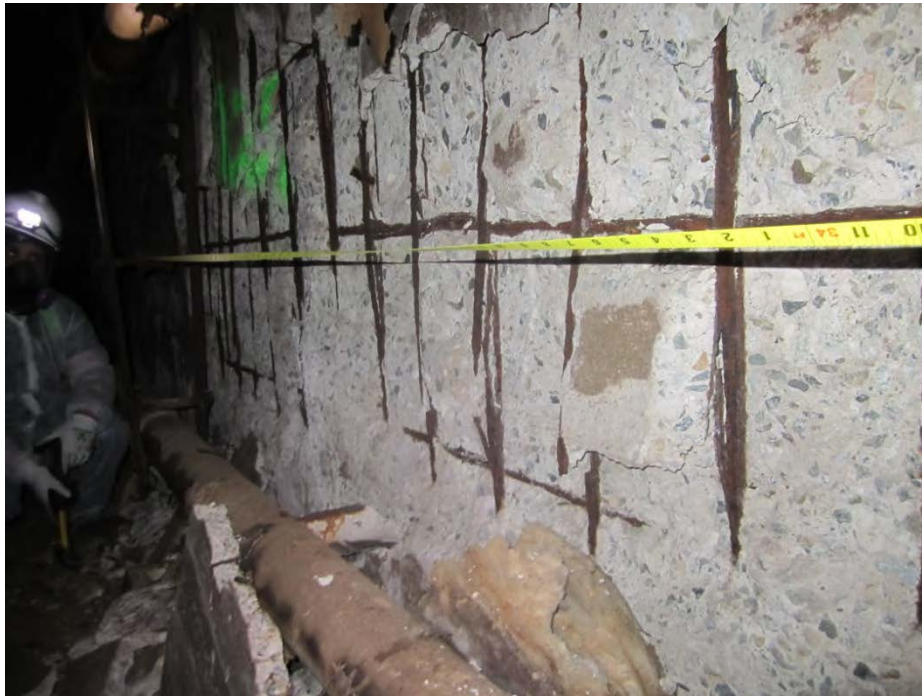
Picture #32- Spall with exposed corroded reinforcing steel Section 21-22

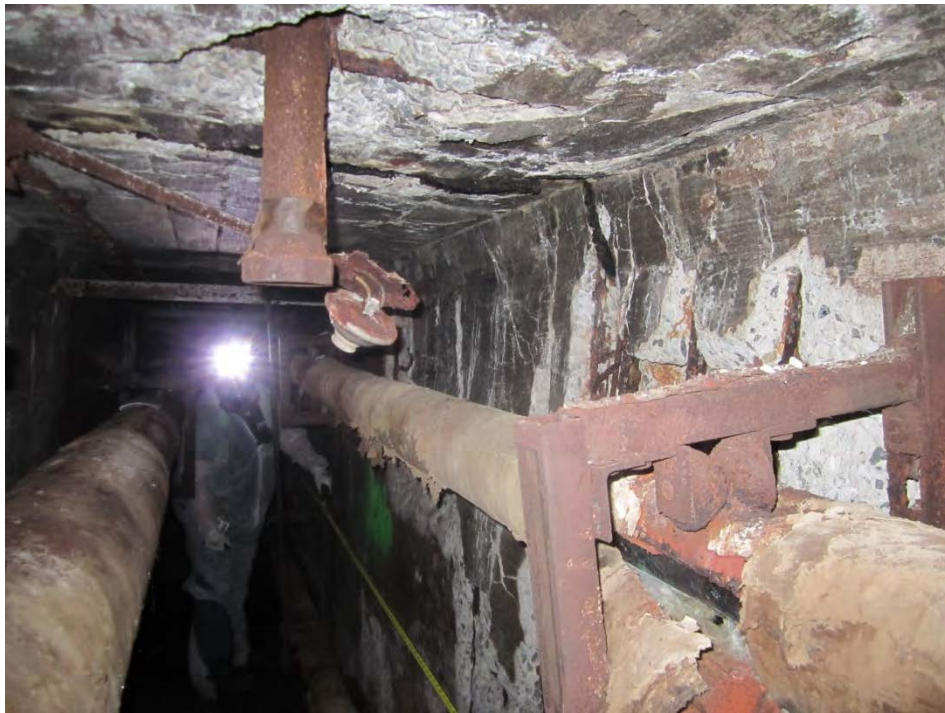
Picture #34- Damage tunnel section with spalling and heavy corrosion near Station 26

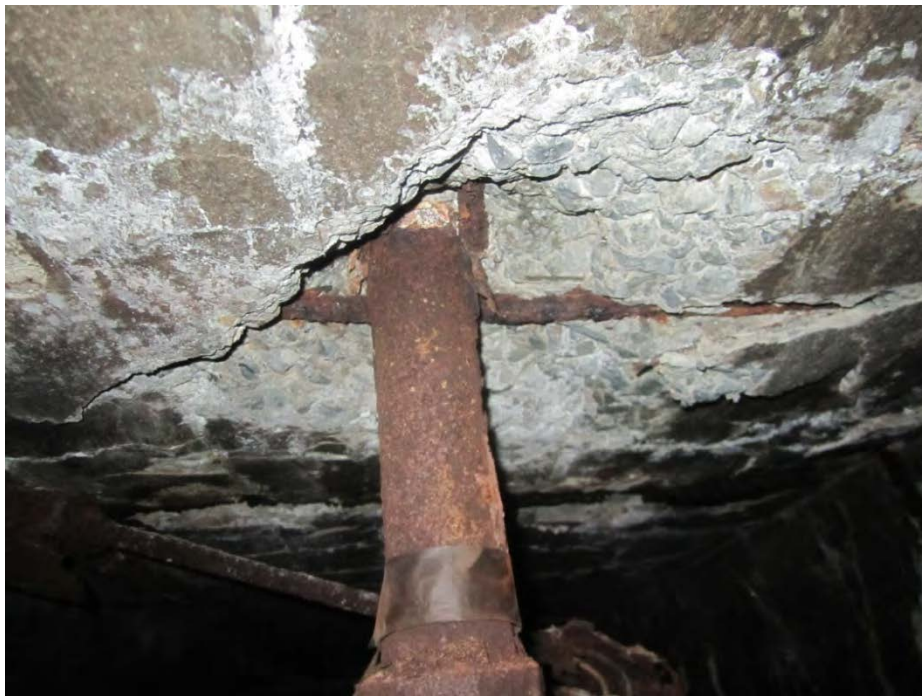
Picture #36- Ceiling delamination with corroded pipe, conduit, and reinforcing steel near Station 26

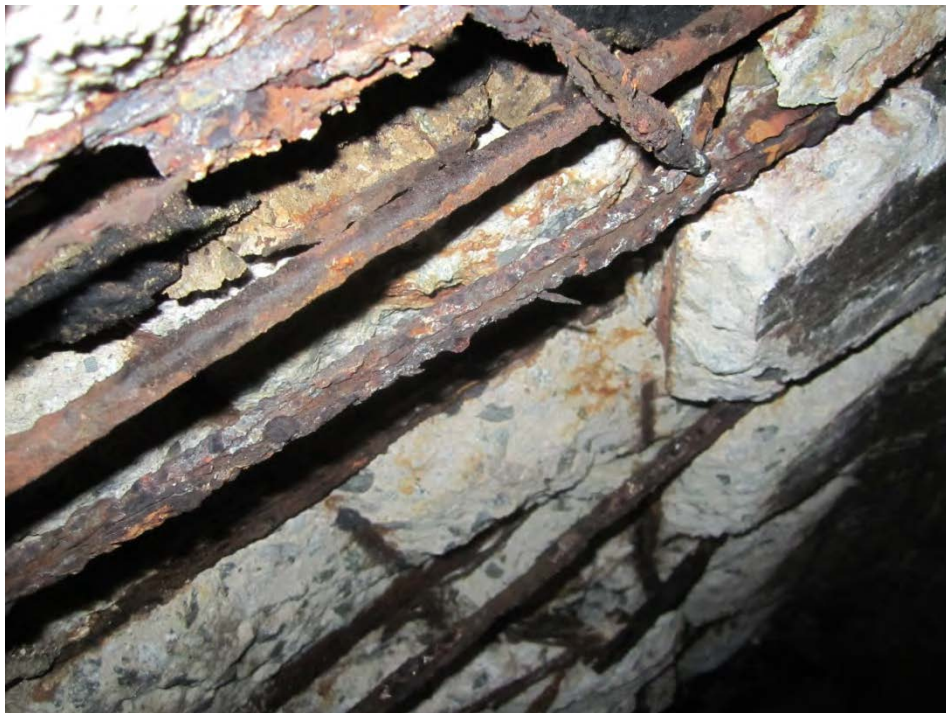
Picture #38- Deep spalling and extensive corrosion near Station 26

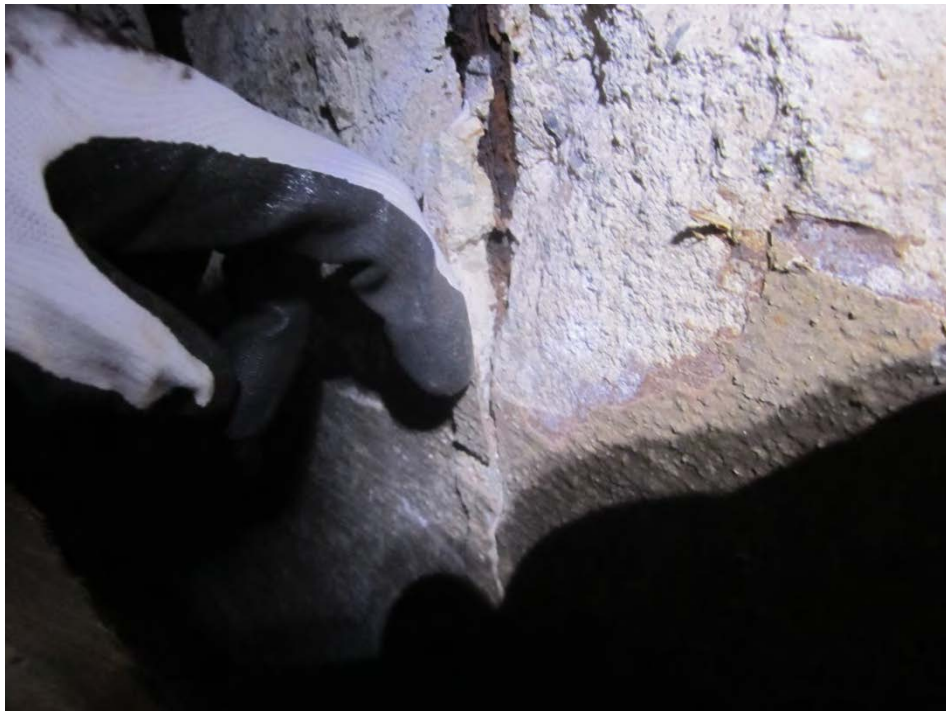
*Picture #40- Spalling and soft concrete Section 35-36*

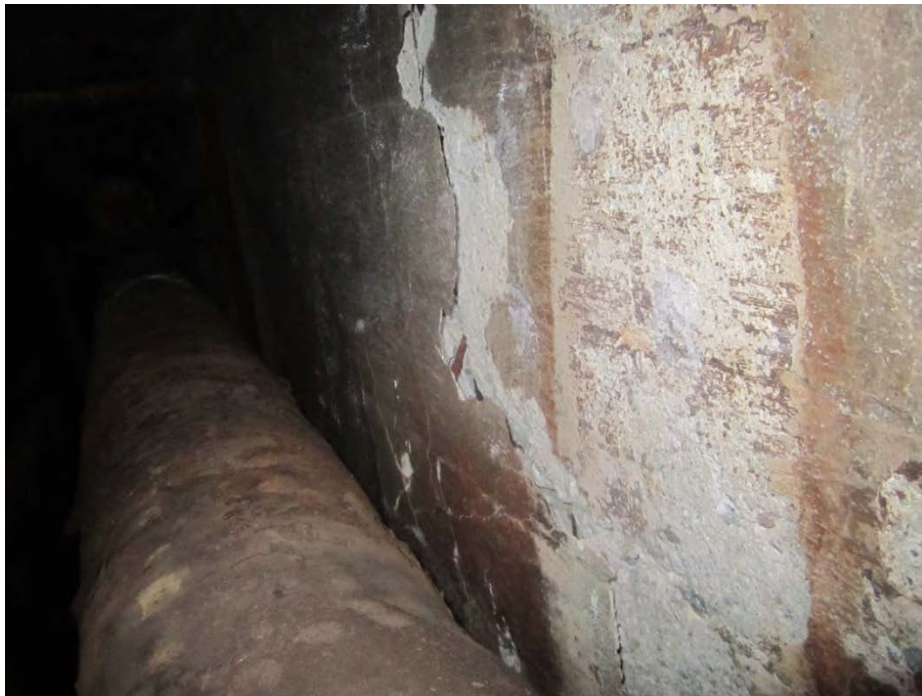
*Picture #42- Shallow delaminations Section 30-31*

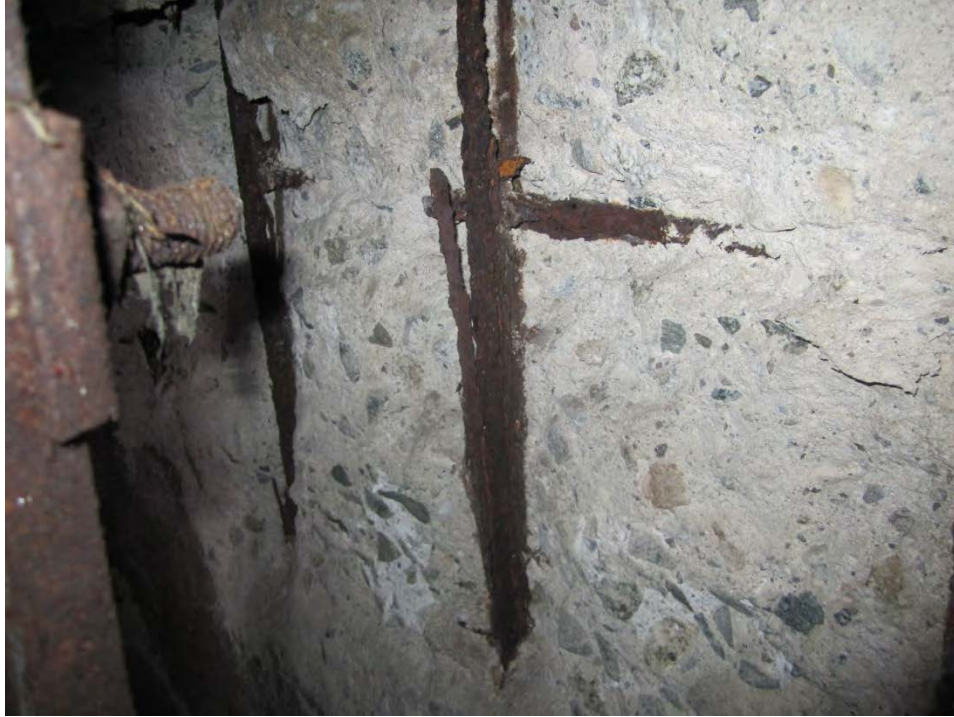
*Picture #43- Spalling and corroded rebar Section 22-23*

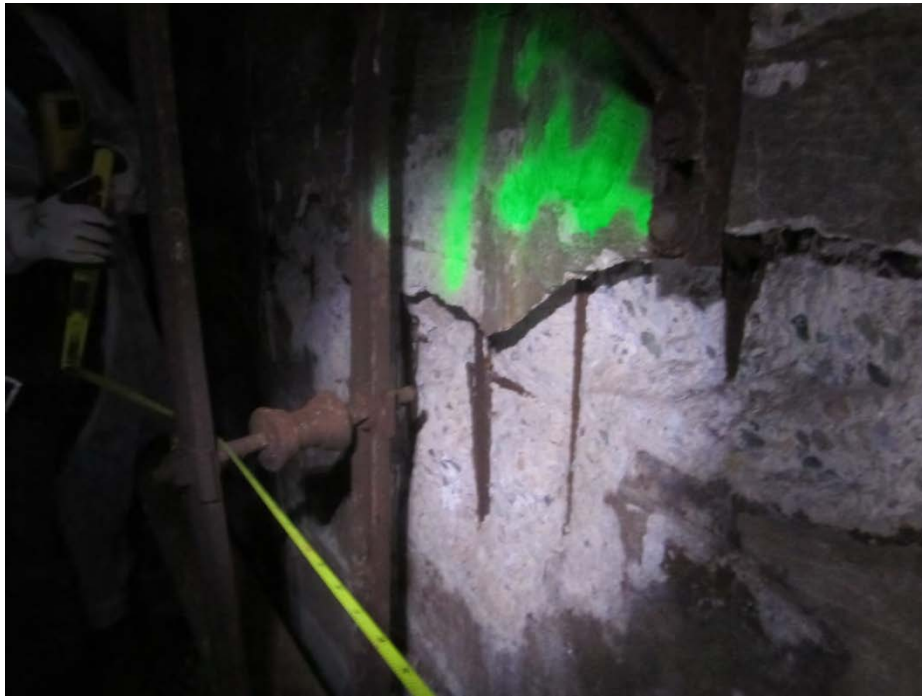
*Picture #44- Spalling at Station 22*

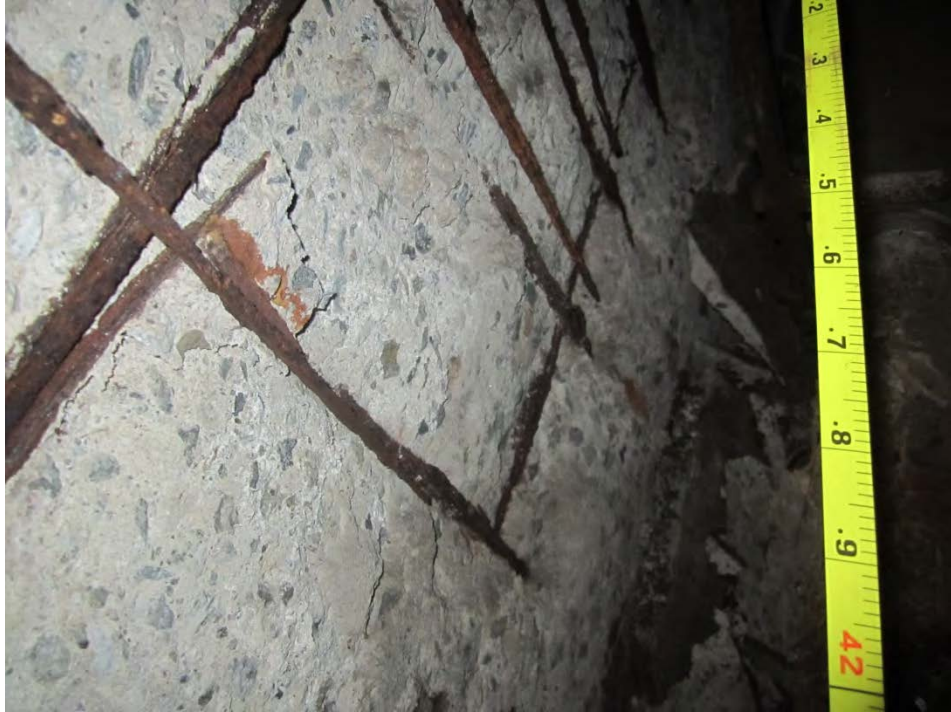
Picture #45- Spall with severe corrosion near station 22

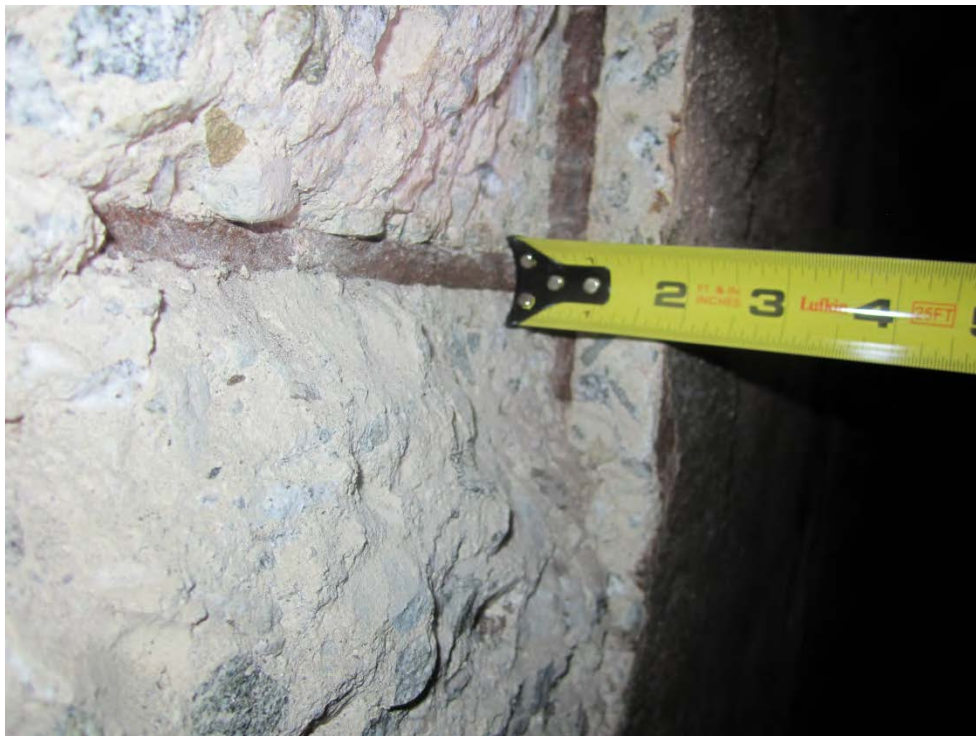
*Picture #52- Spall depth approximately 1-3/4" near Station 19*

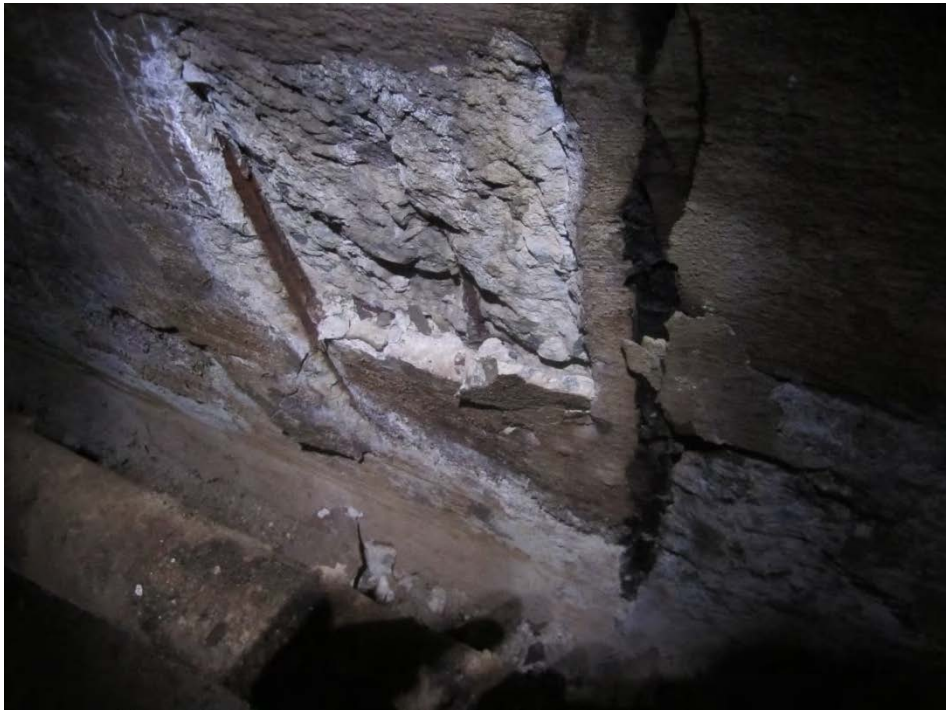
*Picture #54- Spalling near joint Section 19-20*

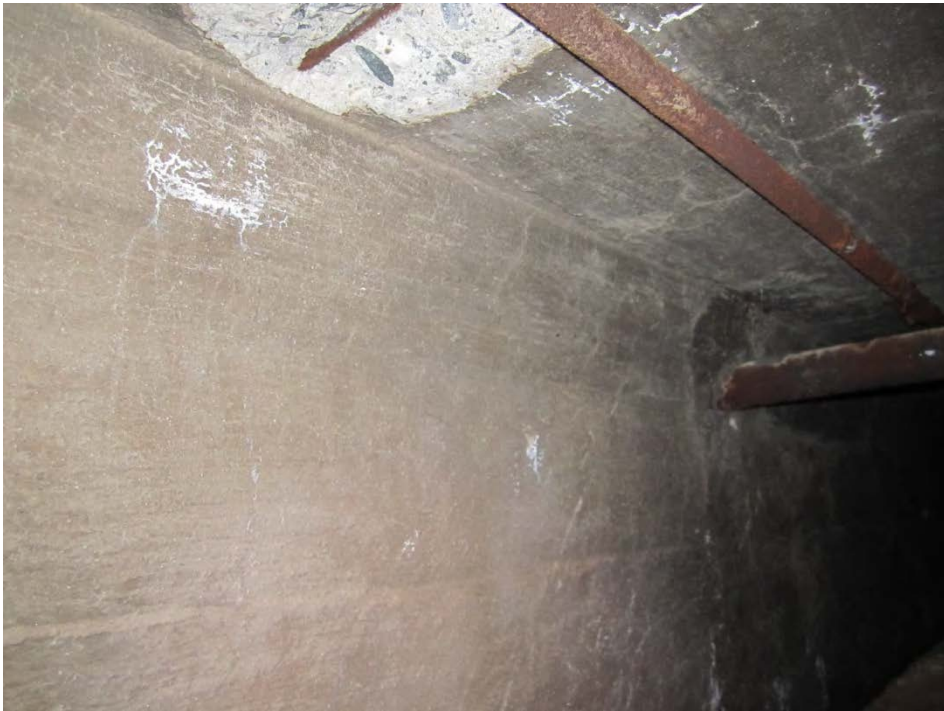
*Picture #56- Ceiling spall Section 19-20*

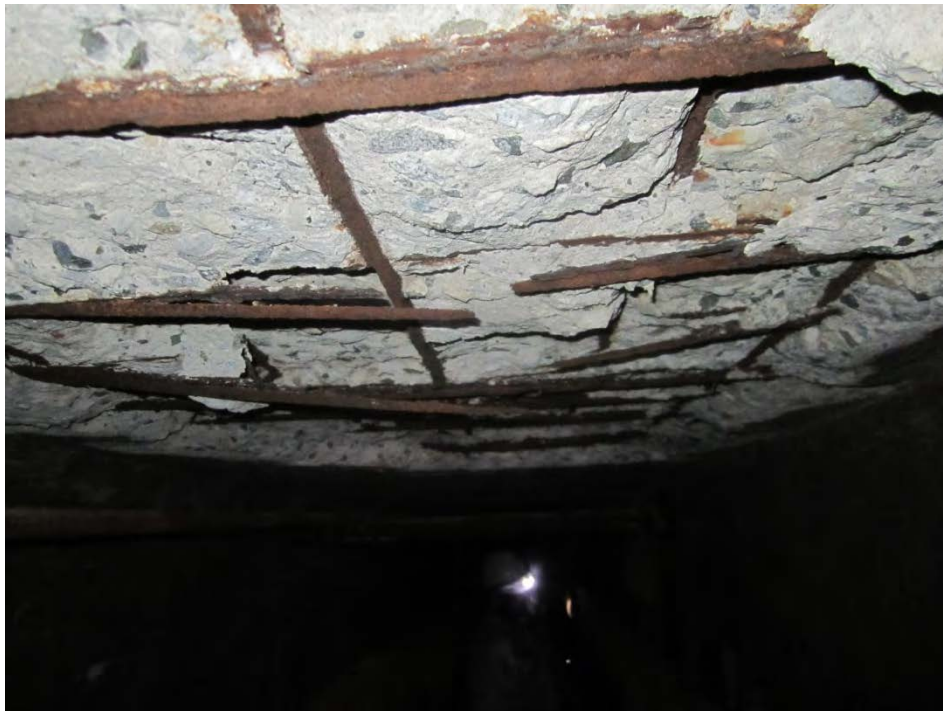
*Picture #58- Ceiling spall with broken corroded reinforcement steel Section 20-21*

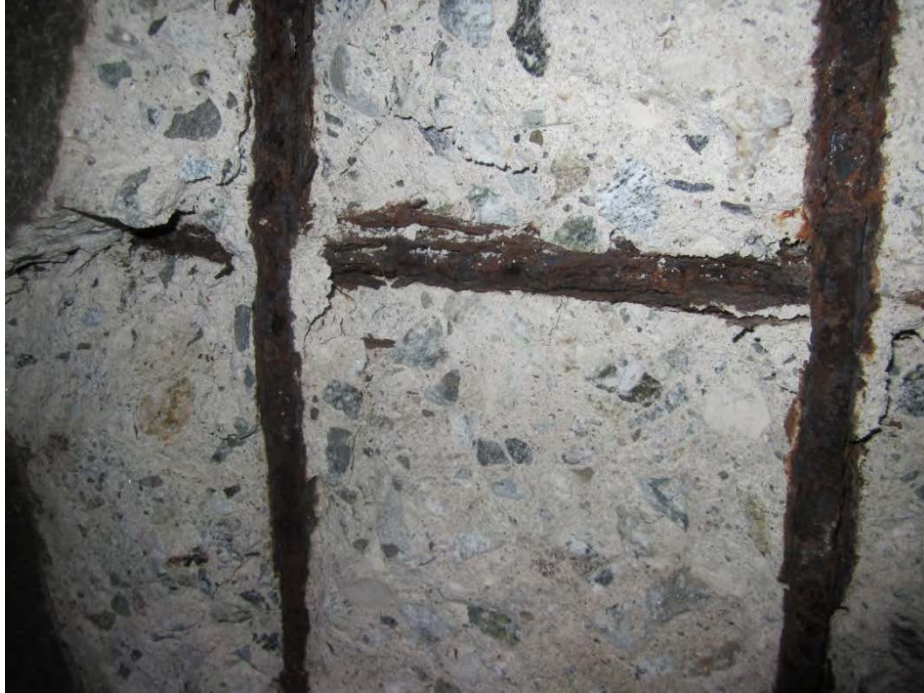
*Picture #59- Spall with reinforcing steel with advanced corrosion occurring Section 20-21*

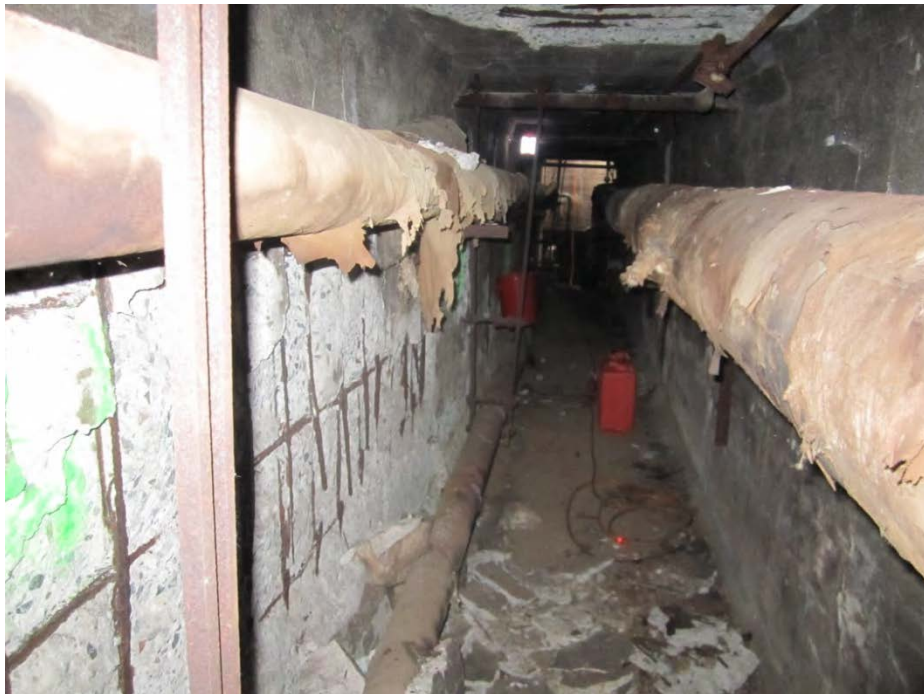
*Picture #60- Spalling Section 20-21*

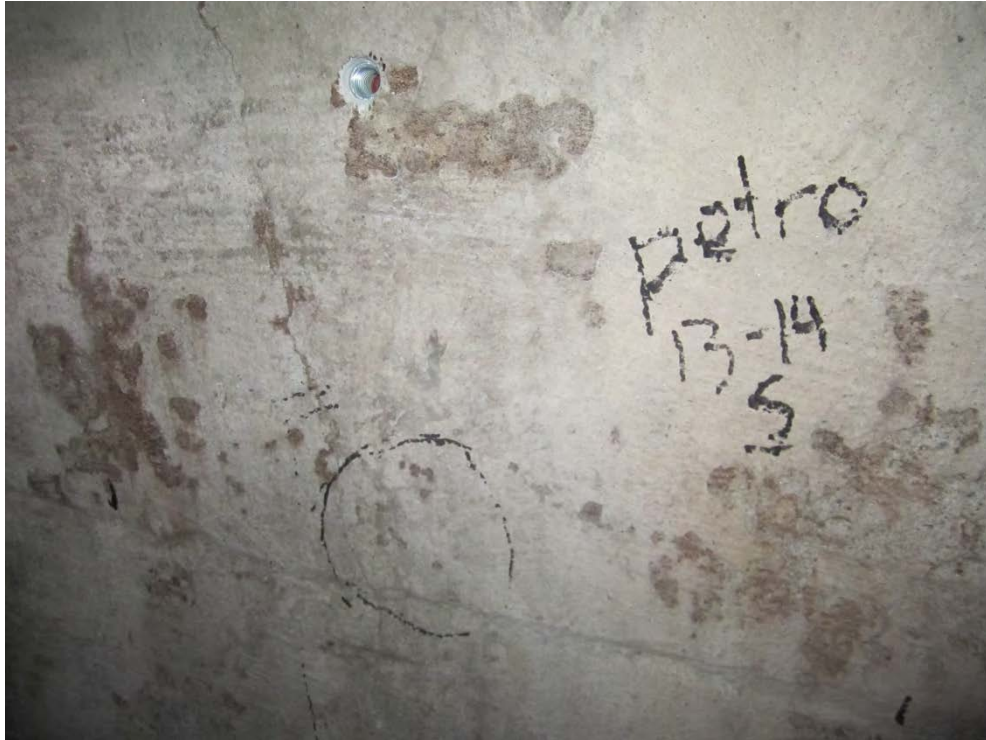
*Picture #73- Area of core Petro13-14-S taken on a crack*

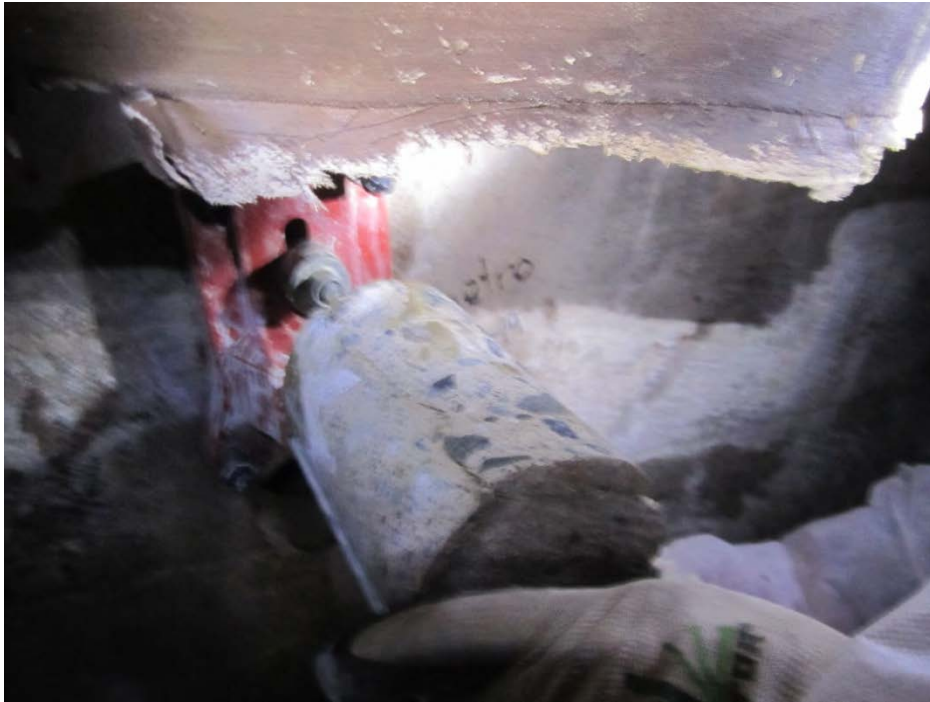
*Picture #77- Petro13-14S visible crack*

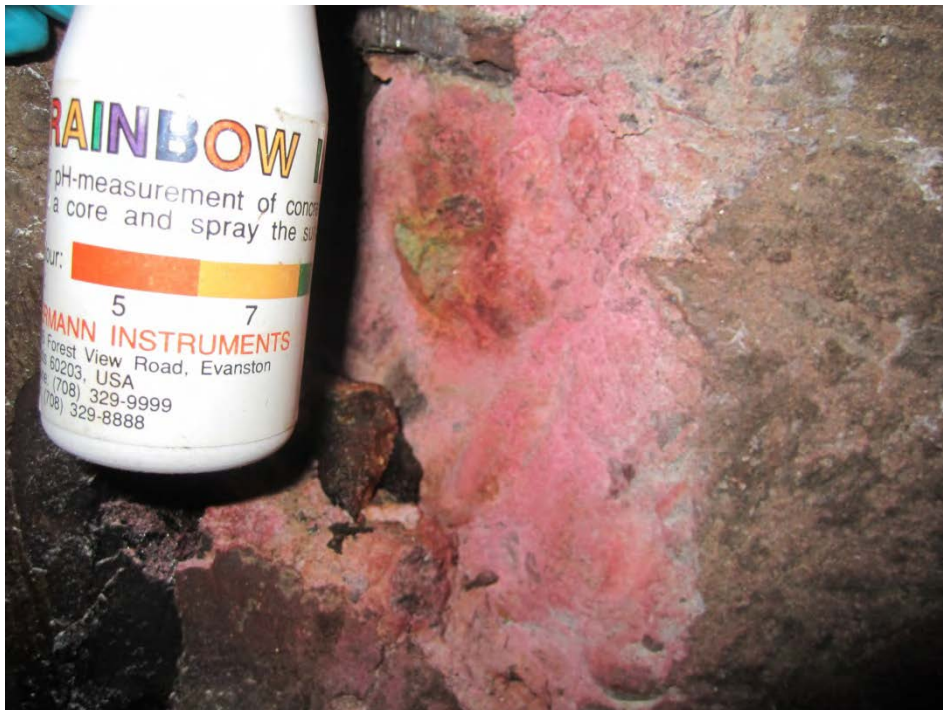
*Picture #78- Spalled area indicating a PH of approximately 5*

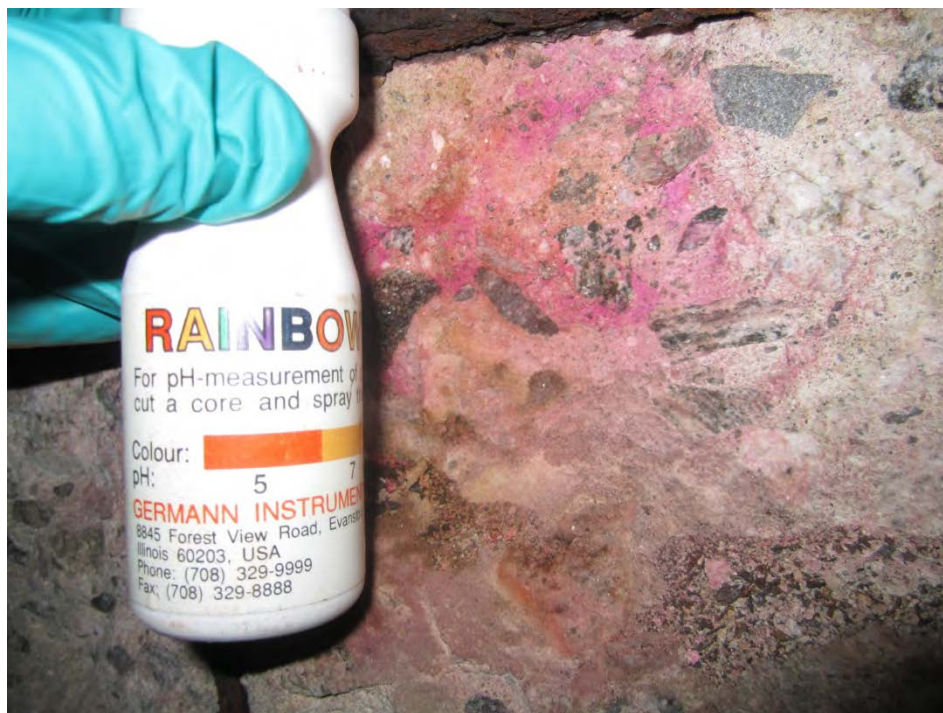
*Picture #80- Spalled area indicating a pH of approximately 5*

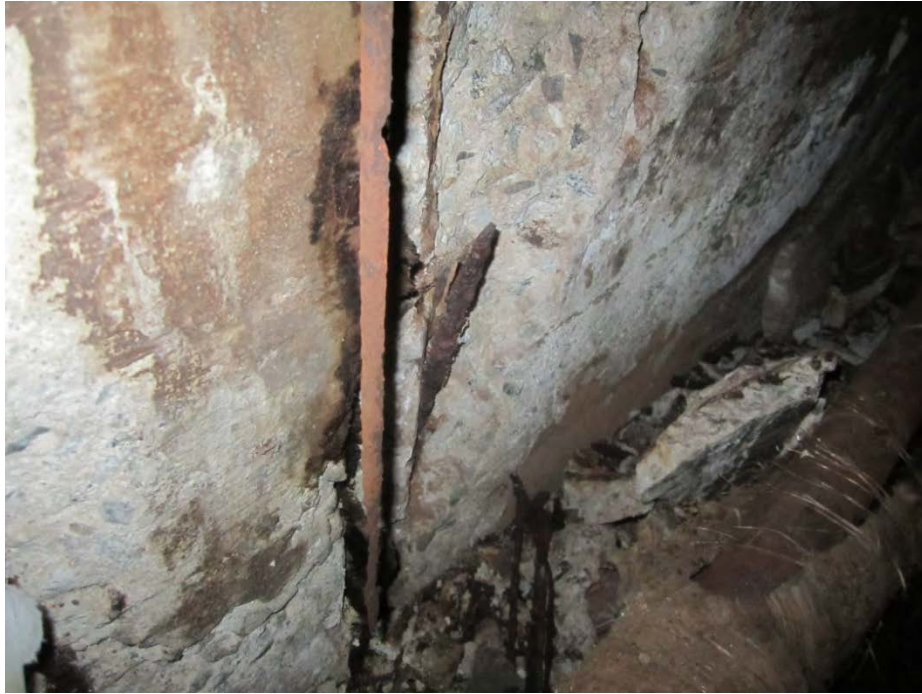
*Picture #83- Spalling around a joint*

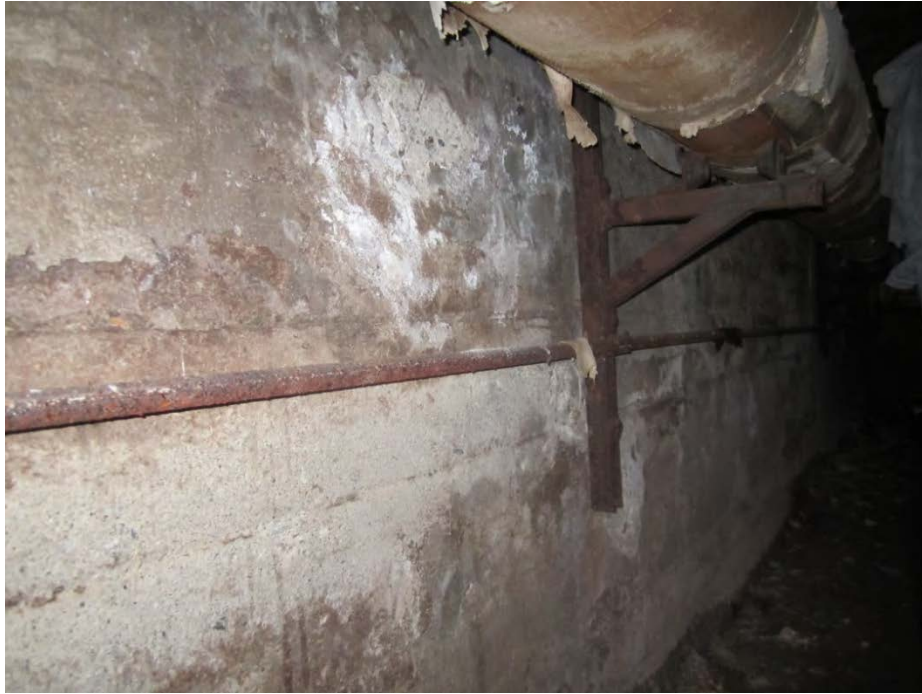
*Picture #85- Soft flakey concrete*

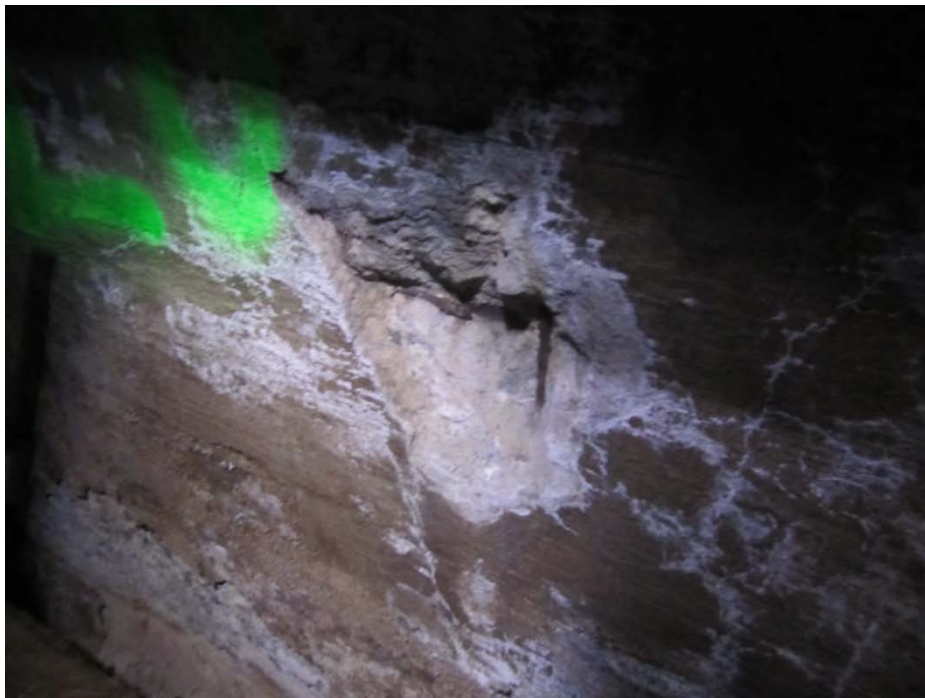
*Picture #86- Spall around Station 20*
