LAC+USC TUNNEL STRUCTURAL AND MECHANICAL ASSESSMENT  
AND ASBESTOS SURVEY,  
1200 NORTH STATE STREET, LOS ANGELES, CALIFORNIA

LAC USC TUNNEL  
Structural and Mechanical  
Assessment and Asbestos Survey

January 30, 2013

**Structural Assessment & Corrosion Evaluation Of  
LAC+USC Medical Center/Utility Tunnel (Juvenile Hall)  
Los Angeles, California**

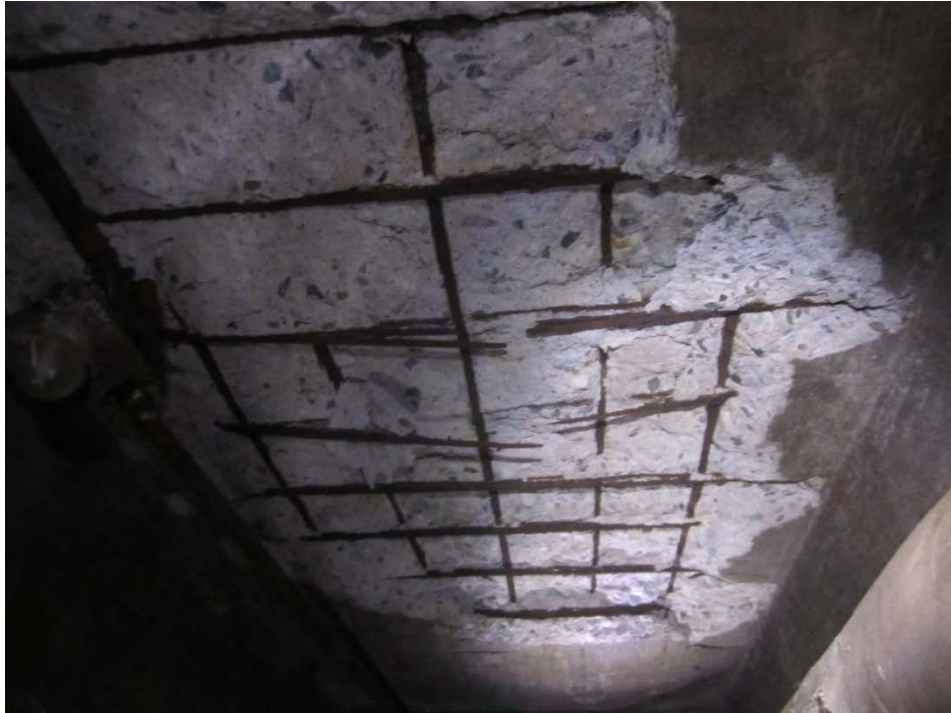
*Picture #91- Ceiling spall near Station 20*

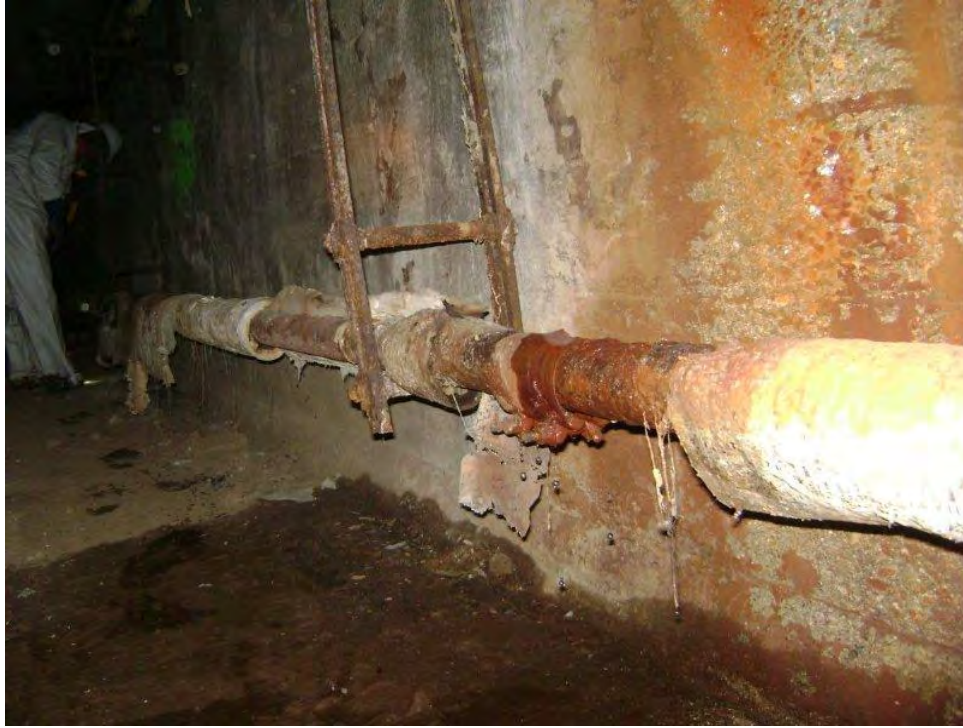
PHOTO 1: STEAM CONDENSATE PIPE LEAKAGE

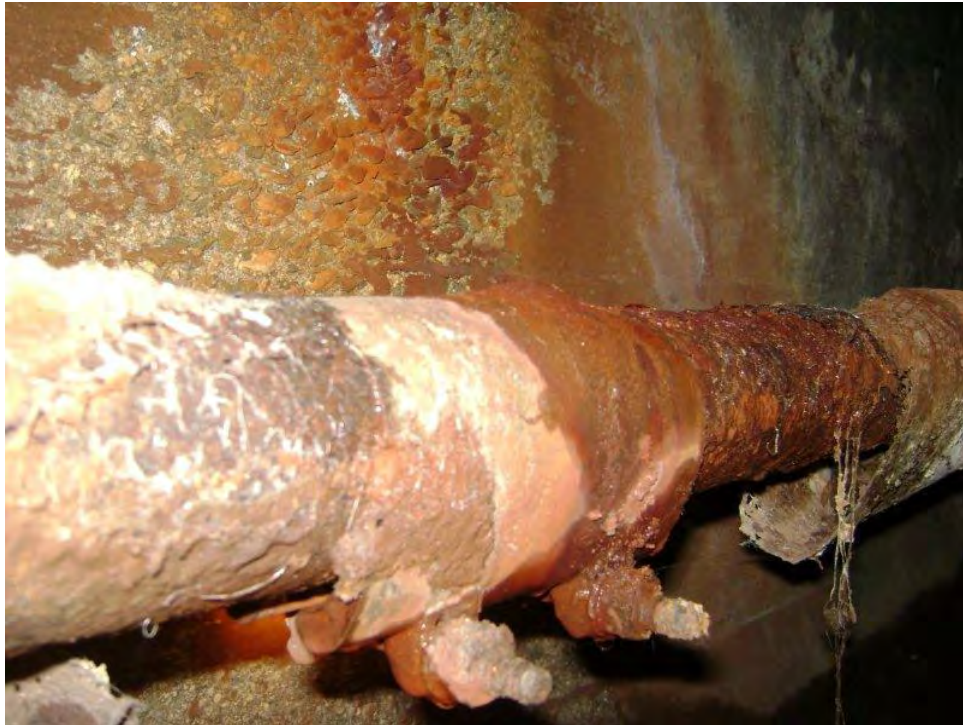
PHOTO 2: STEAM CONDENSATE PIPE LEAKAGE

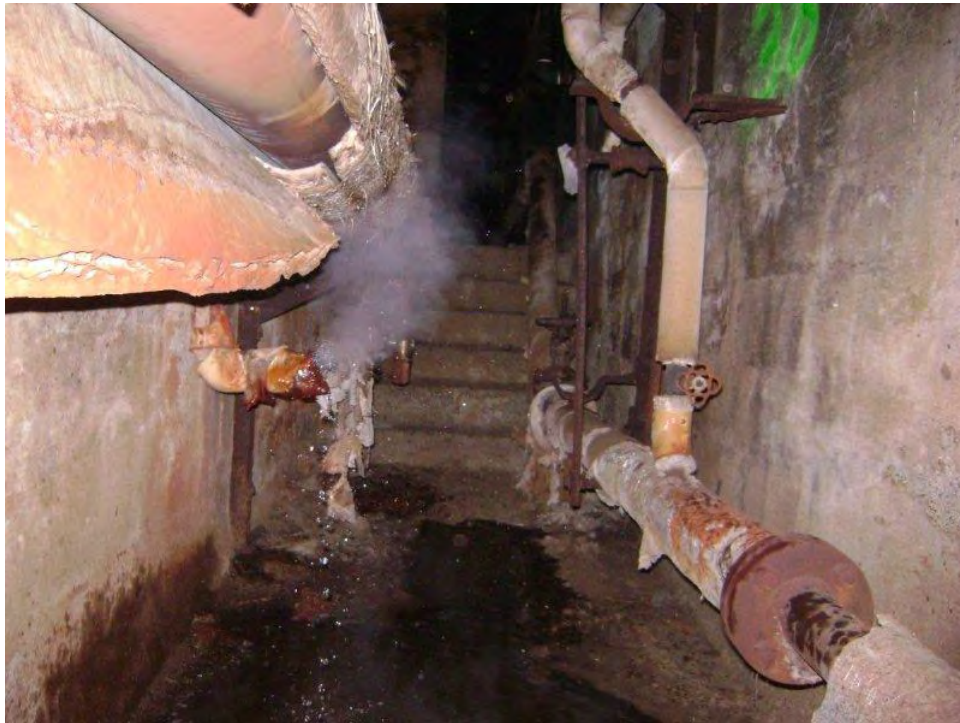
PHOTO 3: STEAM CONDENSATE PIPE LEAKAGE AS IT HEADS TO JUVENILE HALL

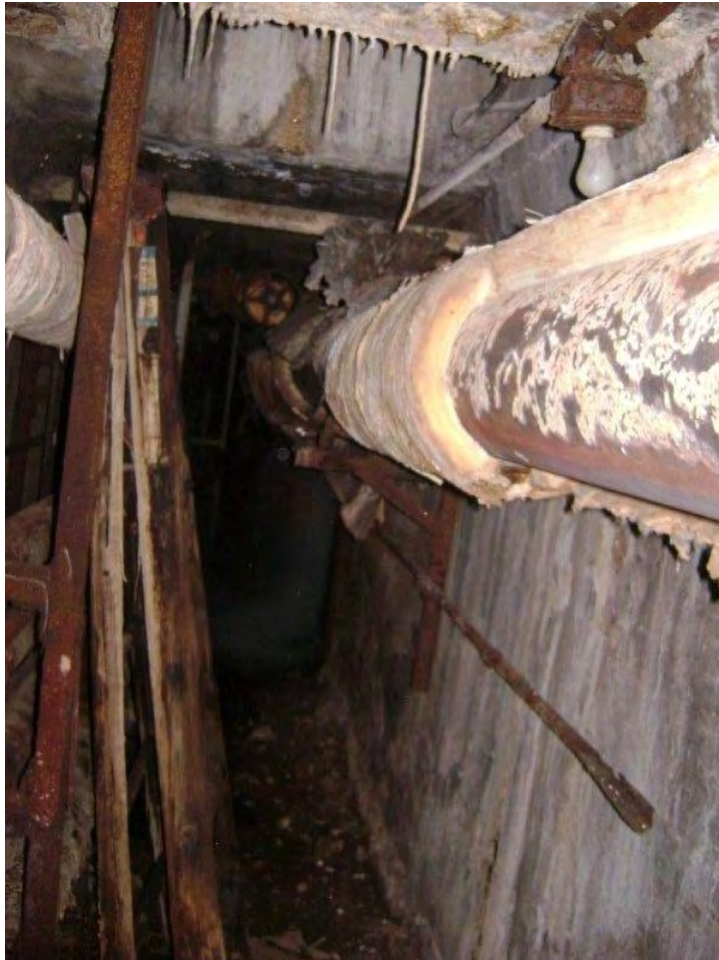
PHOTO 4: STEAM PIPE LEAKAGE NEAR MANHOLE AT ZONAL AVENUE

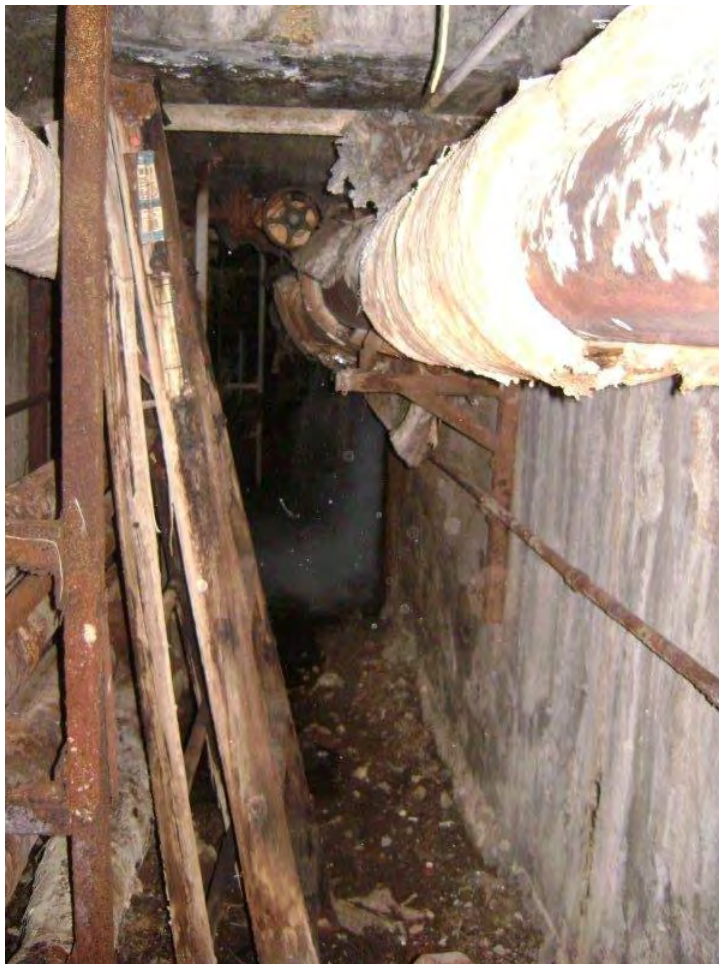
PHOTO 5: TEAM PIPE LEAKAGE NEAR MANHOLE AT ZONAL AVENUE

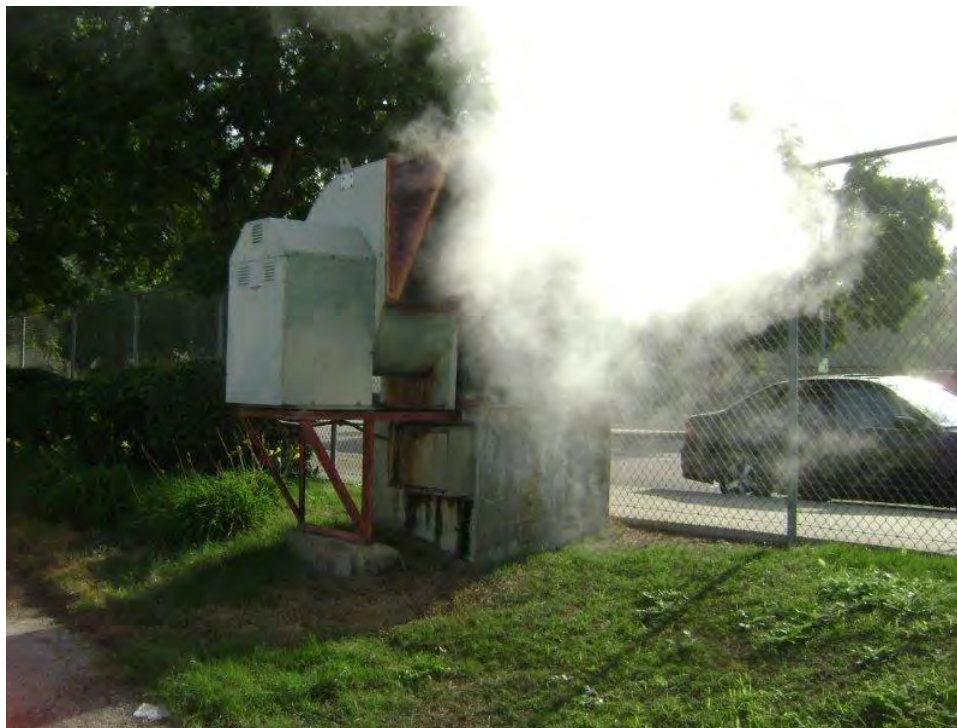
PHOTO 6: STEAM ESCAPING (EASILY OBSERVABLE) THRU EXHAUST FAN ON TOP OF MANHOLE AT ZONAL AVENUE

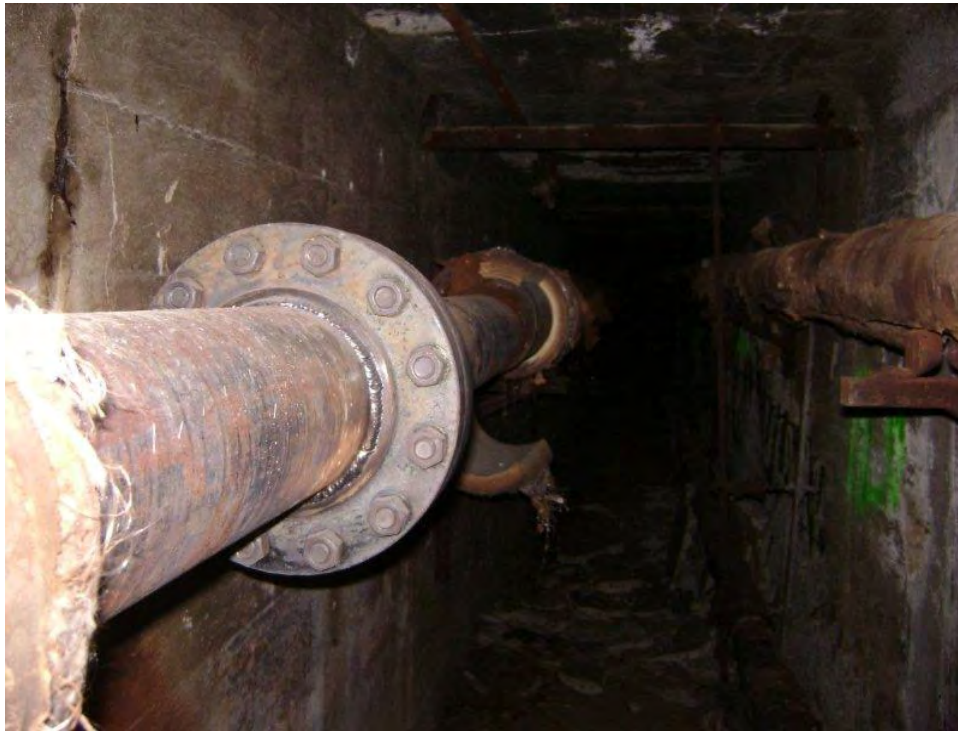
PHOTO 11: INSULATION MISSING FOR STEAM SUPPLY PIPE

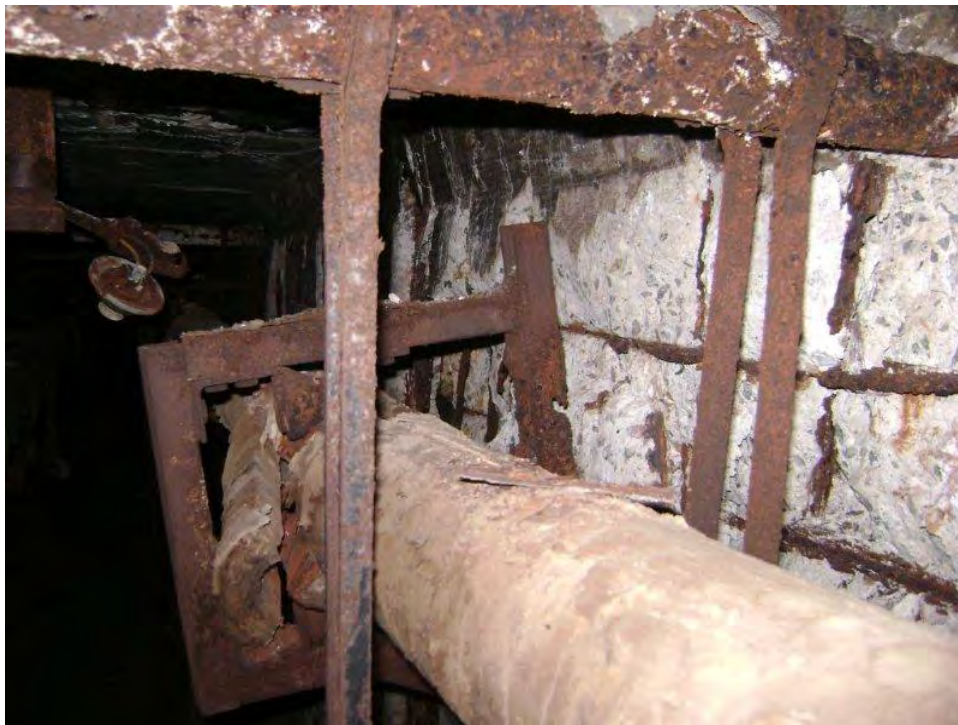
PHOTO 12: STEAM SUPPORT NOT PROPERLY ANCHORED OR SECURED TO CONCRETE WALL

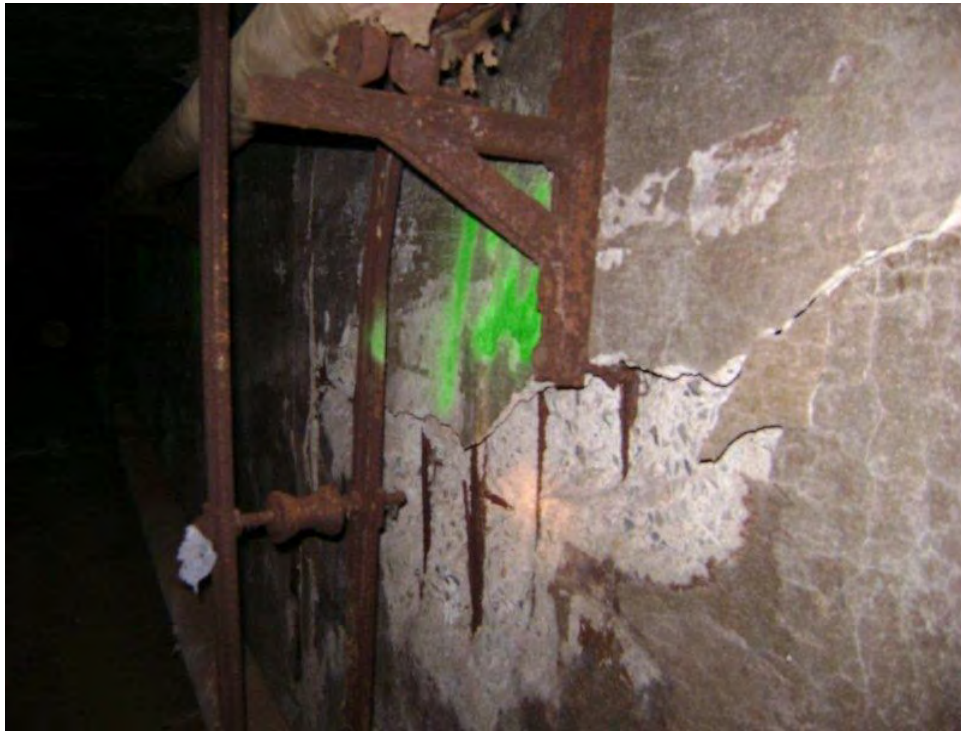
PHOTO 13: CONCRETE WALL SPALLED

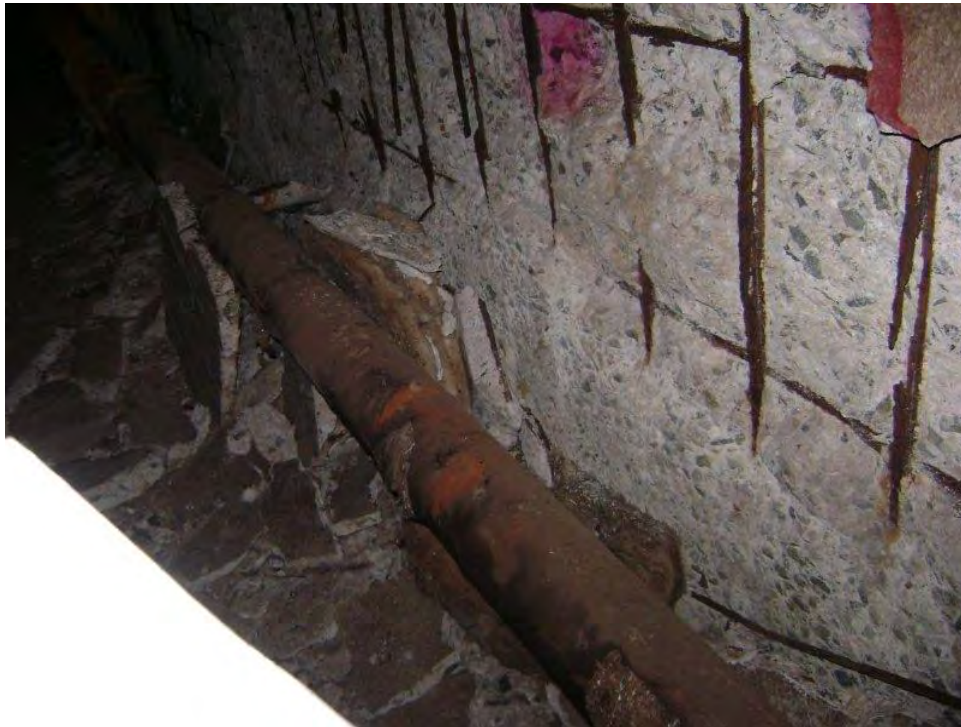
PHOTO 14: CONCRETE WALL FELL ON TOP OF STEAM CONDENSATE PIPE

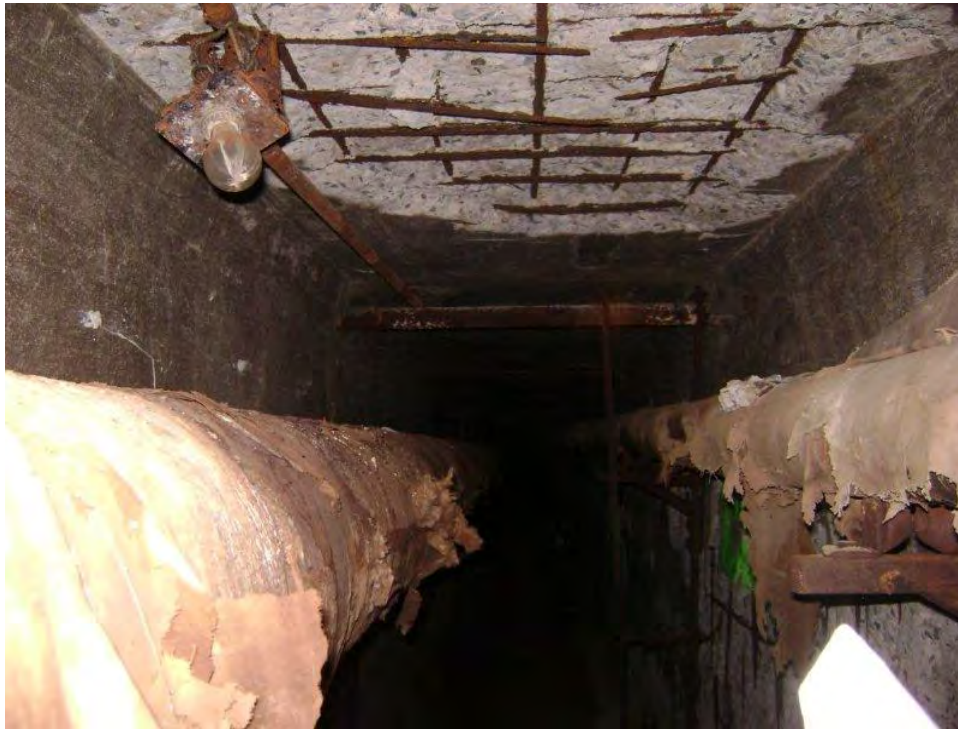
PHOTO 15: ELECTRICAL CONDUIT CORRODED

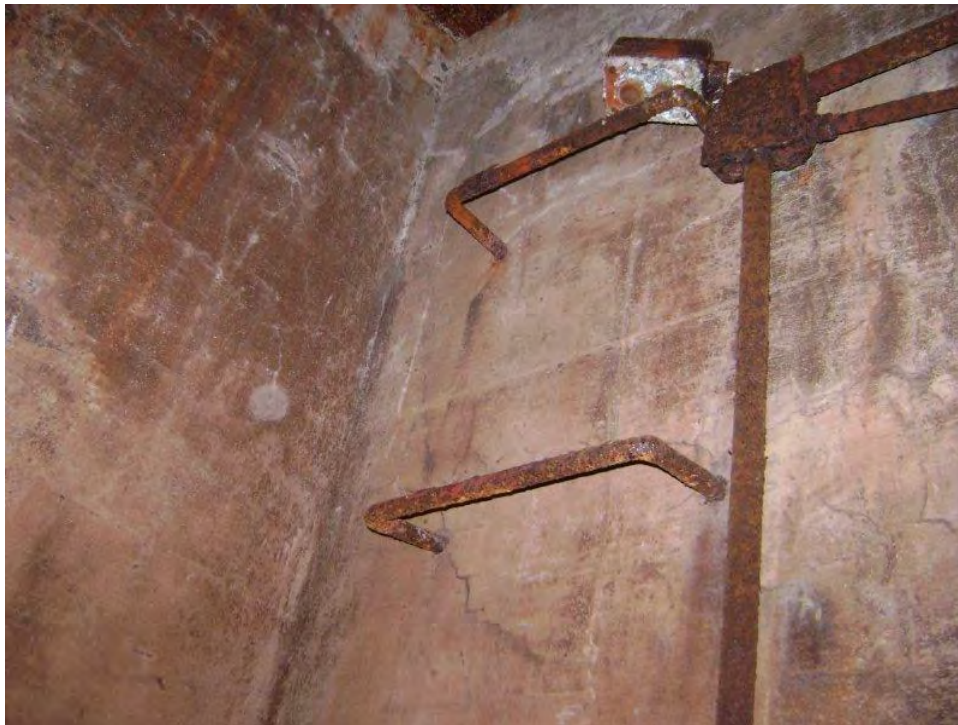
PHOTO 16: ELECTRICAL CONDUIT CORRODED

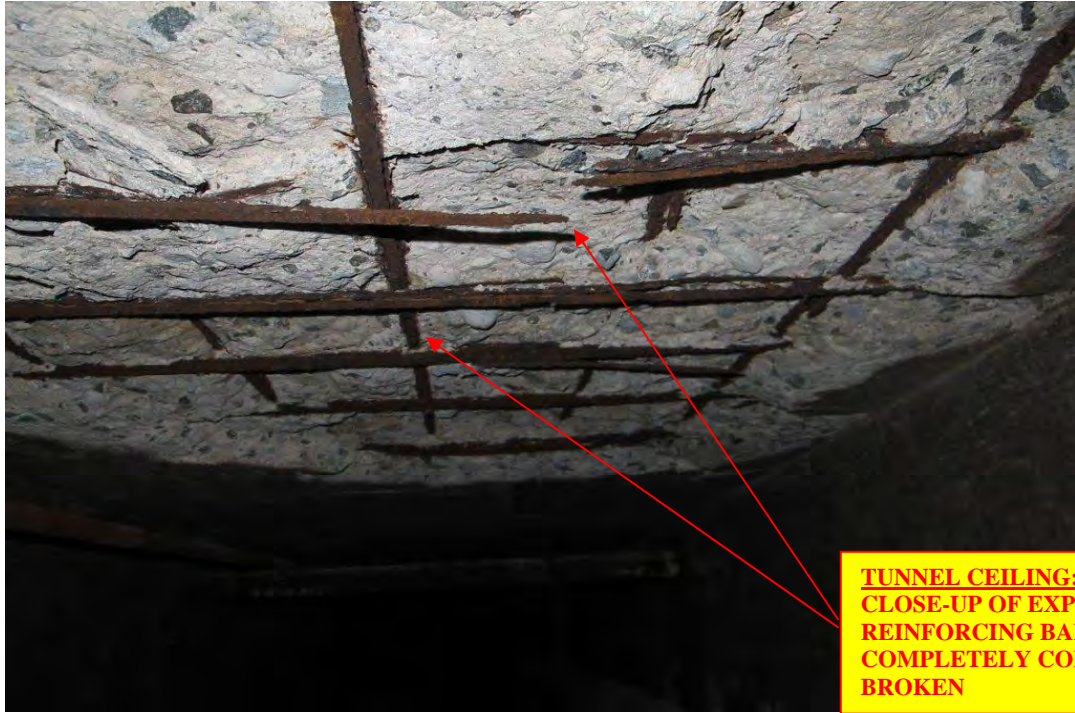
**PHOTO 3: TUNNEL CEILING**

**TUNNEL CEILING:  
CLOSE-UP OF EXPOSED  
REINFORCING BARS,  
COMPLETELY CORRODED &  
BROKEN**

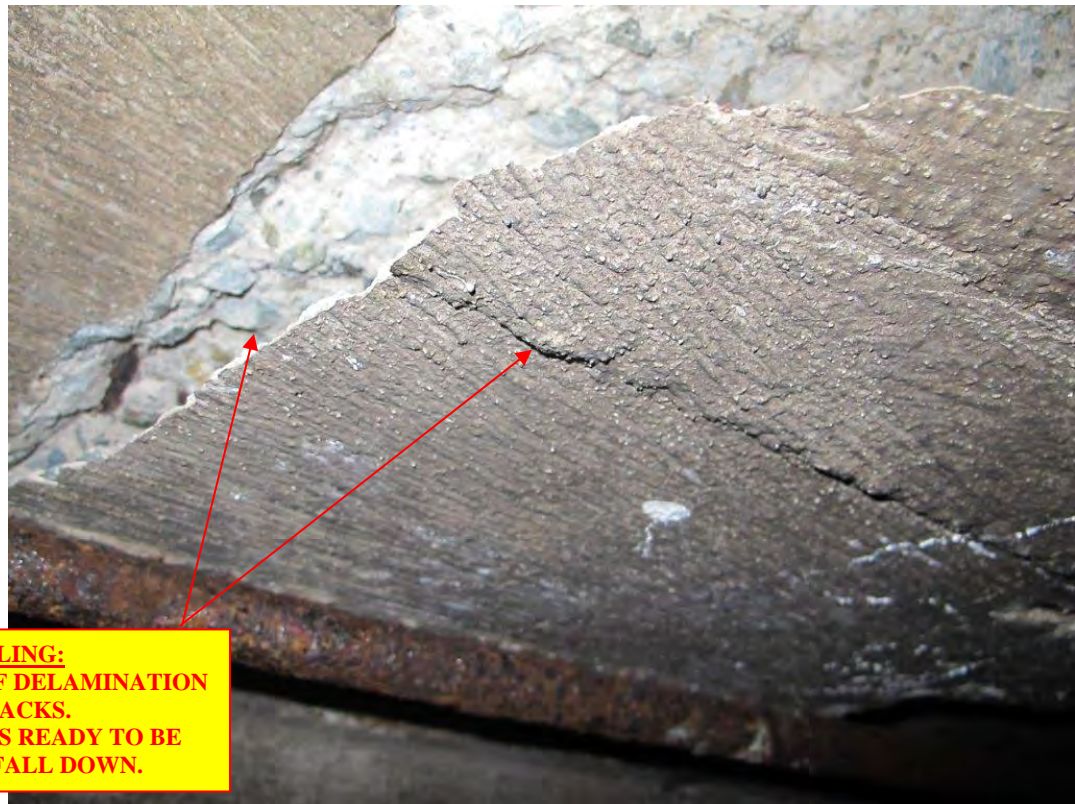
**PHOTO 4: TUNNEL CEILING**

**TUNNEL CEILING:  
CLOSE-UP OF DELAMINATION  
& LARGE CRACKS.  
CONCRETE IS READY TO BE  
SPALLED & FALL DOWN.**

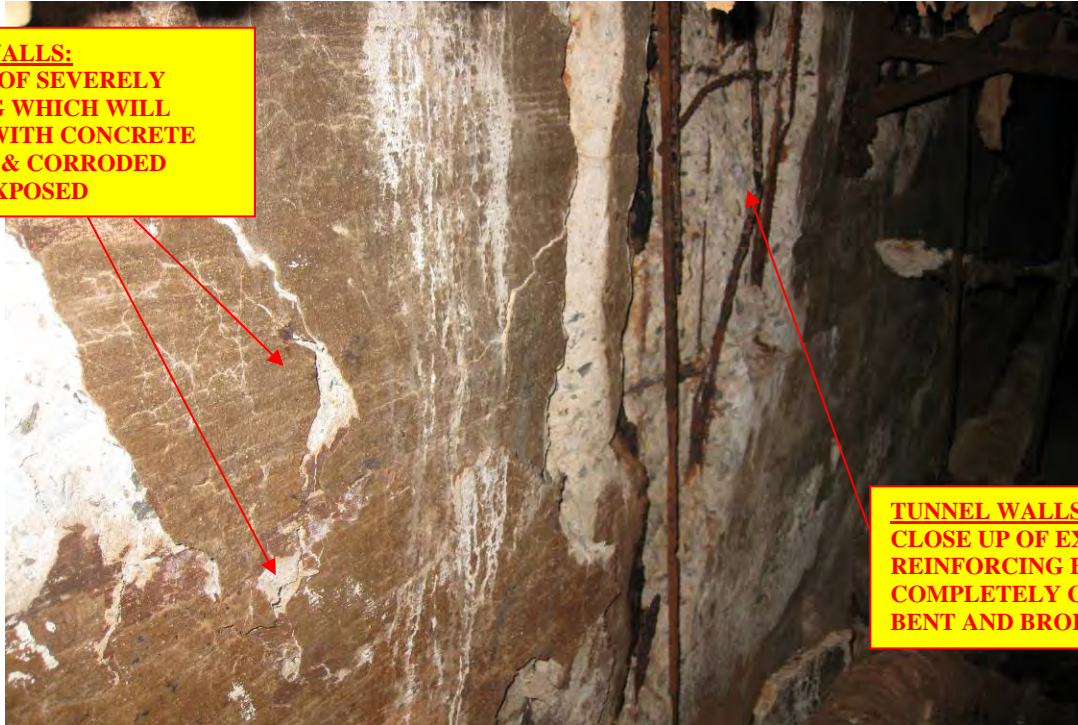
**TUNNEL WALLS:  
CLOSE UP OF EXPOSED  
REINFORCING BARS,  
COMPLETELY CORRODED,  
BENT AND BROKEN**

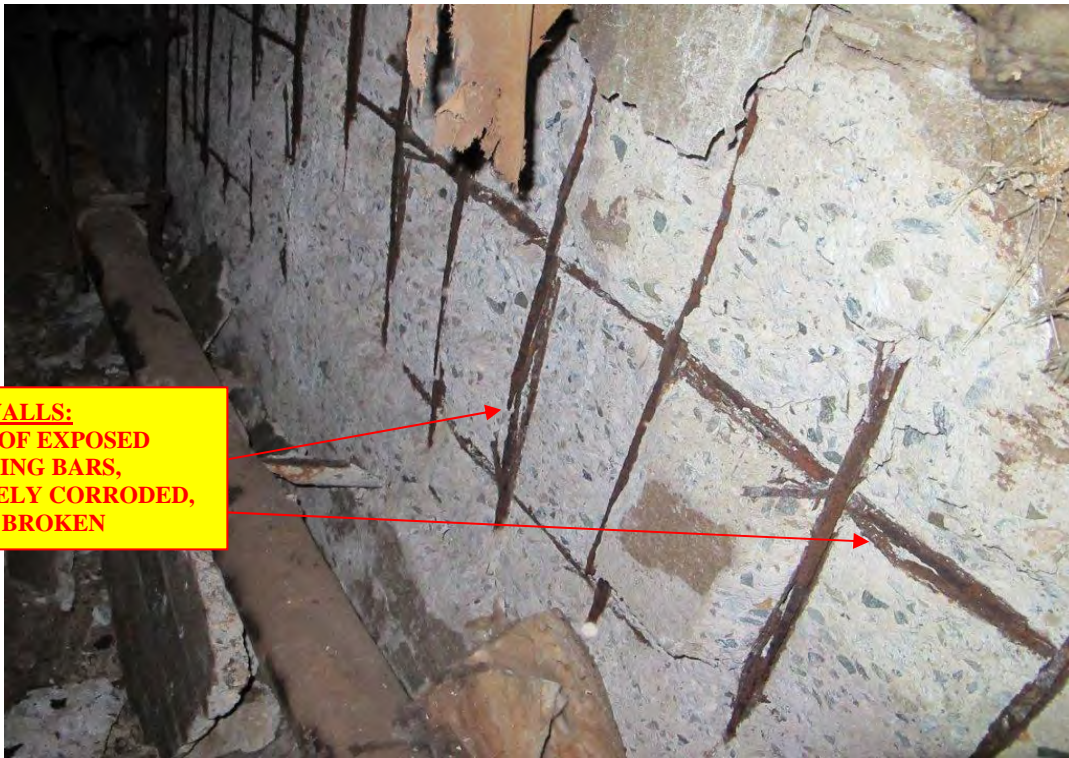
**PHOTO 6: TUNNEL WALLS**

**TUNNEL WALLS:  
CLOSE UP OF EXPOSED  
REINFORCING BARS,  
COMPLETELY CORRODED,  
BENT AND BROKEN**

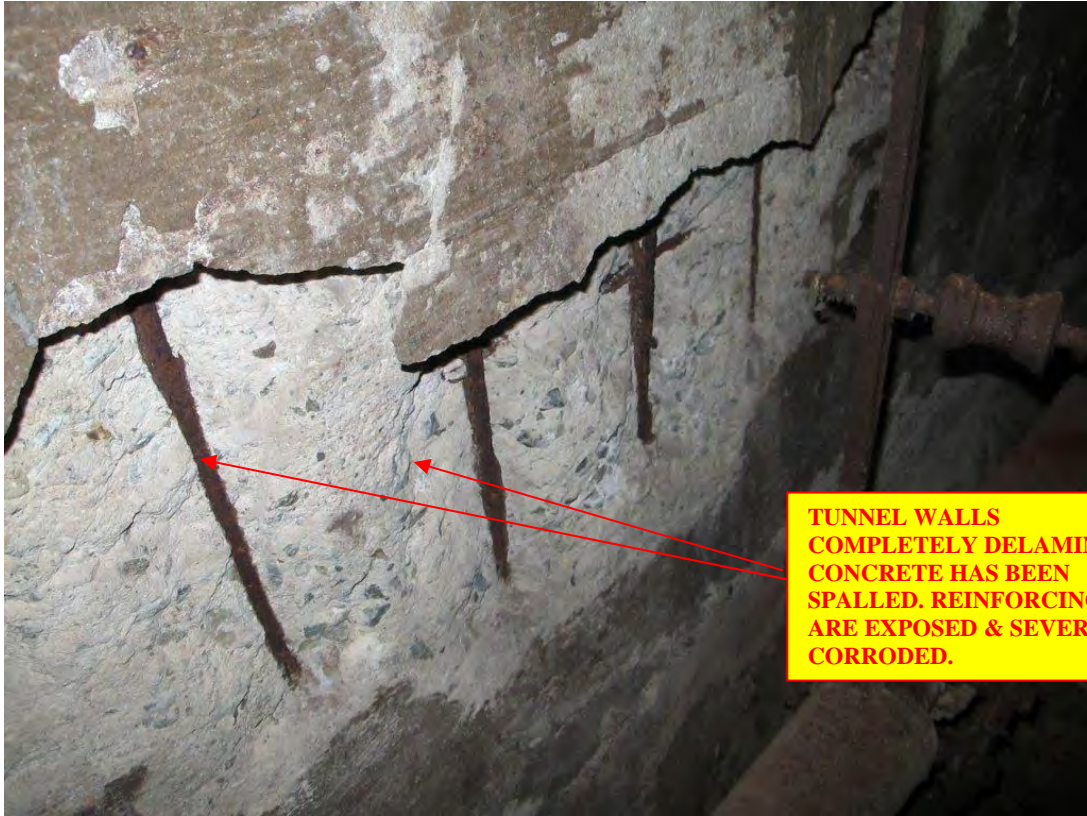
**PHOTO 7: TUNNEL WALLS**

**TUNNEL WALLS COMPLETELY DELAMINATED, CONCRETE HAS BEEN SPALLED. REINFORCING BARS ARE EXPOSED & SEVERELY CORRODED.**

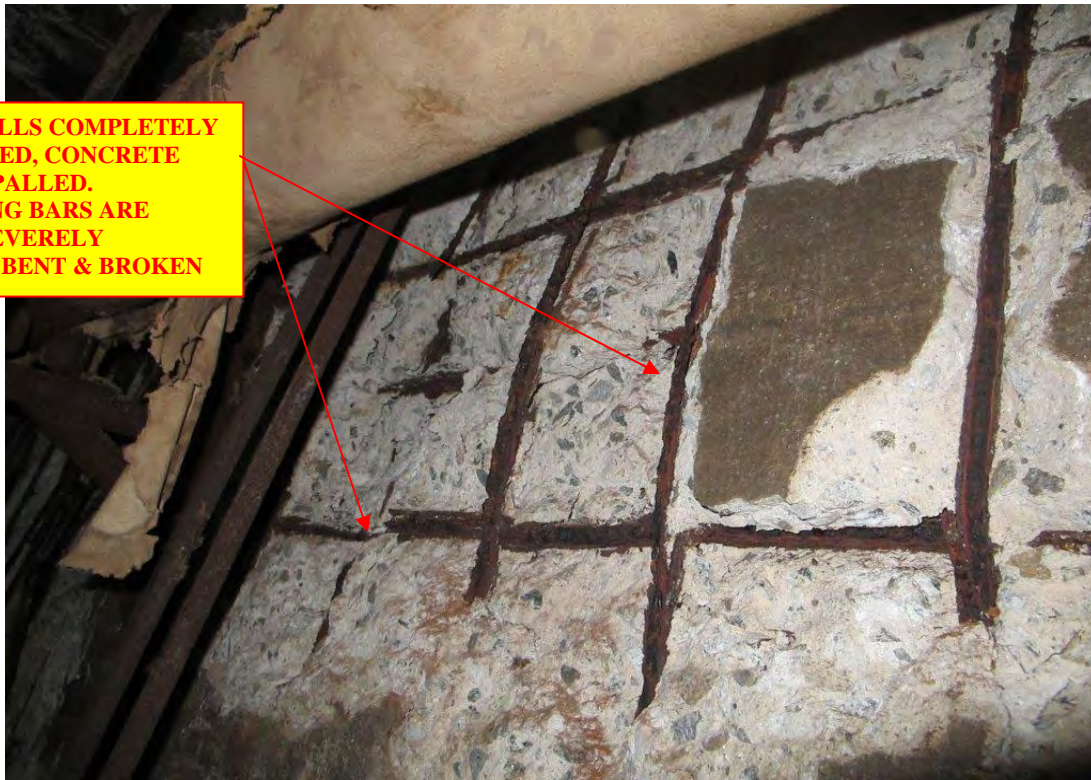
**PHOTO 8: TUNNEL WALLS**

**TUNNEL WALLS COMPLETELY DELAMINATED, CONCRETE HAS BEEN SPALLED. REINFORCING BARS ARE EXPOSED, SEVERELY CORRODED, BENT & BROKEN**

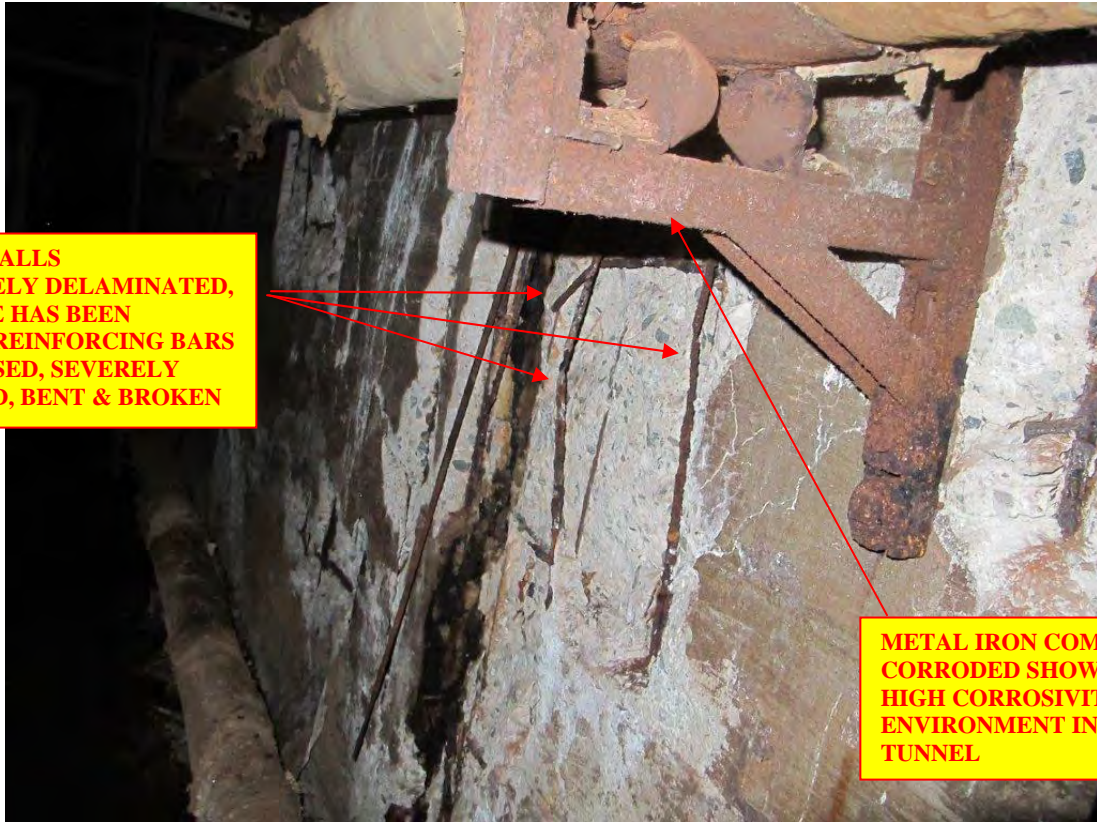
**PHOTO 9: TUNNEL WALLS**

**METAL IRON COMPLETELY CORRODED SHOWING THE HIGH CORROSIVITY ENVIRONMENT INSIDE THE TUNNEL**

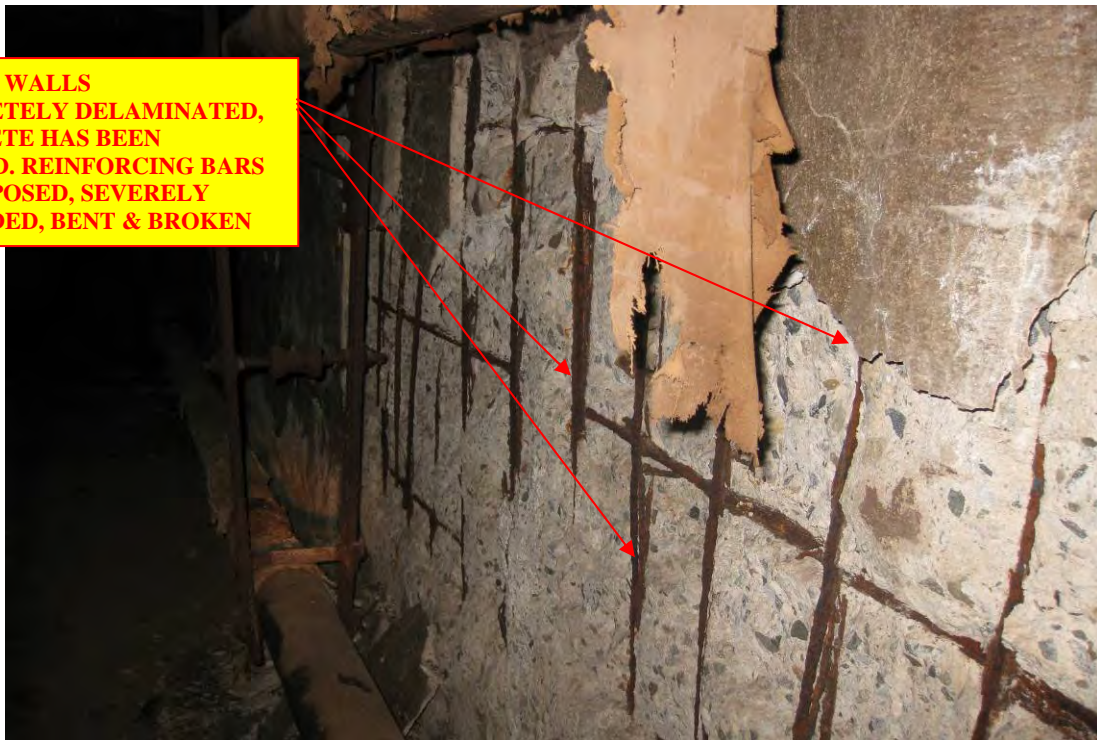
**PHOTO 10: TUNNEL WALLS**

**TUNNEL WALLS COMPLETELY DELAMINATED, CONCRETE HAS BEEN SPALLED. REINFORCING BARS ARE EXPOSED, SEVERELY CORRODED, BENT & BROKEN**

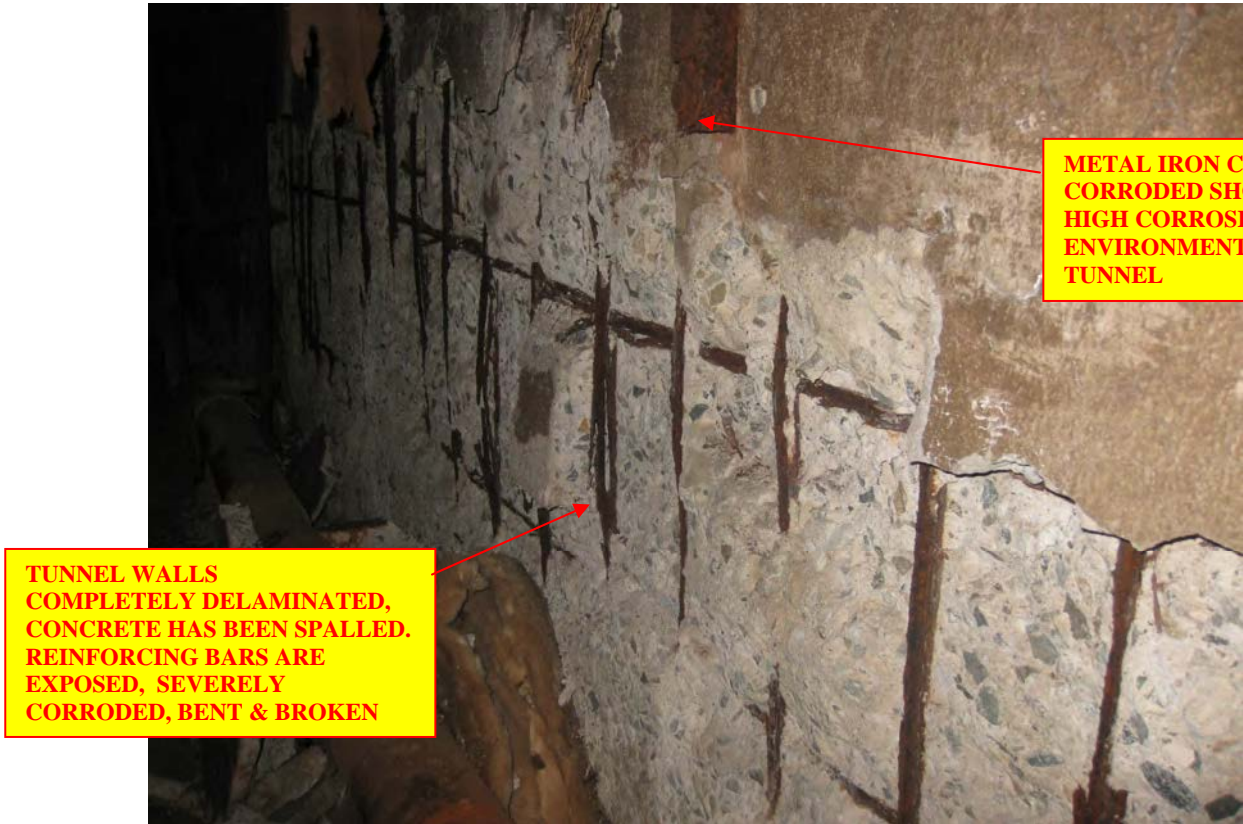
**PHOTO 11: TUNNEL WALLS**

**METAL IRON COMPLETELY CORRODED SHOWING THE HIGH CORROSIVITY ENVIRONMENT INSIDE THE TUNNEL**

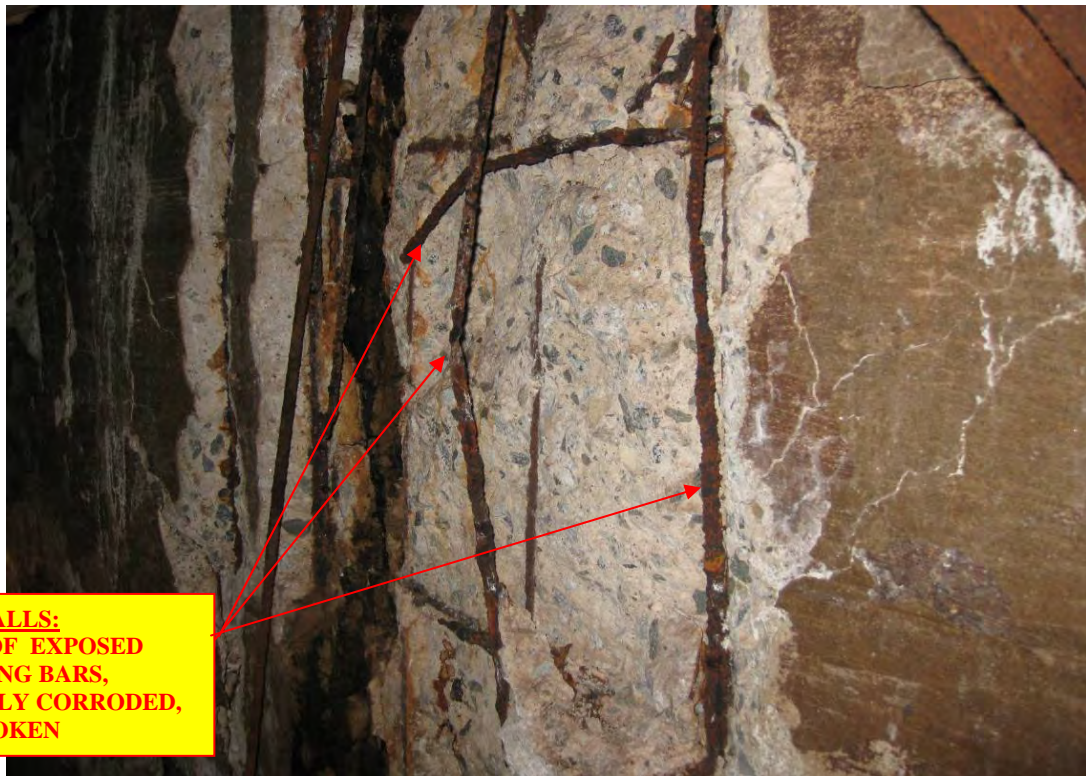
**PHOTO 12: TUNNEL WALLS**

**TUNNEL WALLS: CLOSE UP OF EXPOSED REINFORCING BARS, COMPLETELY CORRODED, BENT & BROKEN**
