LAC+USC TUNNEL STRUCTURAL AND MECHANICAL ASSESSMENT  
AND ASBESTOS SURVEY,  
1200 NORTH STATE STREET, LOS ANGELES, CALIFORNIA

LAC USC TUNNEL  
Structural and Mechanical  
Assessment and Asbestos Survey

January 30, 2013

**Structural Assessment & Corrosion Evaluation Of  
LAC+USC Medical Center/Utility Tunnel (Juvenile Hall)  
Los Angeles, California**

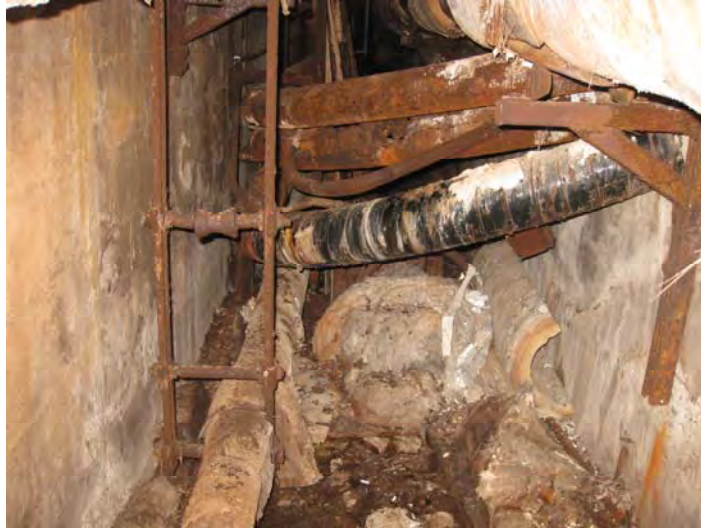
- Structural visual assessment and delimitation survey of the entire accessible portion of the tunnel by Juan Carlos Esquivel, M.S., S.E., Principal of JCE Structural Engineering Group and Andrew Broecker and Clarence Zimmel from Vector Corrosion Technologies. The tunnel was NOT accessible beyond Zonal Avenue (See Photo 1) up to about 100 feet into the Juvenile hall (See Photos 2 & 3).

**1. Tunnel Completely obstructed at Zonal Av.**

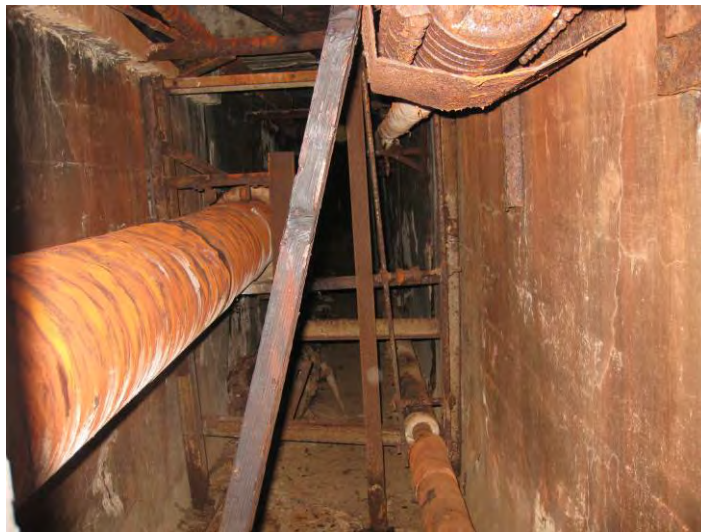
**2. Tunnel Completely Obstructed at 100 FT Inside Juvenile Hall**

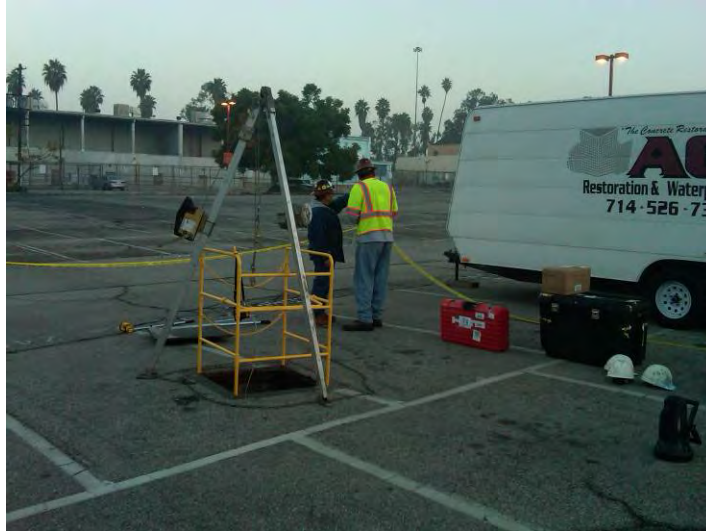
**4. Safety Preparations at Tunnel Entry**

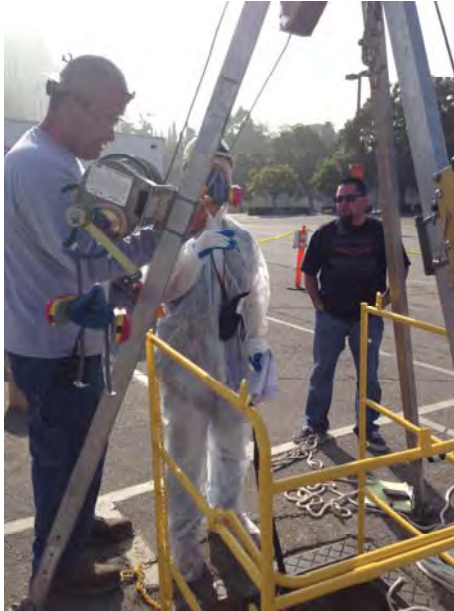
**8. JCE Structural Engineering Group Entry**

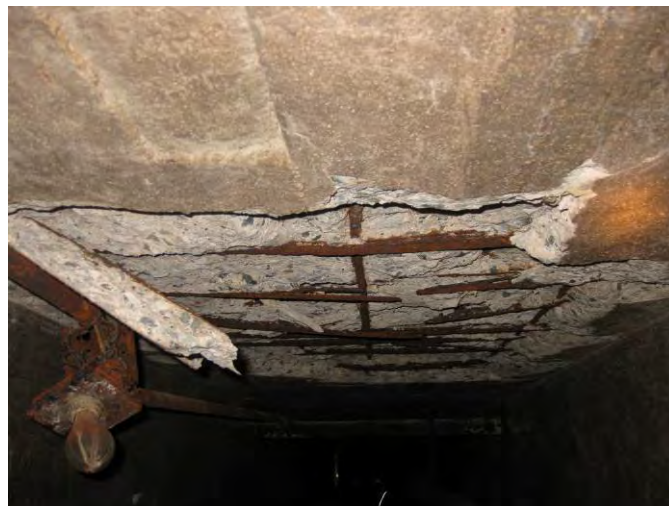
**26. Tunnel's Damaged Ceiling  
(Concrete spalled off & rebars corroded)**

It is recommended that the Medical Center consider abandoning this tunnel instead of repairing it. If the tunnel is going to be repaired, a cathodic protection system will be required to prevent continued damage to the “Good” areas.

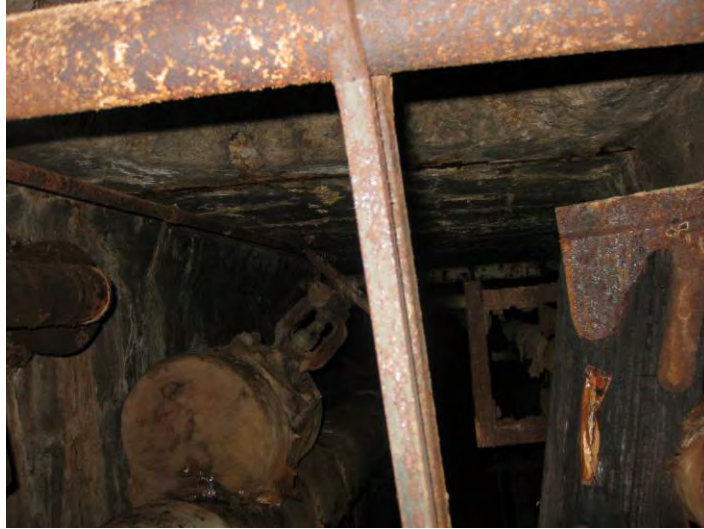
**27. Tunnel's Damaged Ceiling  
(Concrete spalled off & rebars corroded)**

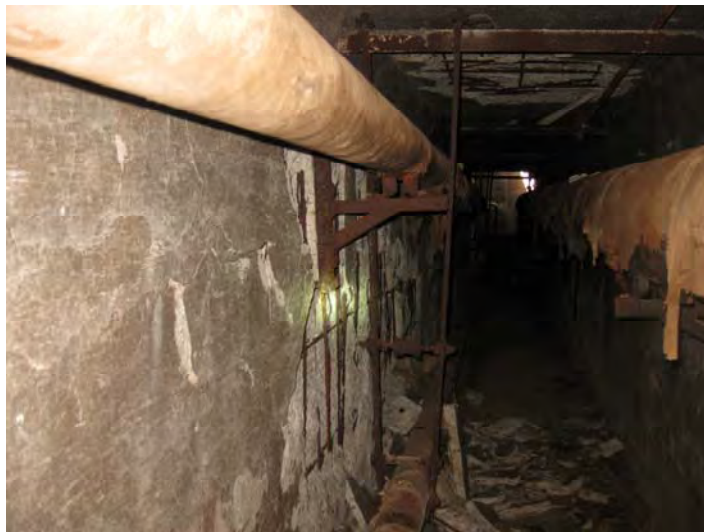
**28. Tunnel's Damaged Ceiling & Shored**

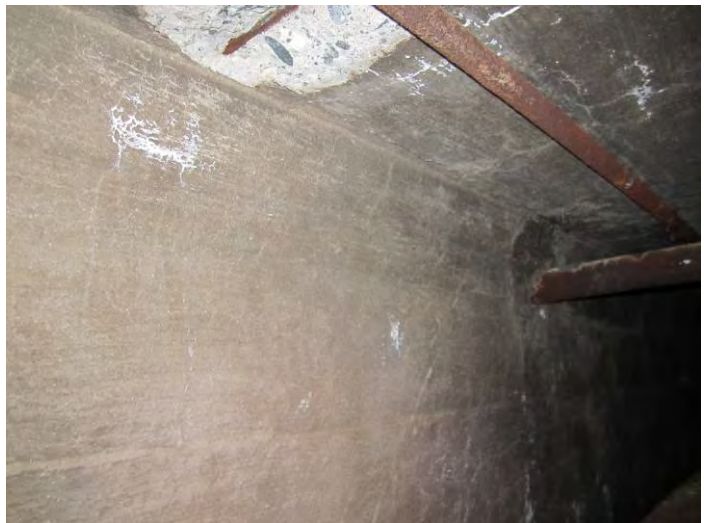
**29. Tunnel's Damaged Ceiling  
(Concrete spalled off & rebars corroded)**

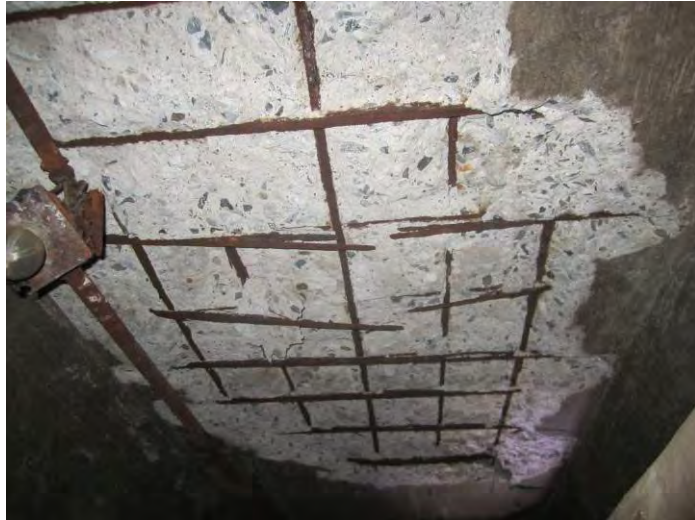
**30. Tunnel's Damaged Ceiling  
(Concrete spalled off & rebars corroded)**

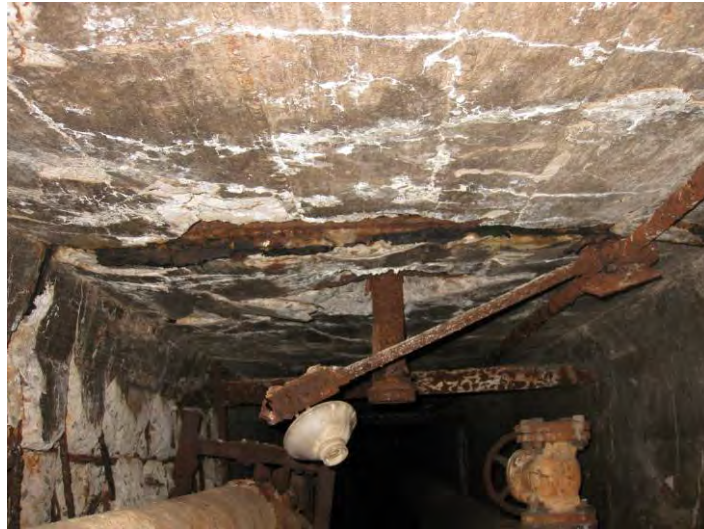
**31. Tunnel's Damaged Ceiling  
(Concrete spalled off & rebars corroded)**

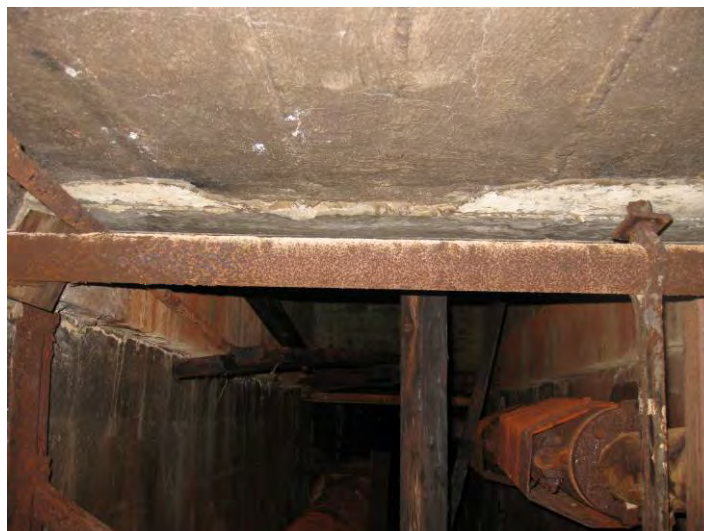
**32. Tunnel's Ceiling Delamination (Concrete Ready to spall off)**

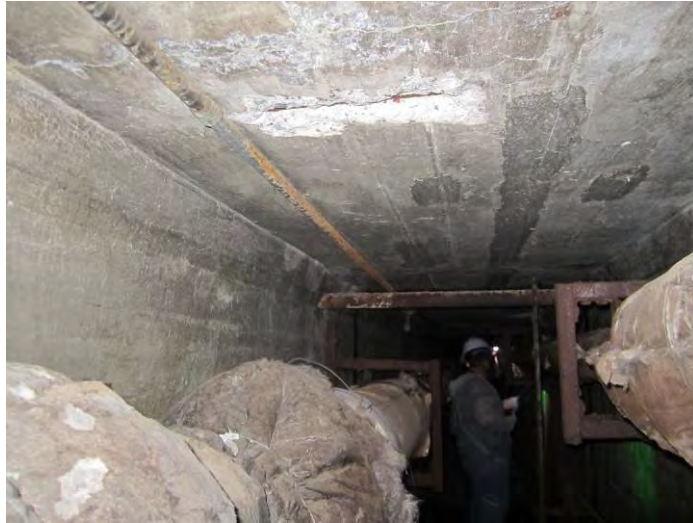
**33. Tunnel's Ceiling Delamination (Concrete Ready to spall off)**

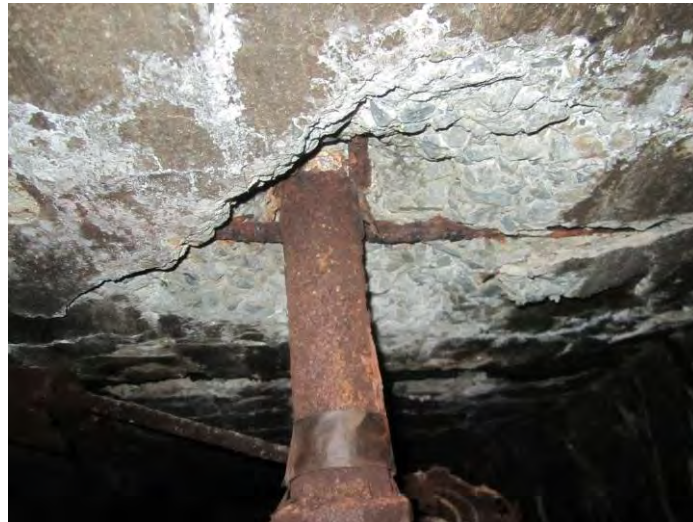
**34. Tunnel's Ceiling Delamination (Concrete Ready to spall off)**

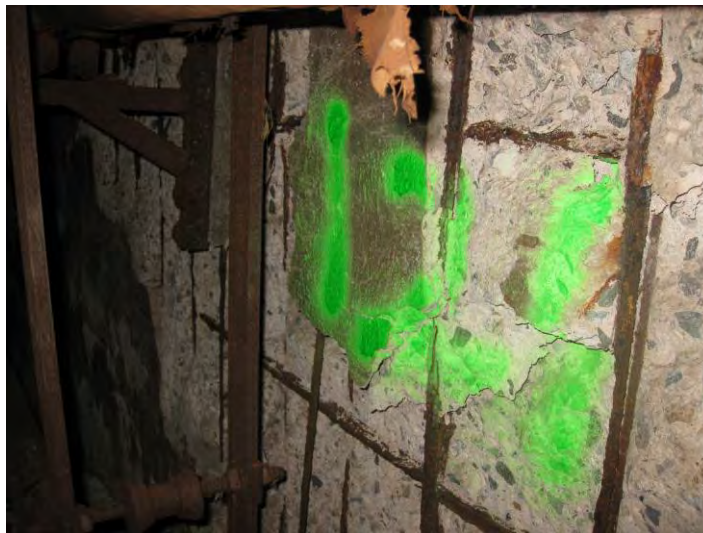
**35. Tunnel's Ceiling Delamination (Concrete Ready to spall off)**

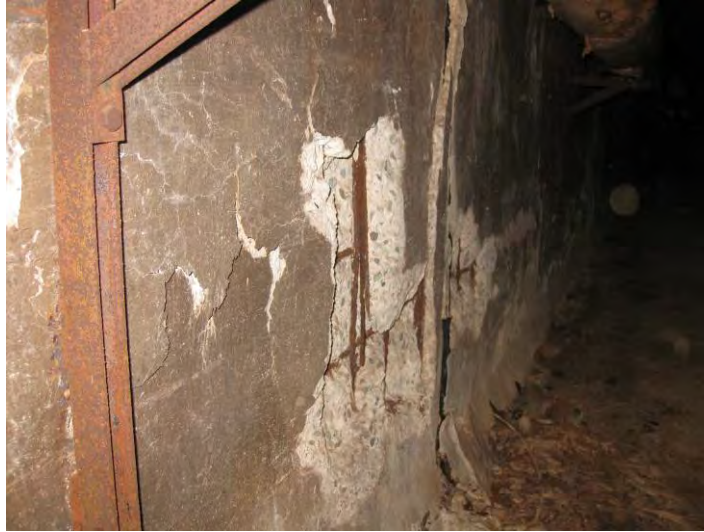
**36. Tunnel's Damaged Walls (Concrete Spalled off & Rebars Corroded)**

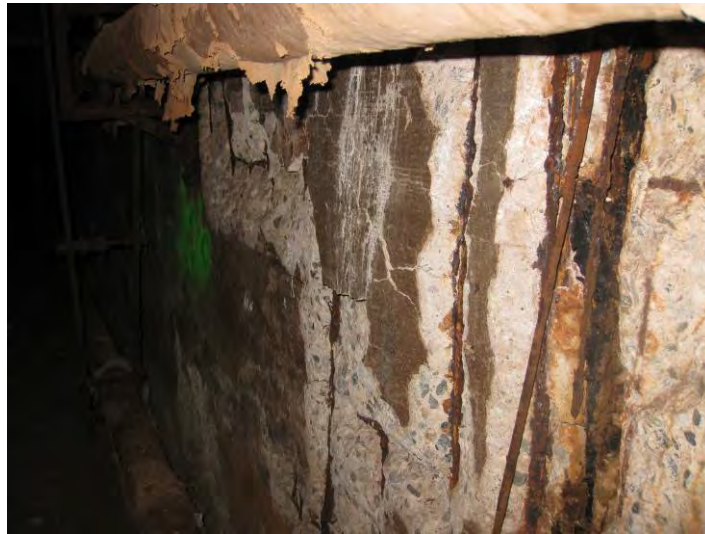
**37. Tunnel's Damaged Walls (Concrete Spalled off & Rebars Corroded)**

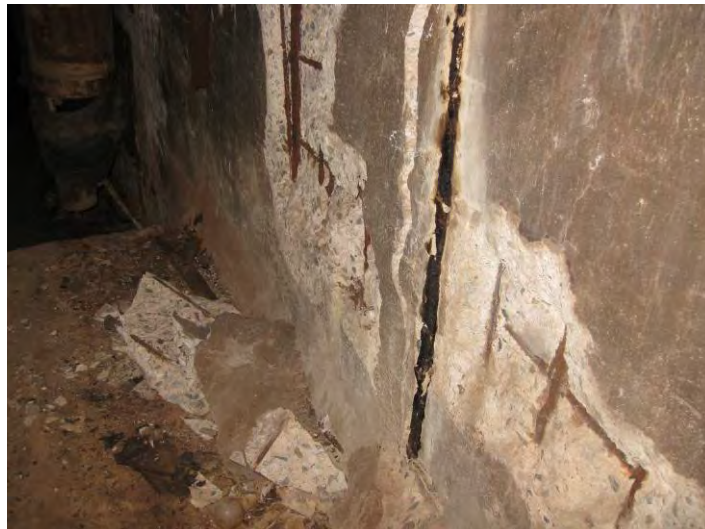
**38. Tunnel's Damaged Walls (Concrete Spalled off & Rebars Corroded)**

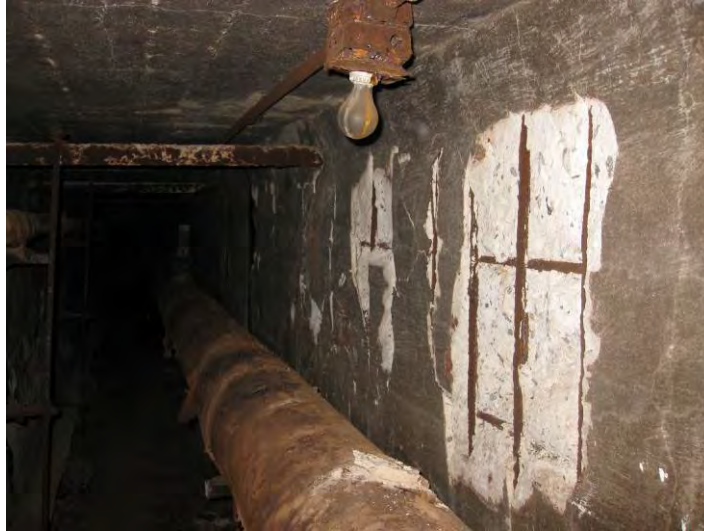
**39. Tunnel's Damaged Walls (Concrete Spalled off & Rebars Corroded)**

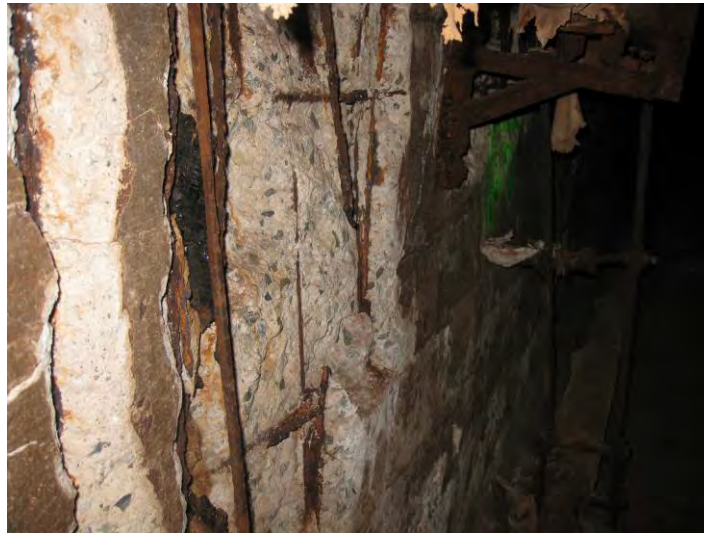
**40. Tunnel's Damaged Walls (Concrete Spalled off & Rebars Corroded)**

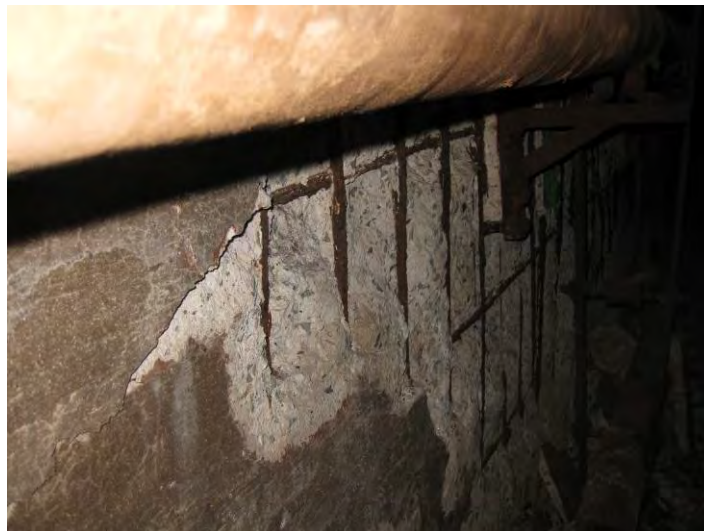
**41. Tunnel's Damaged Walls (Concrete Spalled off & Rebars Corroded)**

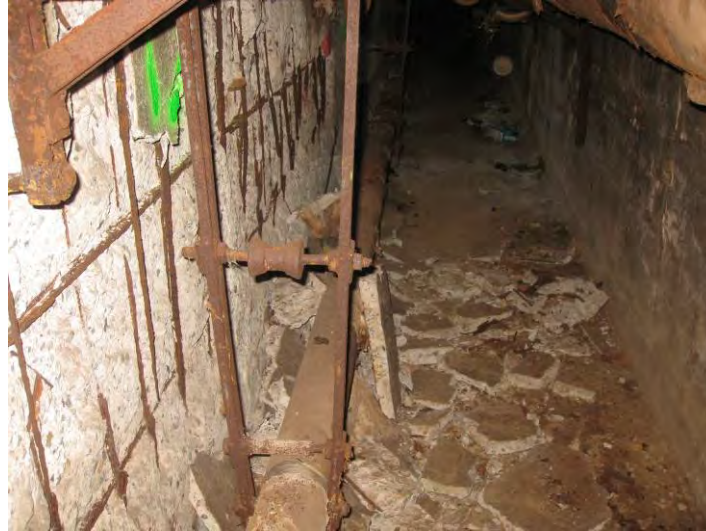
**42. Tunnel's Damaged Walls (Concrete Spalled off & Rebars Corroded)**

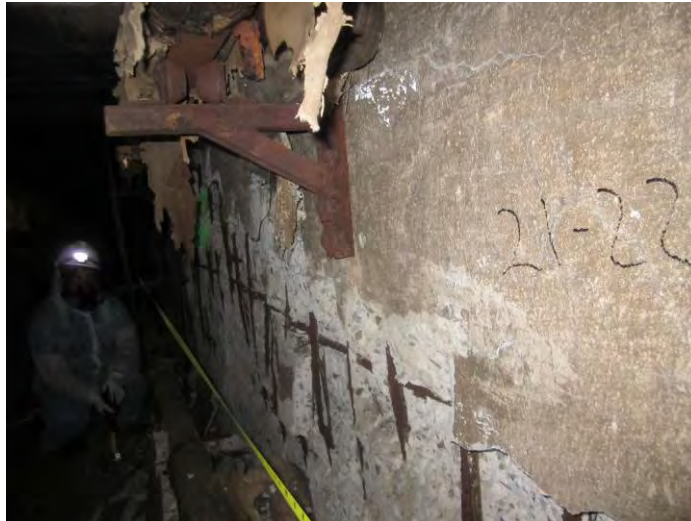
**43. Tunnel's Damaged Walls (Concrete Spalled off & Rebars Corroded)**

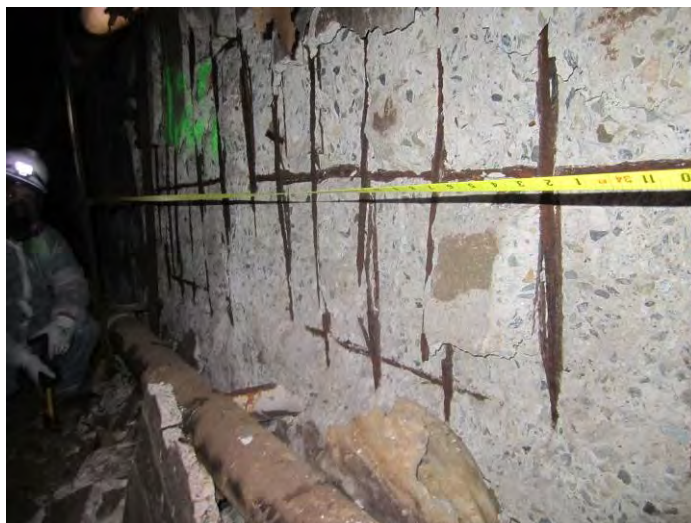
**44. Tunnel's Damaged Walls (Concrete Spalled off & Rebars Corroded)**

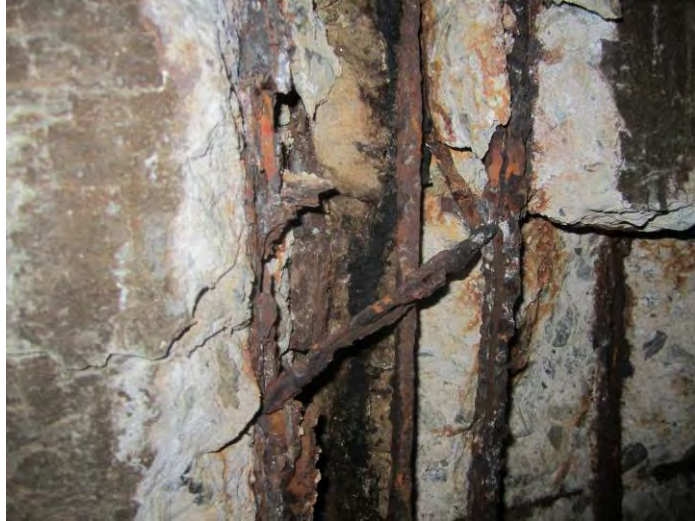
**45. Tunnel's Damaged Walls (Concrete Spalled off & Rebars Corroded)**

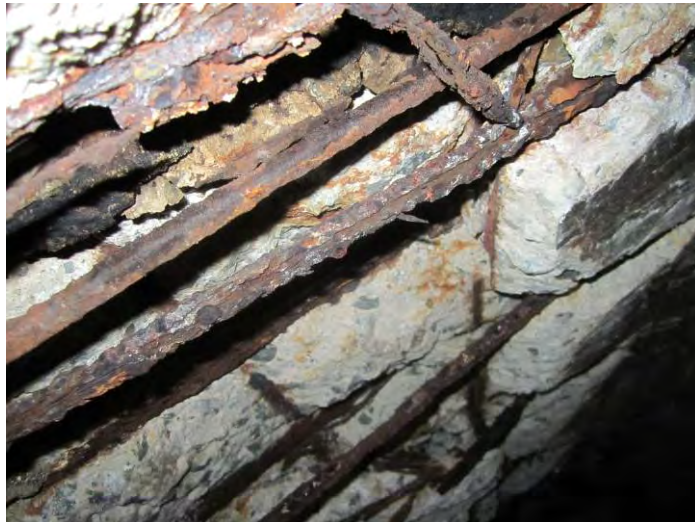
**46. Tunnel's Damaged Walls (Concrete Spalled off & Rebars Corroded)**

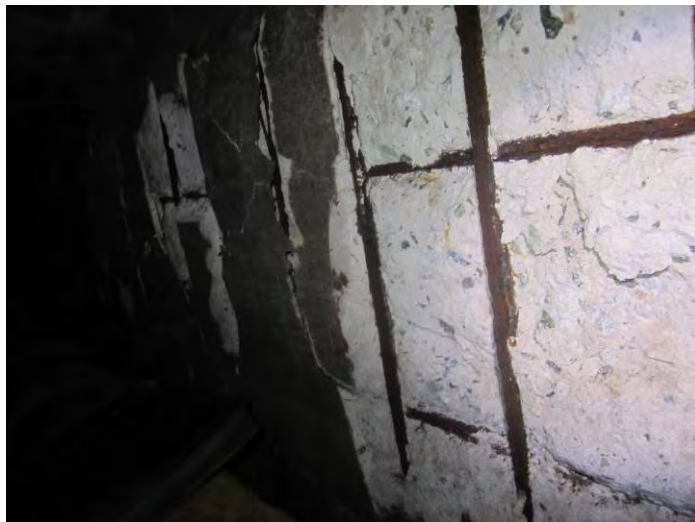
**47. Tunnel's Damaged Walls (Concrete Spalled off & Rebars Corroded)**

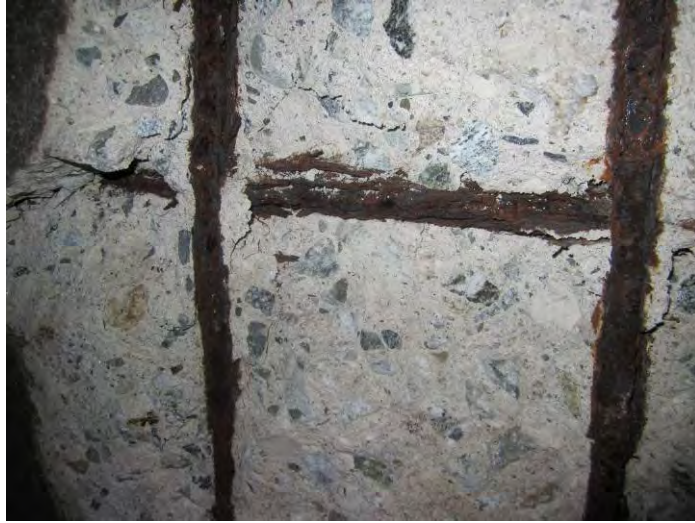
**48. Tunnel's Damaged Walls (Concrete Spalled off & Rebars Corroded)**

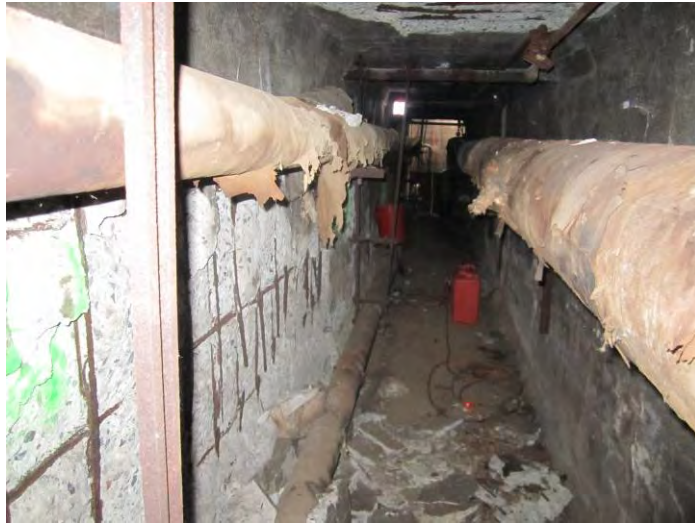
**49. Tunnel's Damaged Walls (Concrete Spalled off & Rebars Corroded)**

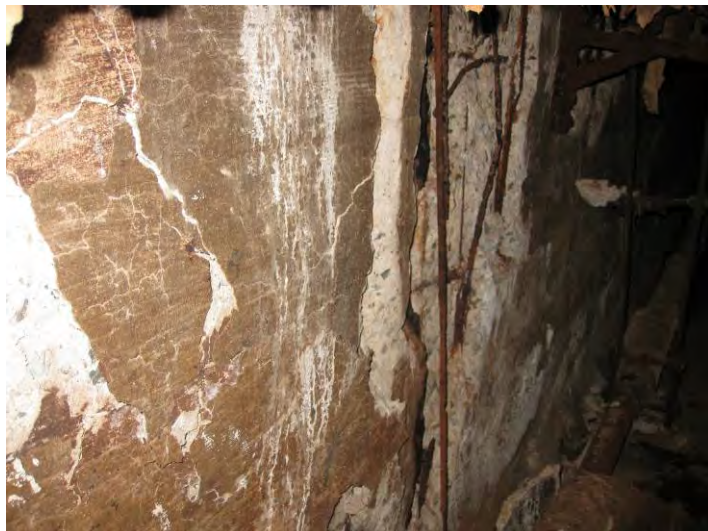
**50. Tunnel's Damaged Walls (Concrete Spalled off & Rebars Corroded)**

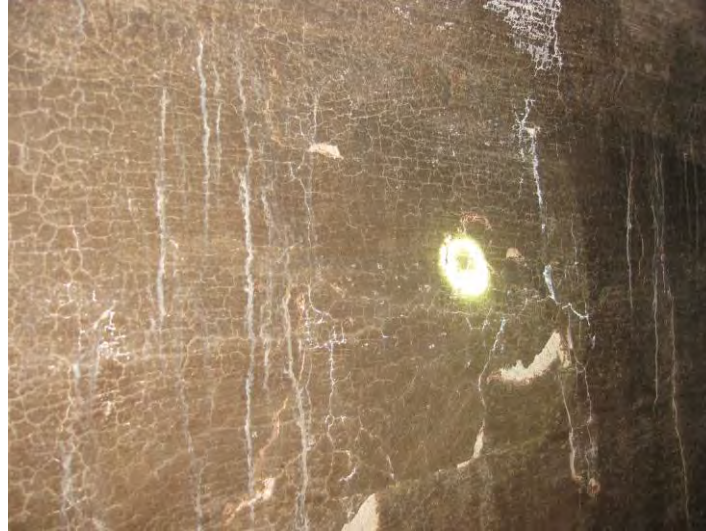
**51. Tunnel Walls Delamination Concrete (Ready to Spall off)**

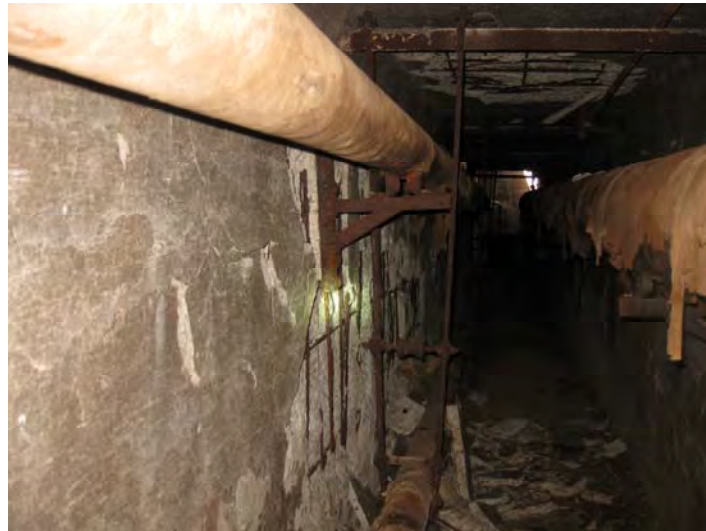
**52. Tunnel Walls Delamination Concrete (Ready to Spall off)**

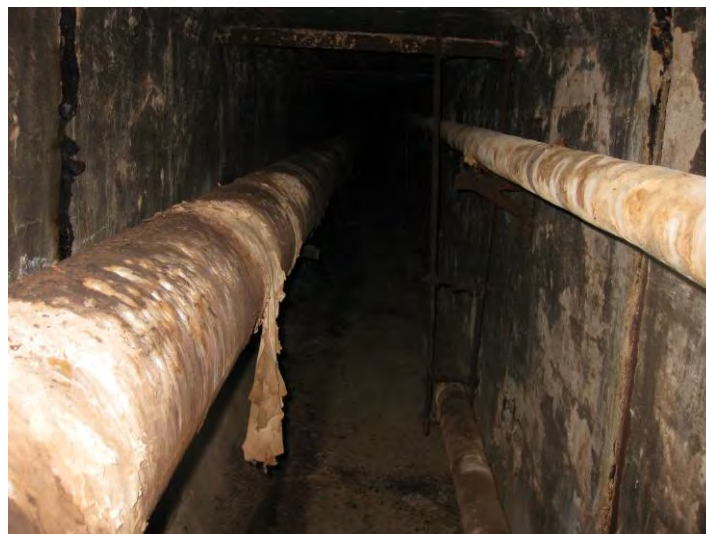
**53. Tunnel Walls Delamination Concrete (Ready to Spall off)**

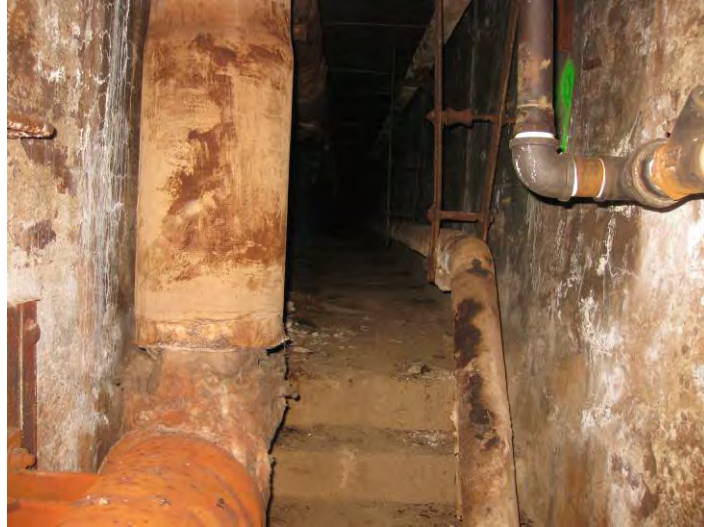
**54. Tunnel Walls Delamination Concrete (Ready to Spall off)**

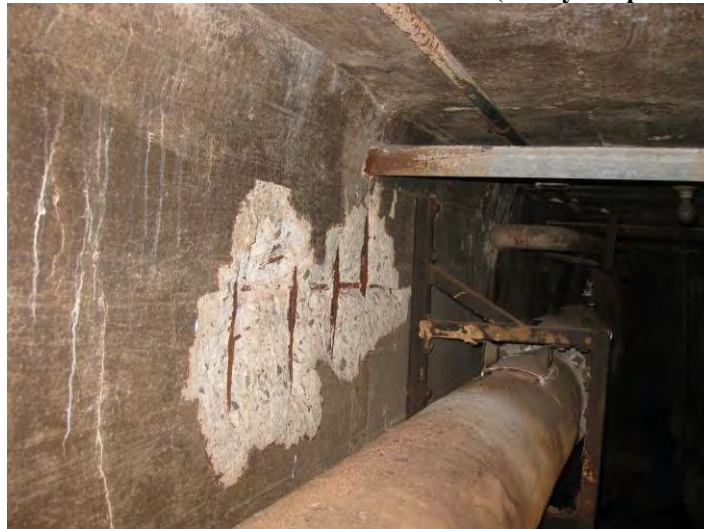
**55. Tunnel Walls Delamination Concrete (Ready to Spall off)**

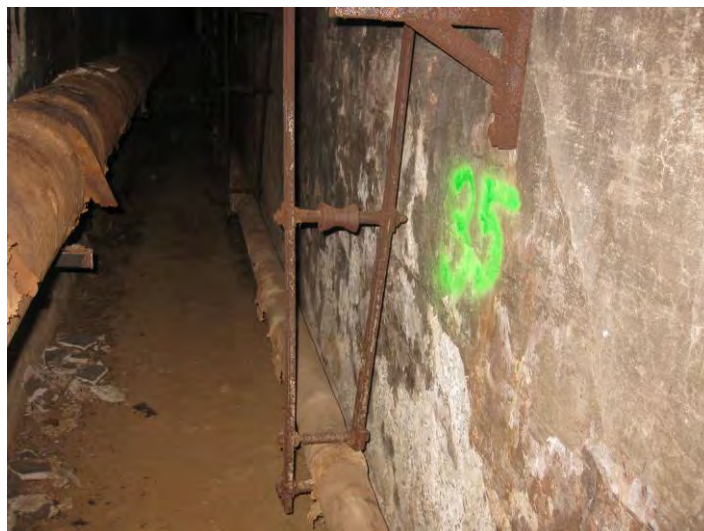
**56. Tunnel Walls Delamination Concrete (Ready to Spall off)**

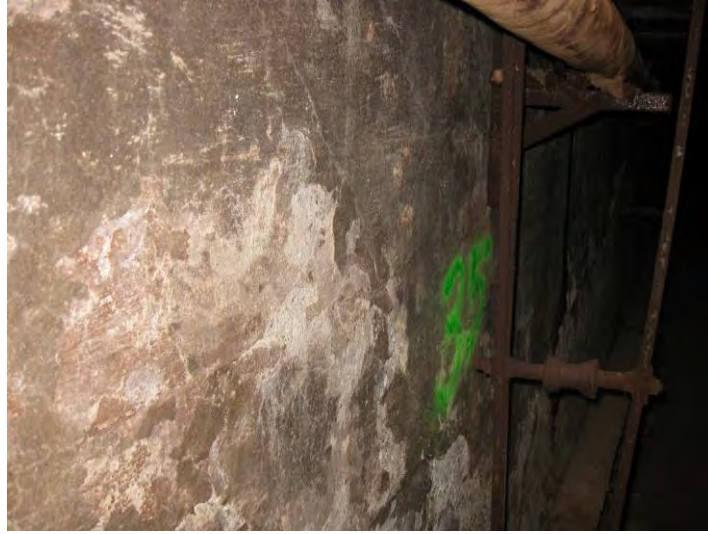
**57. Tunnel Walls Delamination Concrete (Ready to Spall off)**

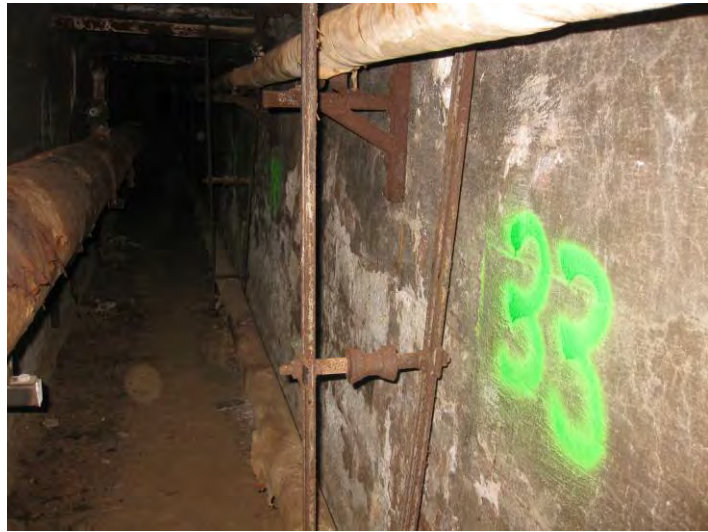
**58. Tunnel Walls Delamination Concrete (Ready to Spall off)**

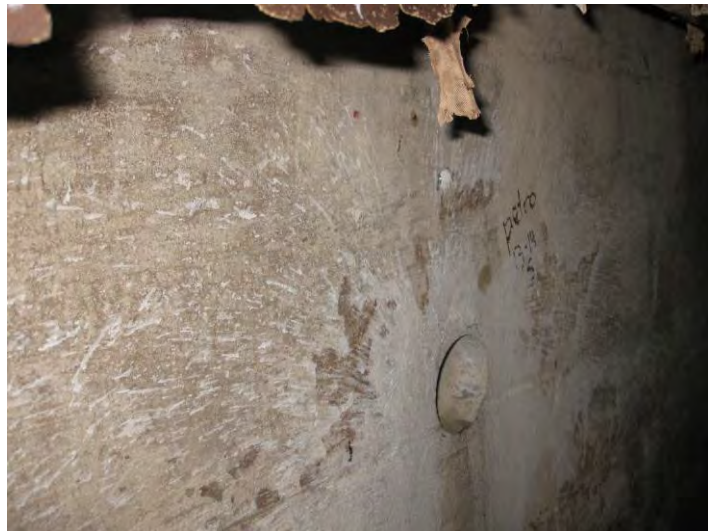
**59. Tunnel Walls Delamination Concrete (Ready to Spall off)**

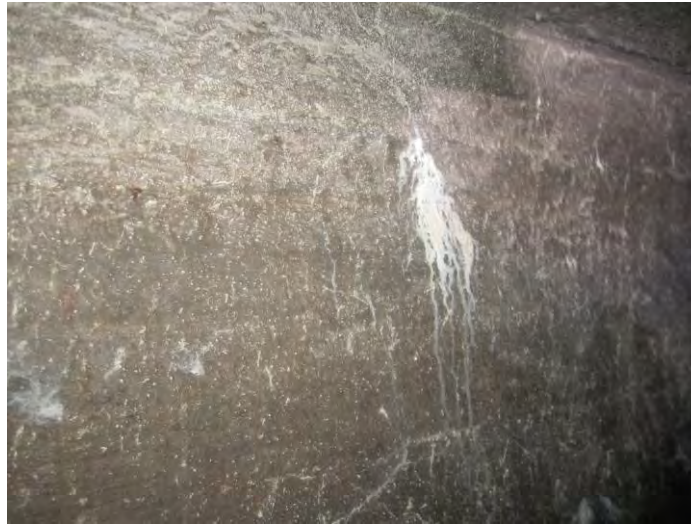
**60. Tunnel Walls Delamination Concrete (Ready to Spall off)**

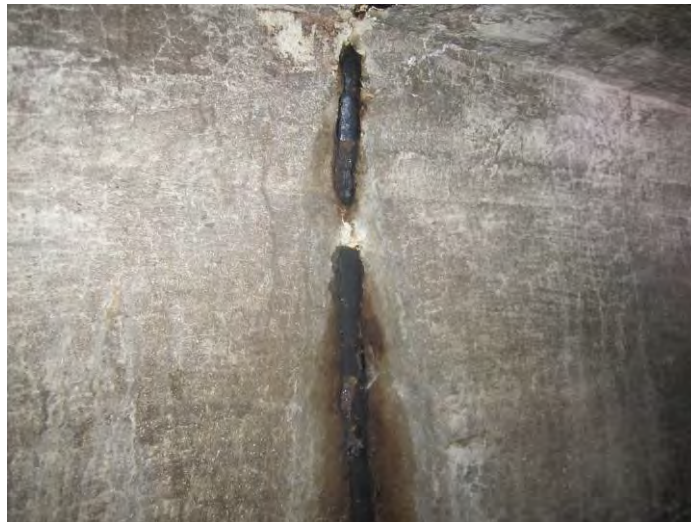
**61. Tunnel Walls Delamination Concrete (Ready to Spall off)**

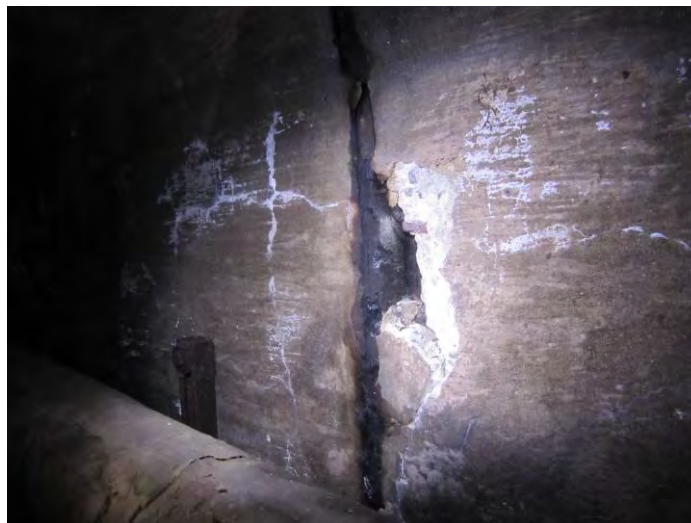
**62. Tunnel Walls Delamination Concrete (Ready to Spall off)**

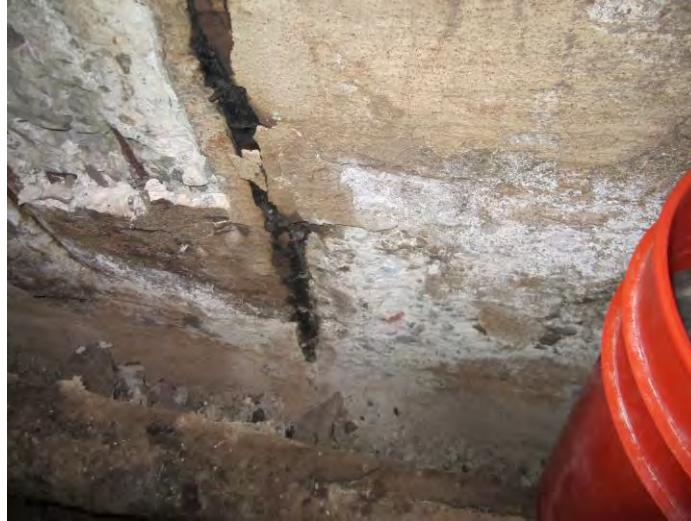
**63. Tunnel Walls Delamination Concrete (Ready to Spall off)**

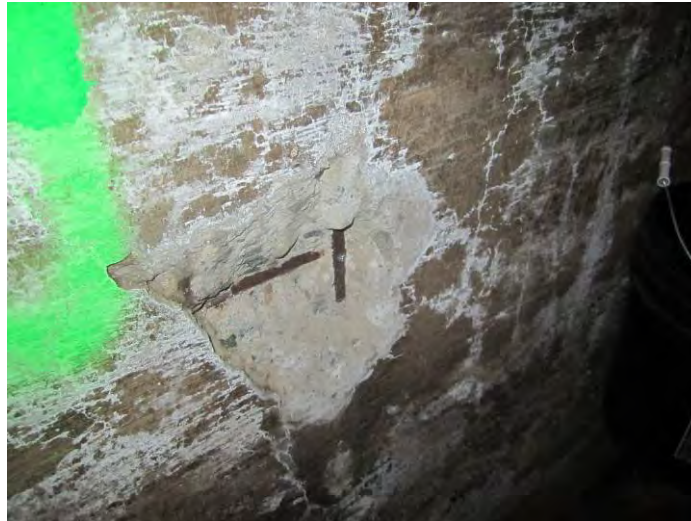
**64. Tunnel Walls Delamination Concrete (Ready to Spall off)**

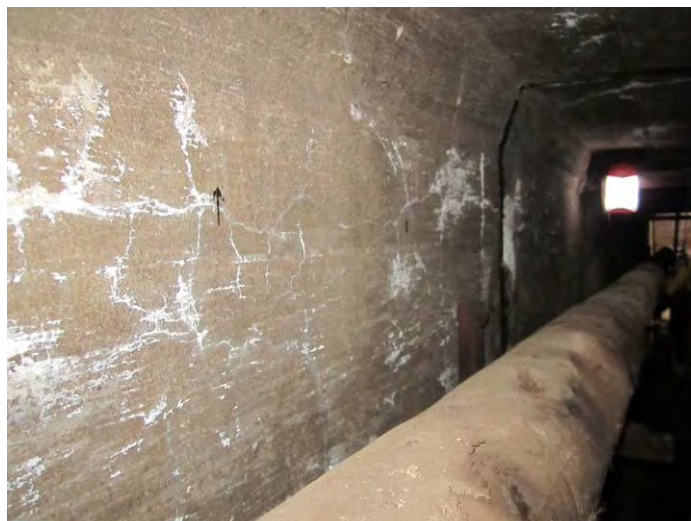
**65. Tunnel Walls Delamination Concrete (Ready to Spall off)**

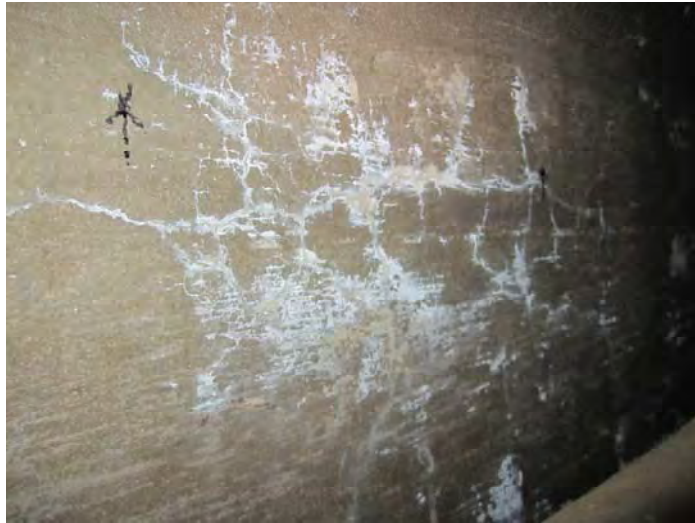
**66. Tunnel Walls Delamination Concrete (Ready to Spall off)**

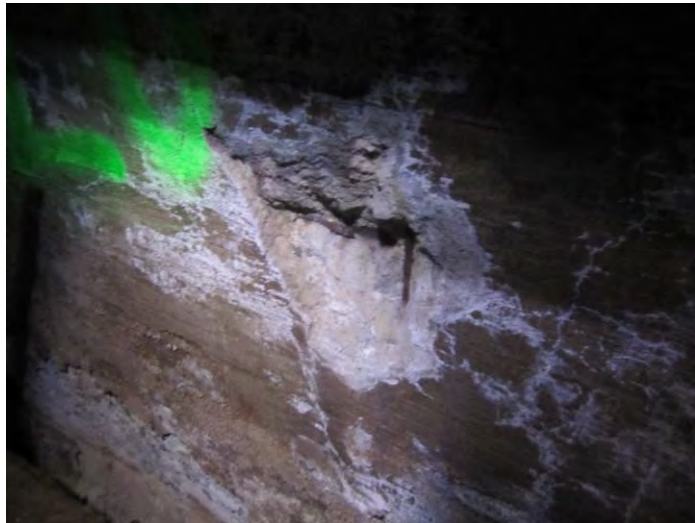
**67. Tunnel Walls Delamination Concrete (Ready to Spall off)**

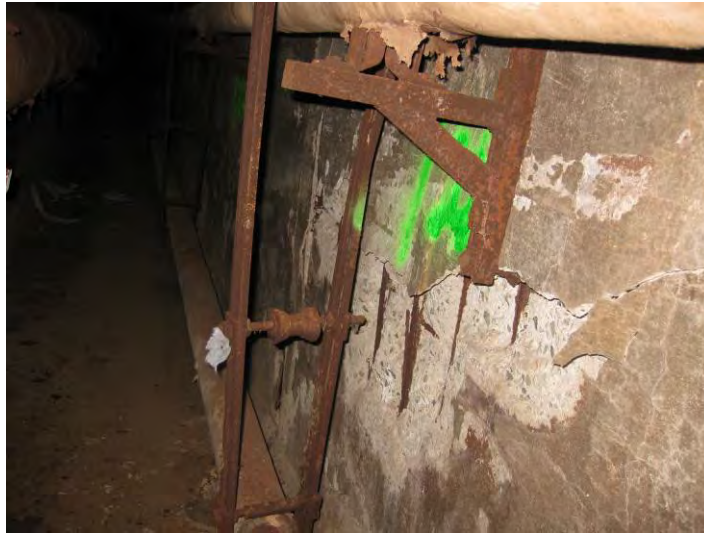
**70. Tunnel Steam Pipe Support Completely Rusted & Not Adequately Anchored**

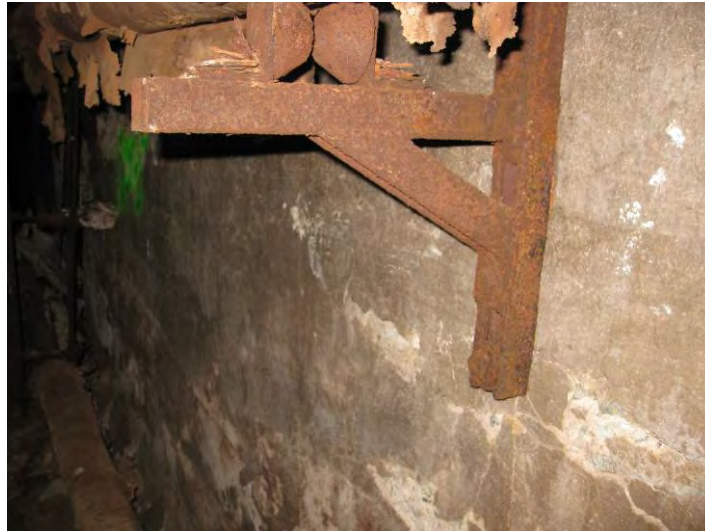
**71. Tunnel Steam Pipe Support Completely Rusted & Not Adequately Anchored**

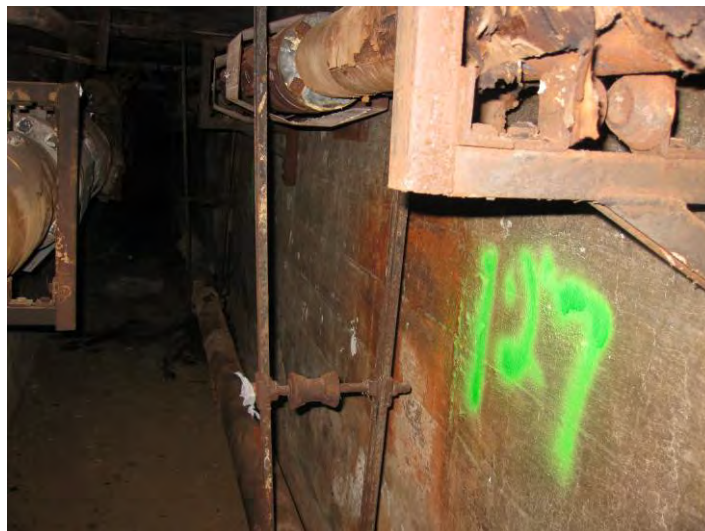
**72. Tunnel Steam Pipe Support Completely Rusted & Not Adequately Anchored 4**

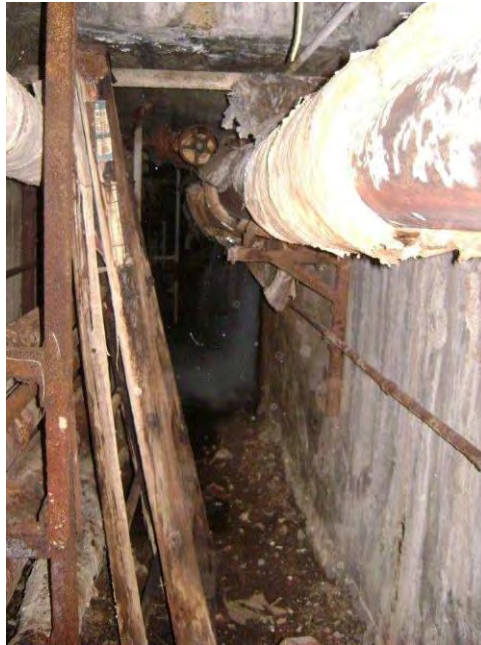
**73. Tunnel Steam Pipe Support Completely Rusted & Not Adequately Anchored**

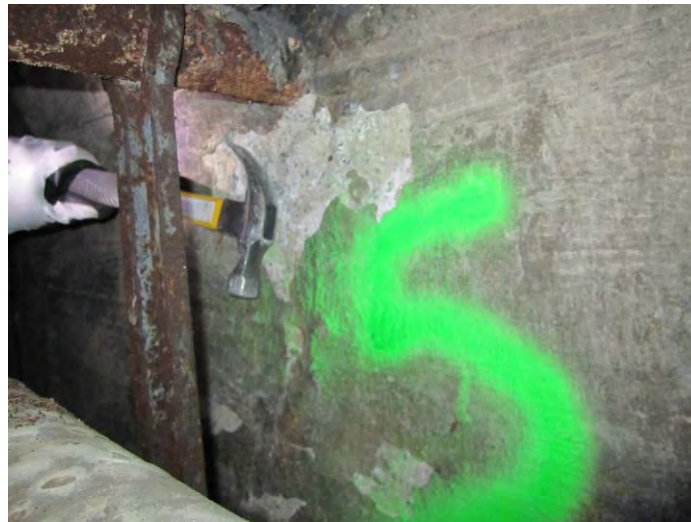
**74. Tunnel Steam Pipe Support Completely Rusted & Not Adequately Anchored**

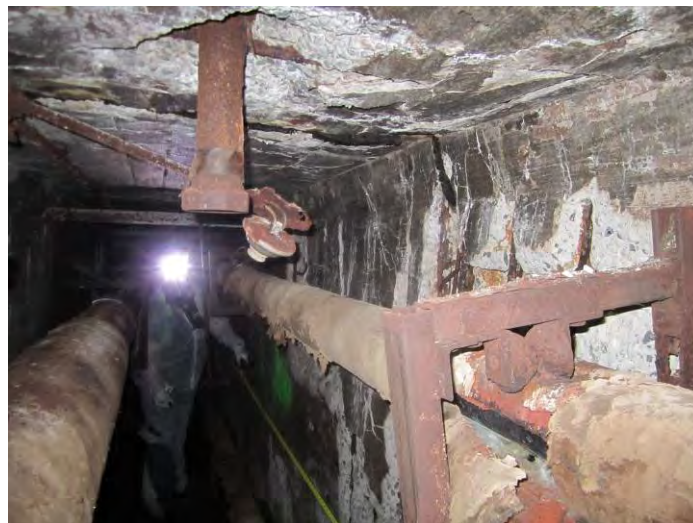
**75. Tunnel Steam Pipe Support Completely Rusted & Not Adequately Anchored**

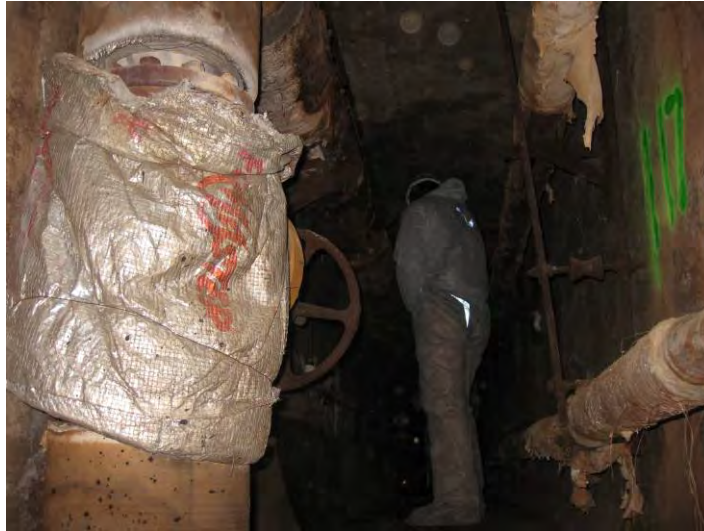
**76. Tightness Space Inside the (E) Tunnel**

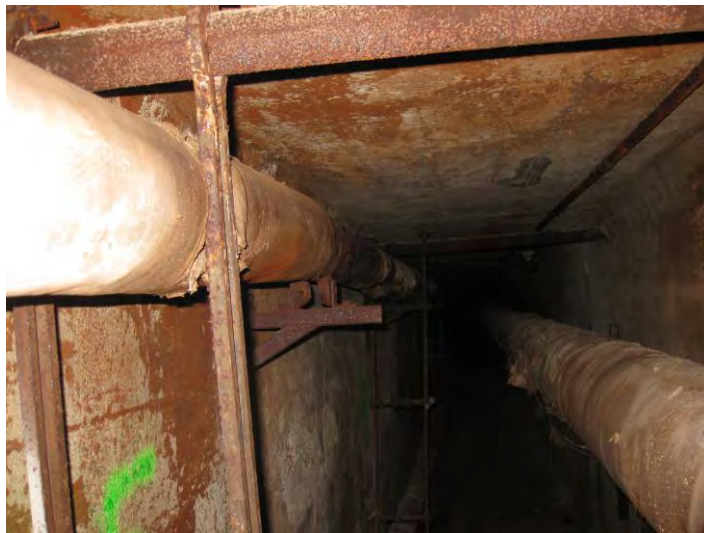
**77. Tightness Space Inside the (E) Tunnel**

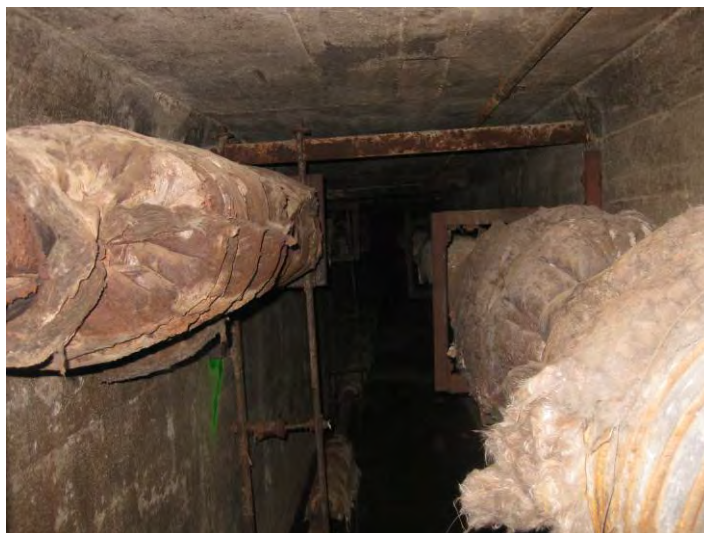
**78. Tightness Space Inside the (E) Tunnel**

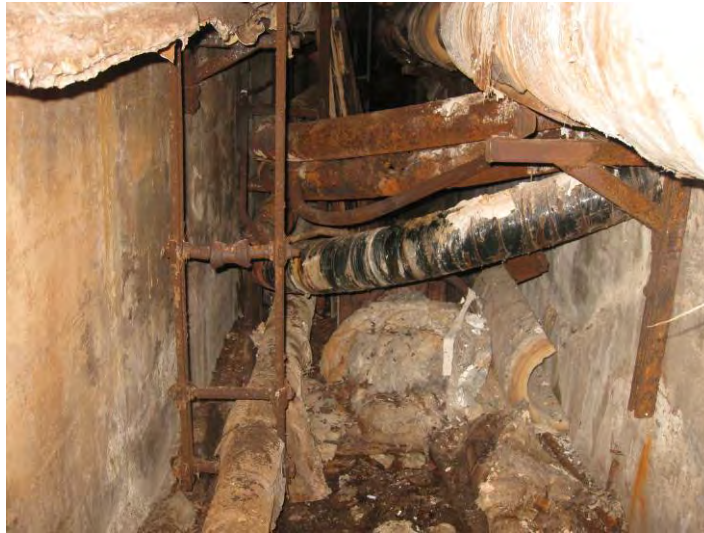
**79. Tightness Space Inside the (E) Tunnel**

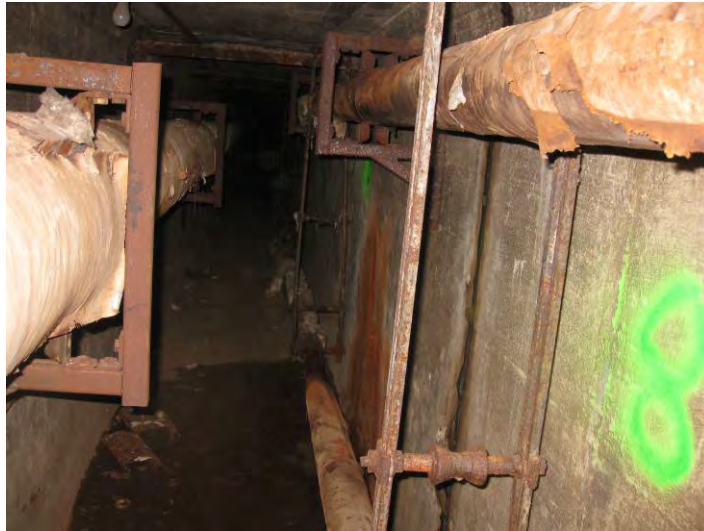
**80. Tightness Space Inside the (E) Tunnel**

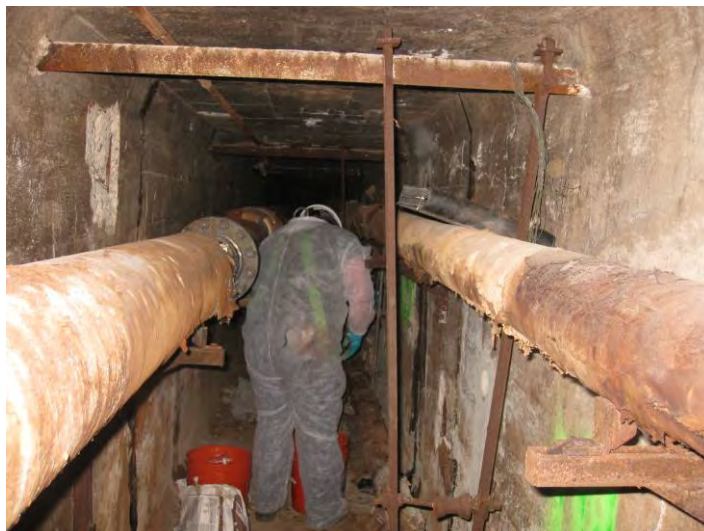
**81. Tightness Space Inside the (E) Tunnel**

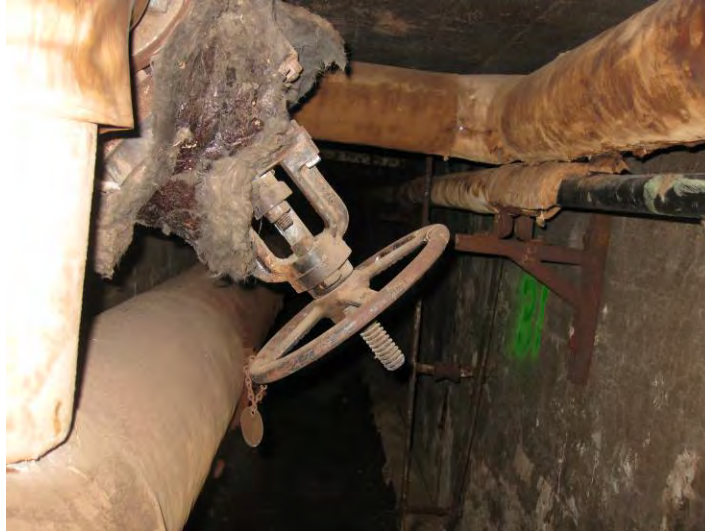
**82. Tightness Space Inside the (E) Tunnel**
