LAC+USC TUNNEL STRUCTURAL AND MECHANICAL ASSESSMENT  
AND ASBESTOS SURVEY,  
1200 NORTH STATE STREET, LOS ANGELES, CALIFORNIA

LAC USC TUNNEL  
Structural and Mechanical  
Assessment and Asbestos Survey

January 30, 2013

**Structural Assessment & Corrosion Evaluation Of  
LAC+USC Medical Center/Utility Tunnel (Juvenile Hall)  
Los Angeles, California**

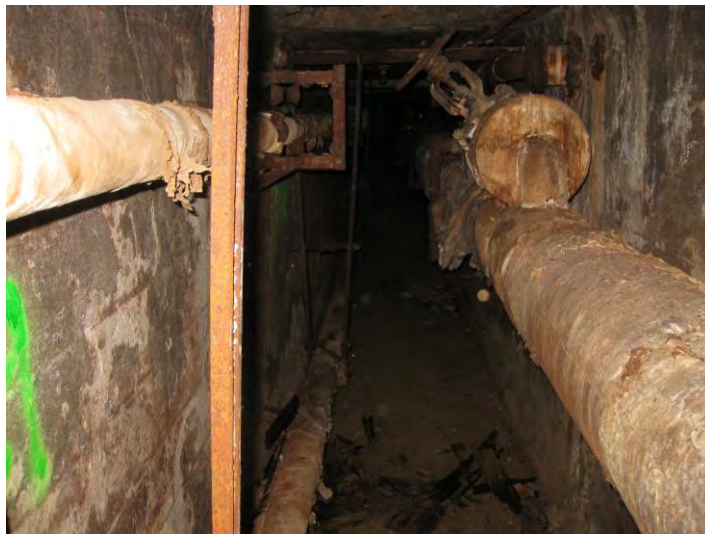
**83. Tightness Space Inside the (E) Tunnel**

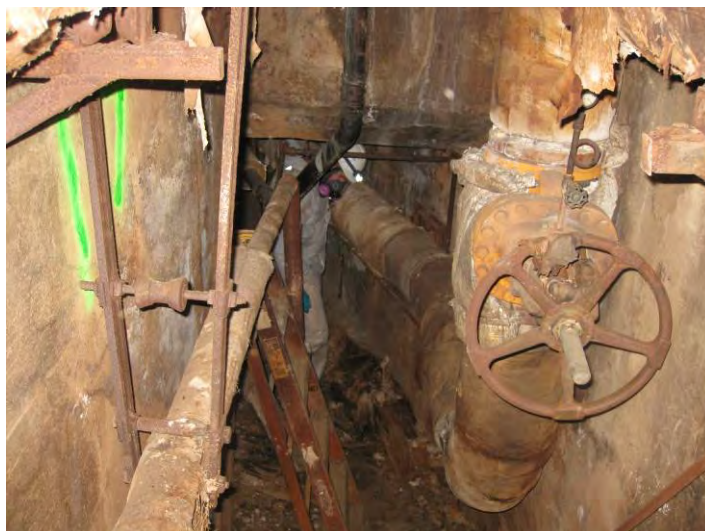
**84. Tightness Space Inside the (E) Tunnel**

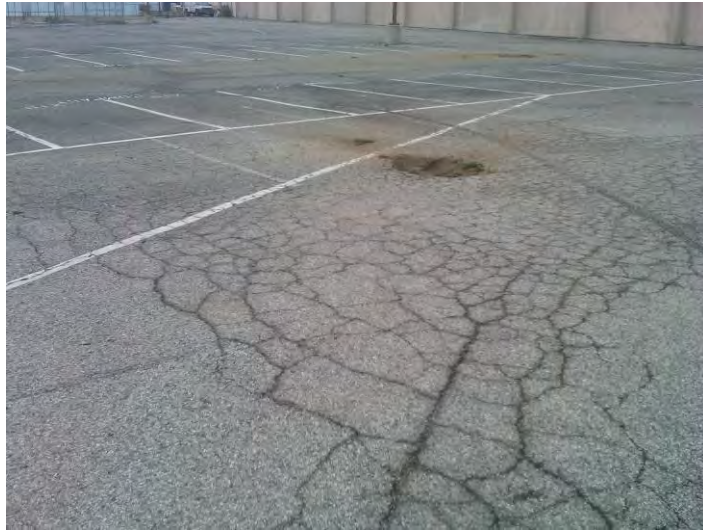
**85. Damaged Surface parking Structure above the (E) Tunnel**

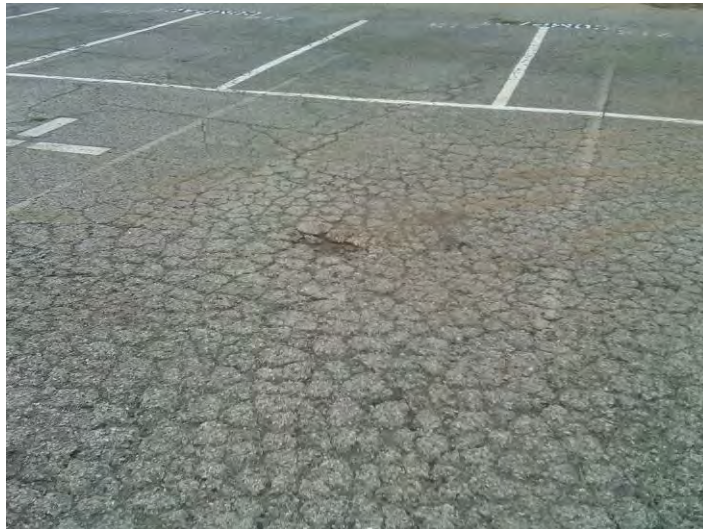
**86. Damaged Surface parking Structure above the (E) Tunnel**

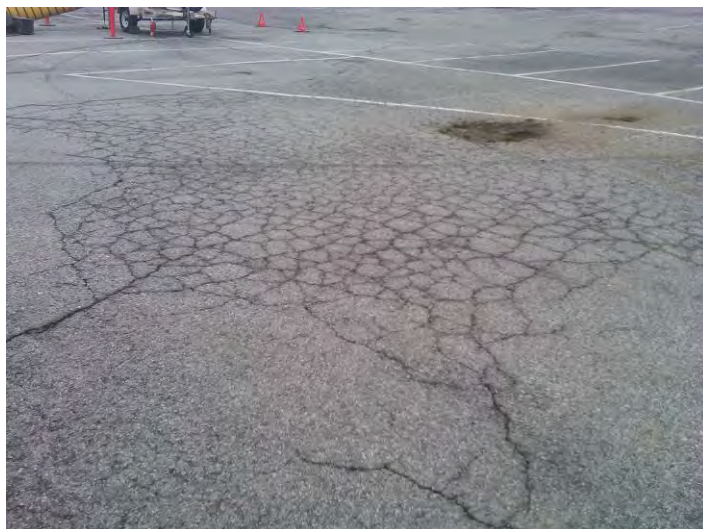
**87. Damaged Surface parking Structure above the (E) Tunnel**

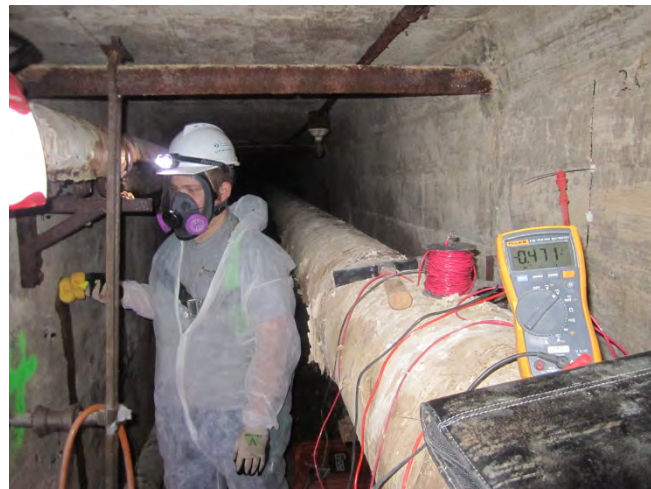
For the purposes of this investigation, all half-cell readings were recorded in mV vs. CSE (copper-sulfate reference electrode). When reviewing the results of the corrosion potential survey, the majority of the readings were in the high probability of corrosion activity range. This is indicating high levels of corrosion activity currently underway in reinforcing steel of the tunnel. This is true even in Test Area #1, which is not currently showing as many visual signs of corrosion as Test Area #2. See 'Appendix C' for specific half-cell readings at each location.

**Figure 5 - Half-cell Corrosion Potential Testing**

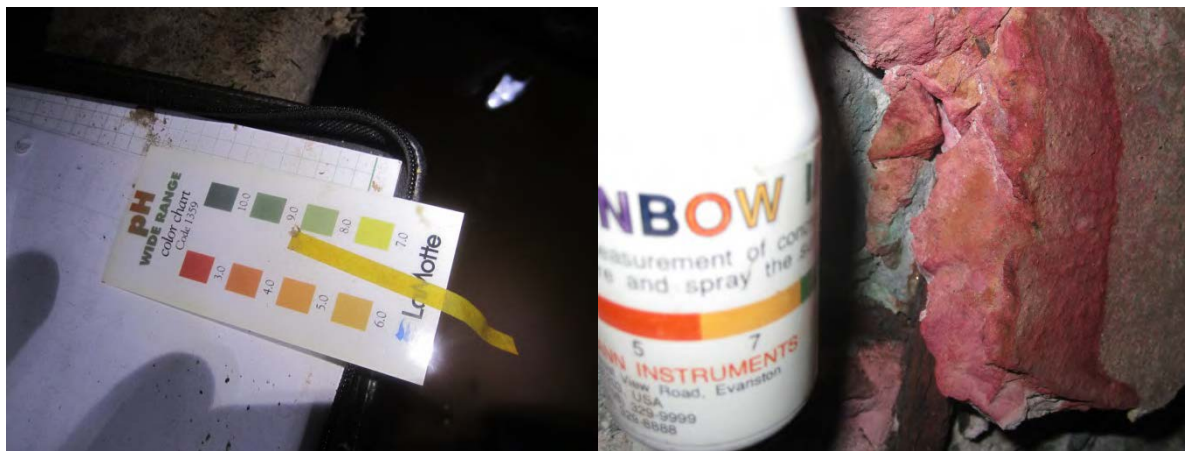
On site pH testing was conducted in multiple locations in the tunnel. Rainbow Indicator by Germann Instruments was sprayed on the freshly broken concrete surfaces of the tunnel. The color that the sample turns to when the indicator dries indicates its pH. A color scale was used to determine the pH of each sample. All of the concrete samples sprayed were found to have a pH of approximately 6-7.

**Figure 6 - pH testing of concrete**

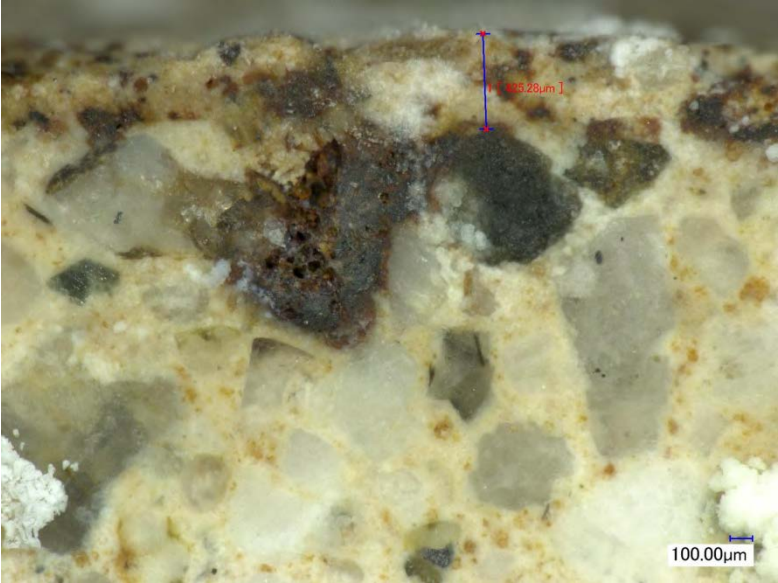
- The hardened paste is uniform white in color in the bulk section of the core. However, in the top and bottom of the core veneer of paste is dark brown. In addition, it seems that the top surface of the core was coated with a sort of cement-based layer. Figure 2 shows examples of a brown cement-based primer on the surface of core P13-14S.

Figure 2 – Brown cement-based coating on the surface of the core

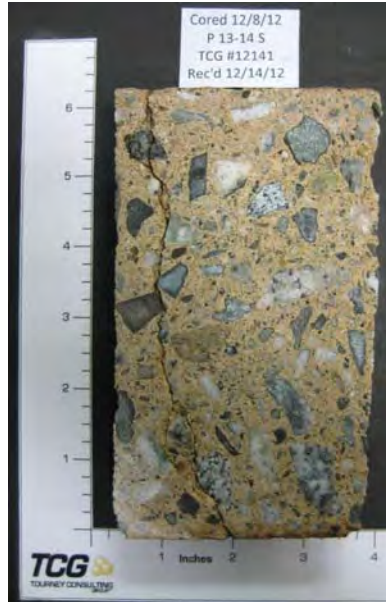
Figure 7 – Core P13-14S after staining with phenolphthalein showing lack of pink staining through the entire section of the core

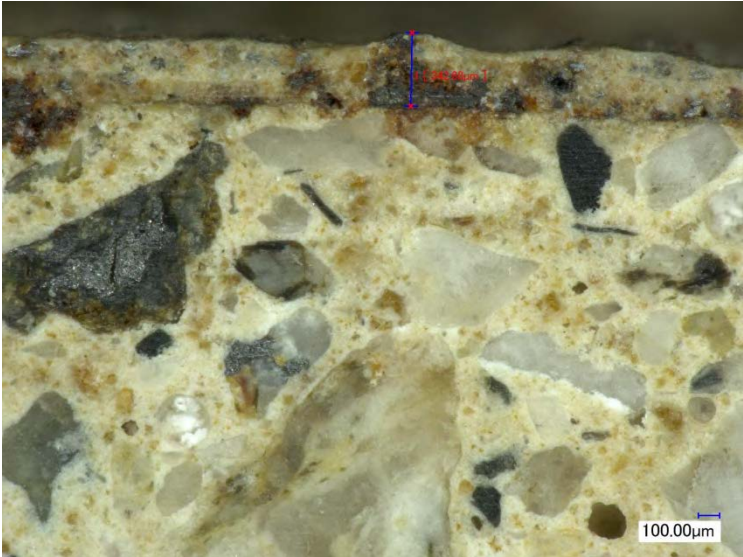
- The hardened paste is uniform white in color in the bulk section of the core. However, in the top and bottom of the core veneer of paste is dark brown. In addition, it seems that the top surface of the core was coated with a sort of cement-based layer. Figure 11 shows examples of a brown cement-based primer on the surface of core P19-20S.

Figure 11 – Brown cement-based coating on the surface of the core

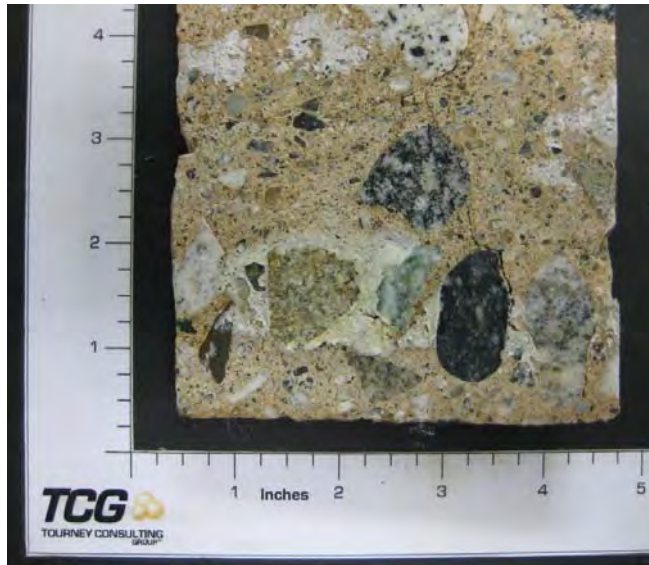
- High amount of crystalline deposits exuded on the surface of partially submerged sample. The crystals where white to transparent in color and appeared in the paste and paste-aggregate interface. Figure 12 shows general view of crystalline deposits exuded on the surface of core P13-14S, whereas Figure 13 shows detailed morphology of these crystals.

Figure 12 – Example of white crystalline deposits exuded on the surface of core P19-20S

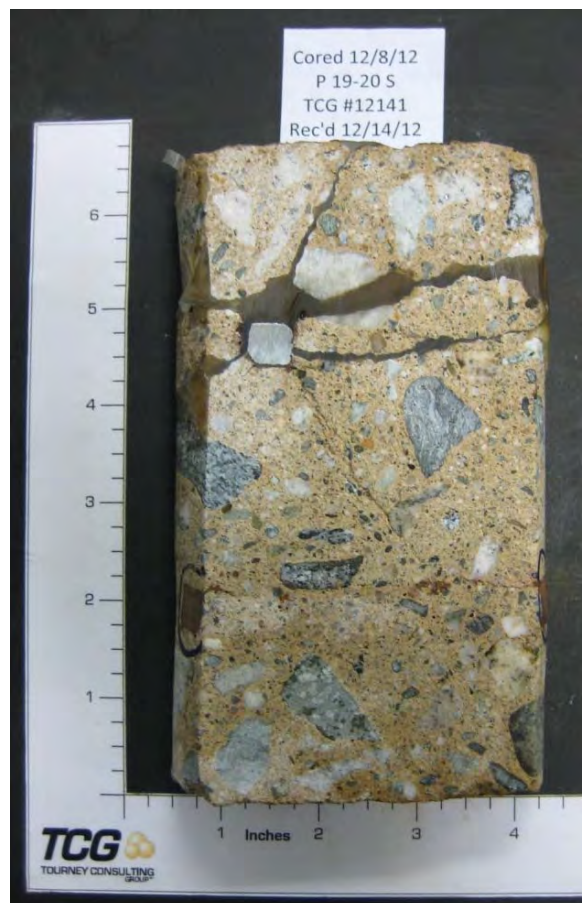
- The carbonation was uniform and was measured through the entire cross-section of the core. Figure 18 shows lack of pink staining in the core sample.

Figure 18 – Core P19-20S after staining with phenolphthalein showing lack of pink staining through the entire section of the core

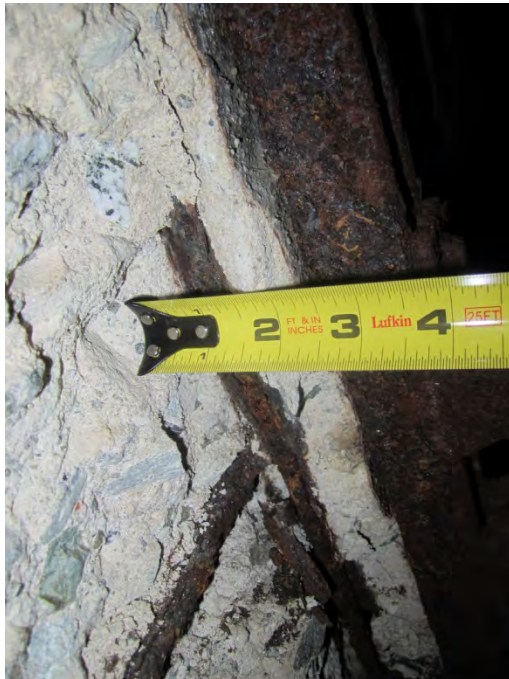
Picture #1-Approximate 2.5" thick spall

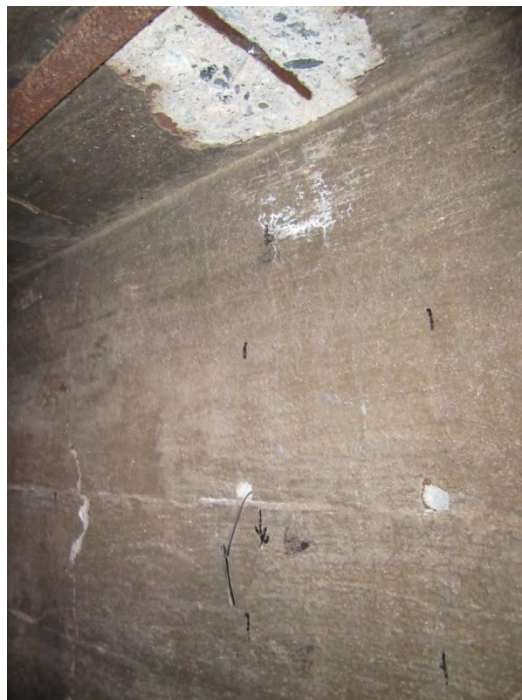
Picture #2- Ceiling spall

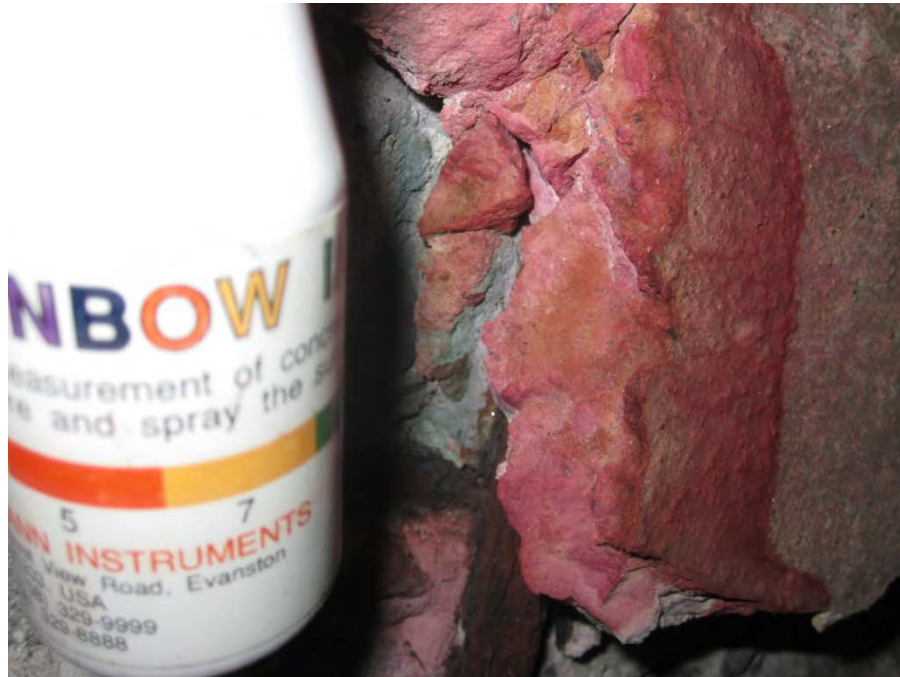
Picture #3- Spall sprayed with rainbow indicator around a 6 pH

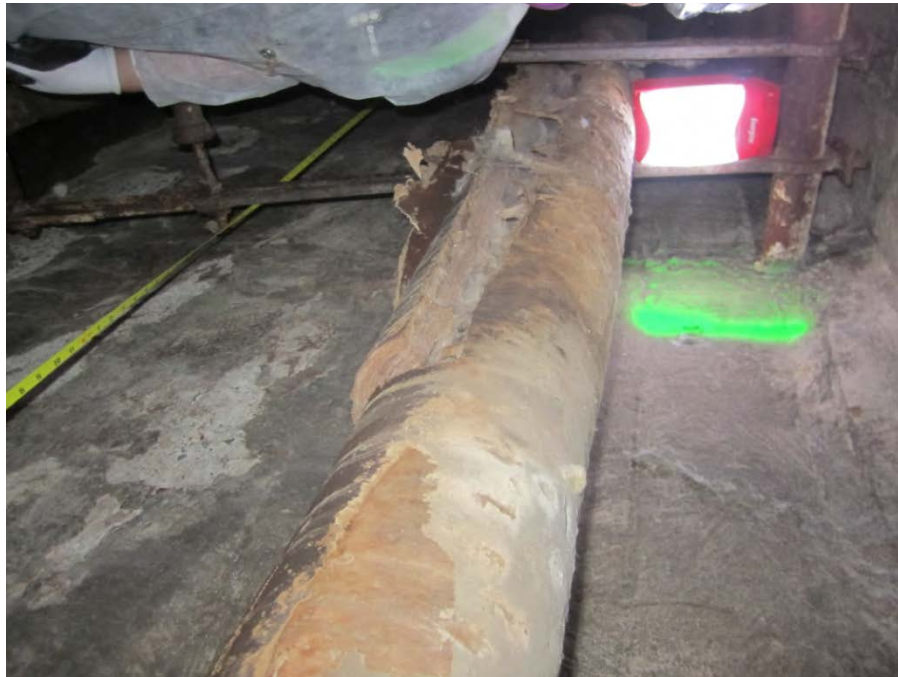
Picture #5- Soft concrete and shallow spalls in Section 0-1

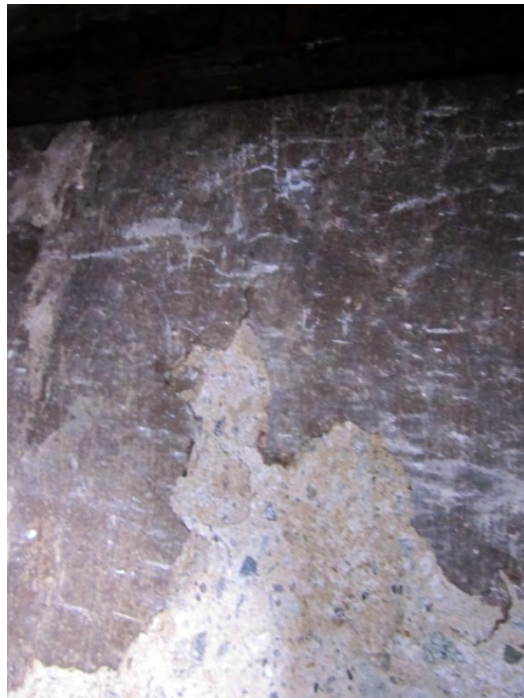
Picture #8- Soft concrete Section 12-13

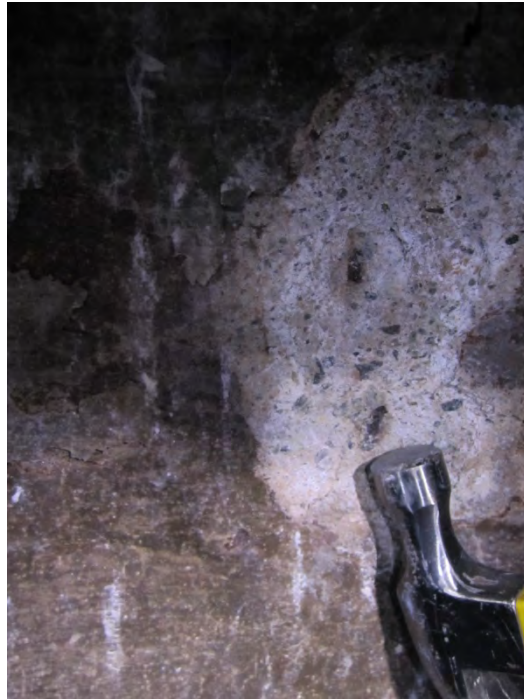
Picture #9- Soft Concrete Section 12-13

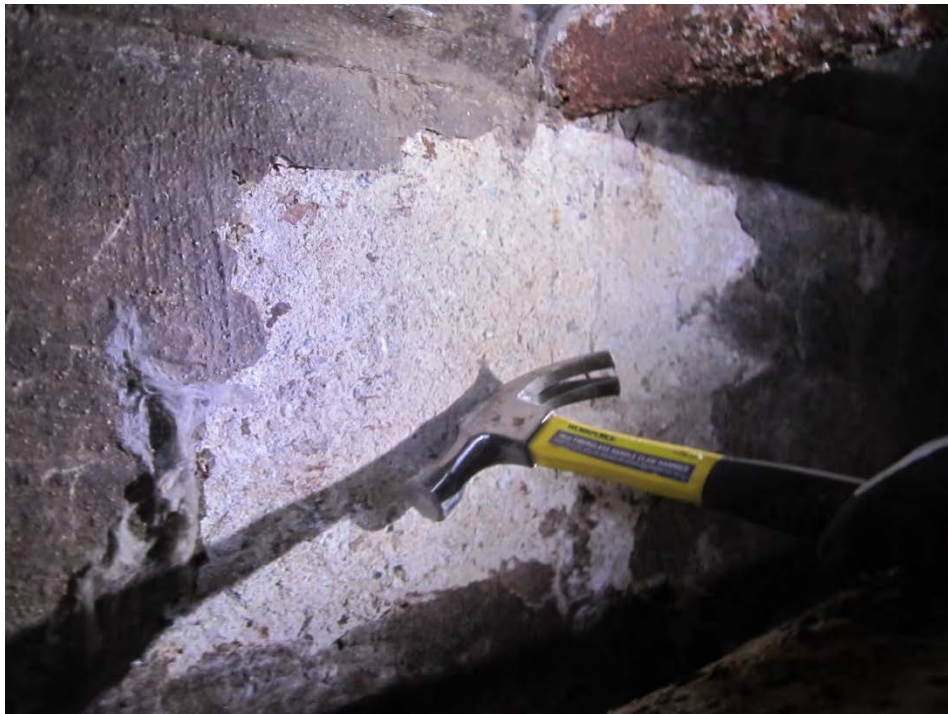
Picture #10- Soft concrete Section 12-13

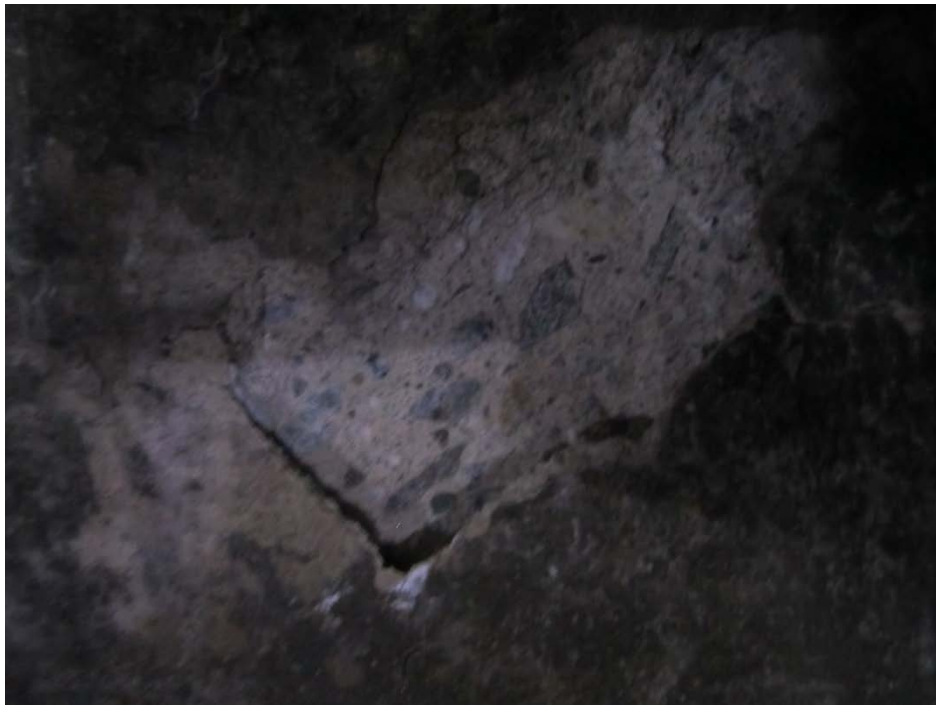
Picture #12- Soft concrete Section 3-4

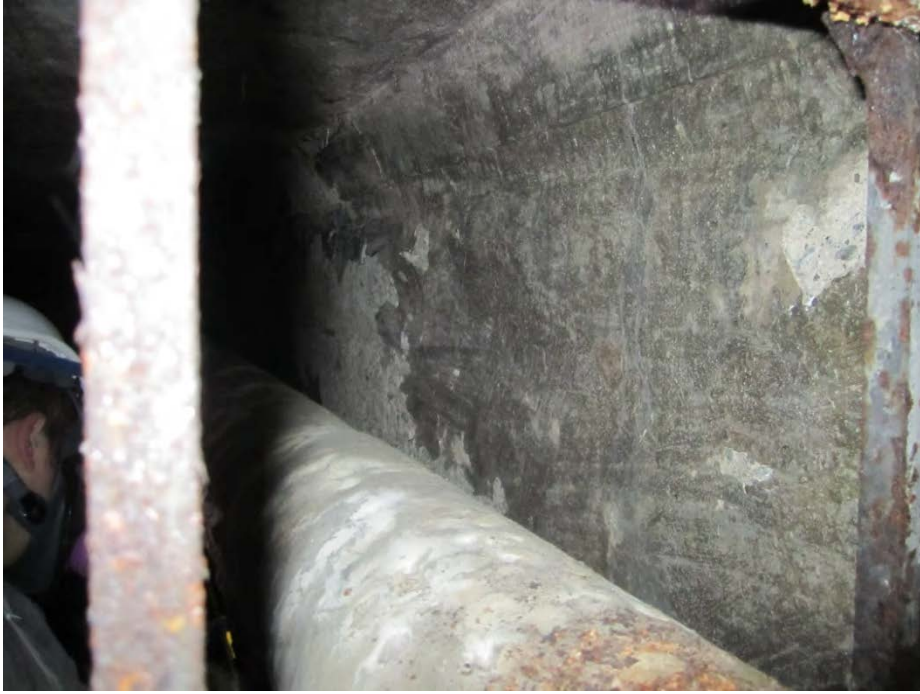
Picture #13- Soft concrete Section 3-4

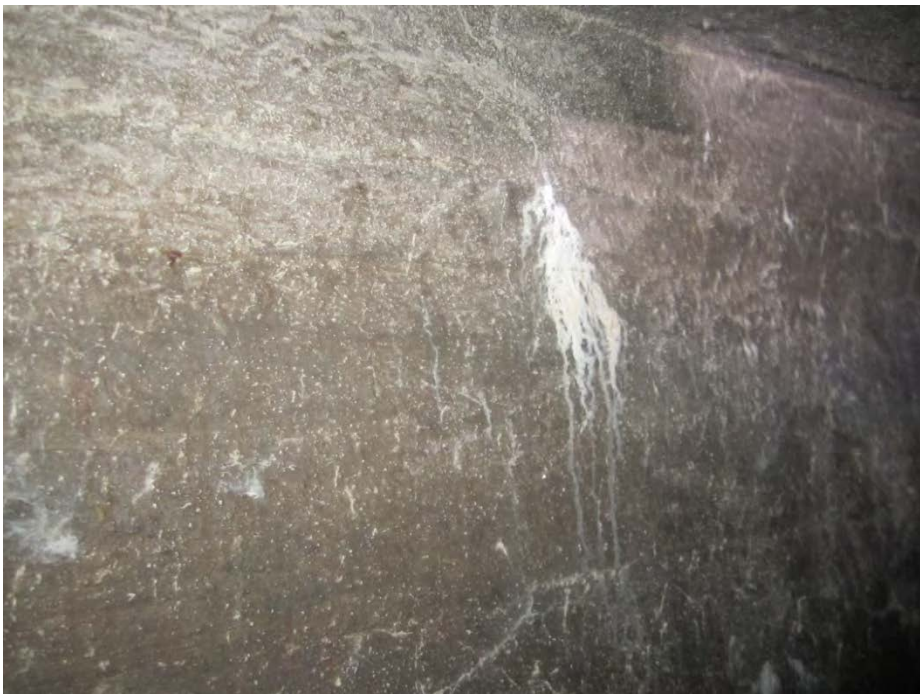
Picture #14- Efflorescent Section 3-4

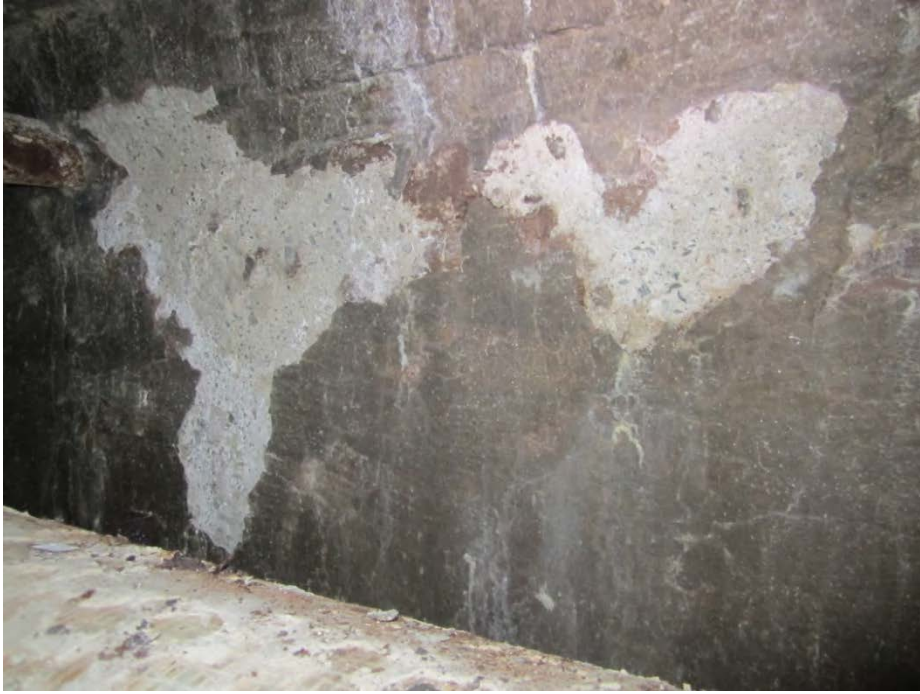
Picture #15- Soft Concrete Section 3-4

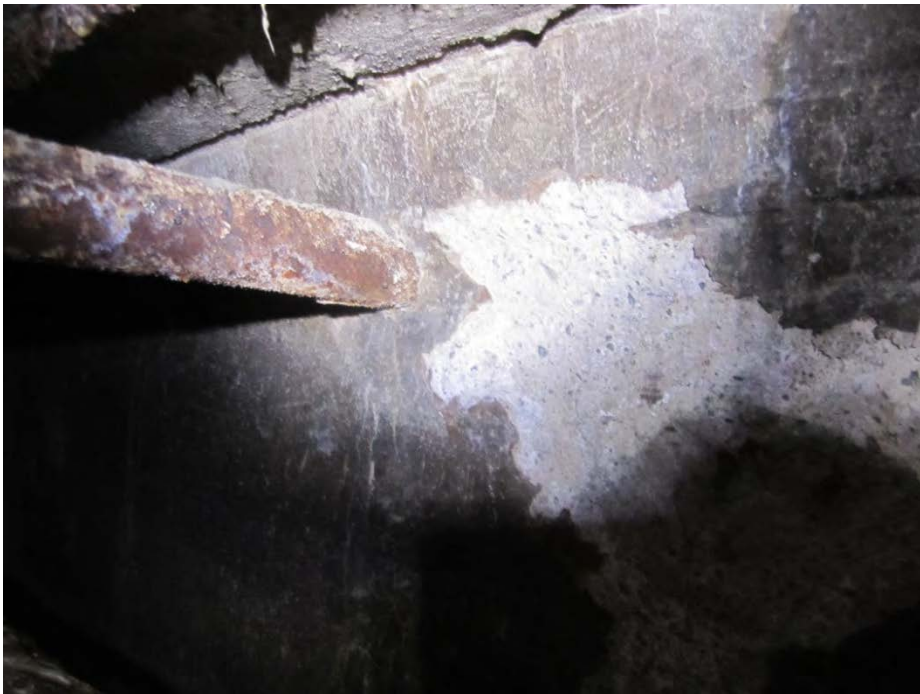
Picture #16- Soft concrete Section 3-4

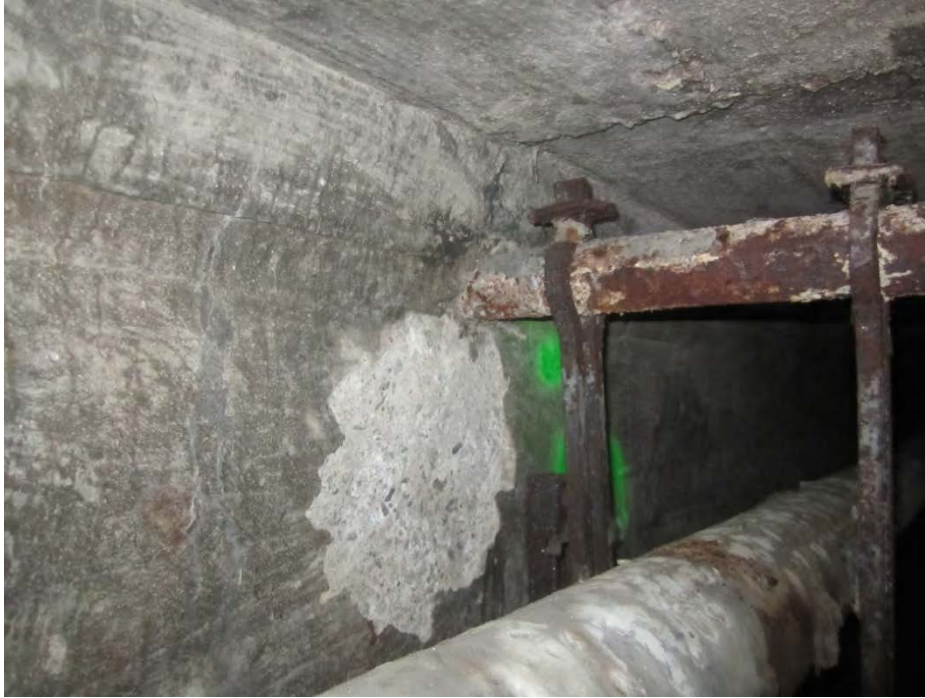
Picture #17- Soft concrete Section 3-4

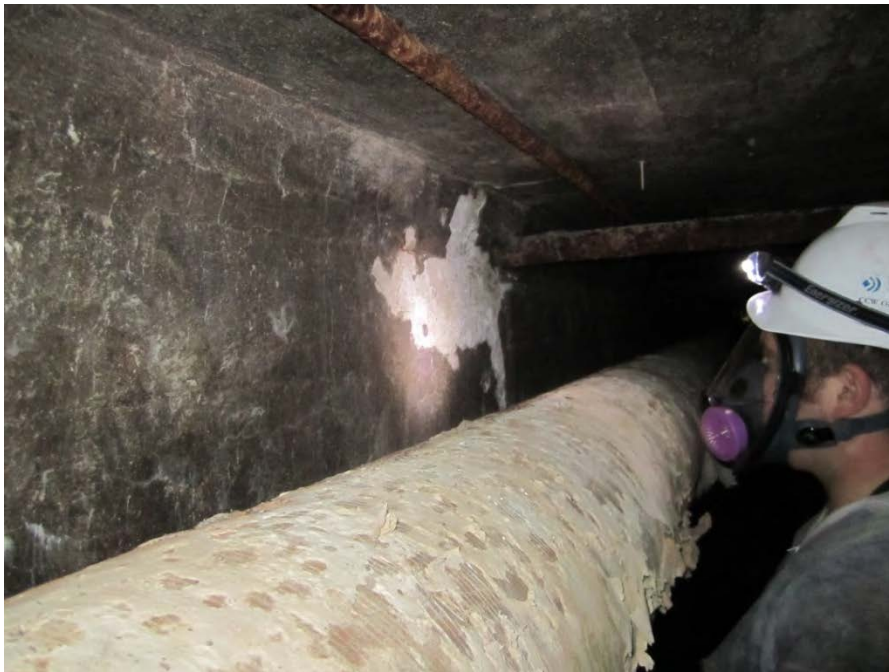
Picture #18- Soft Concrete Section 3-4

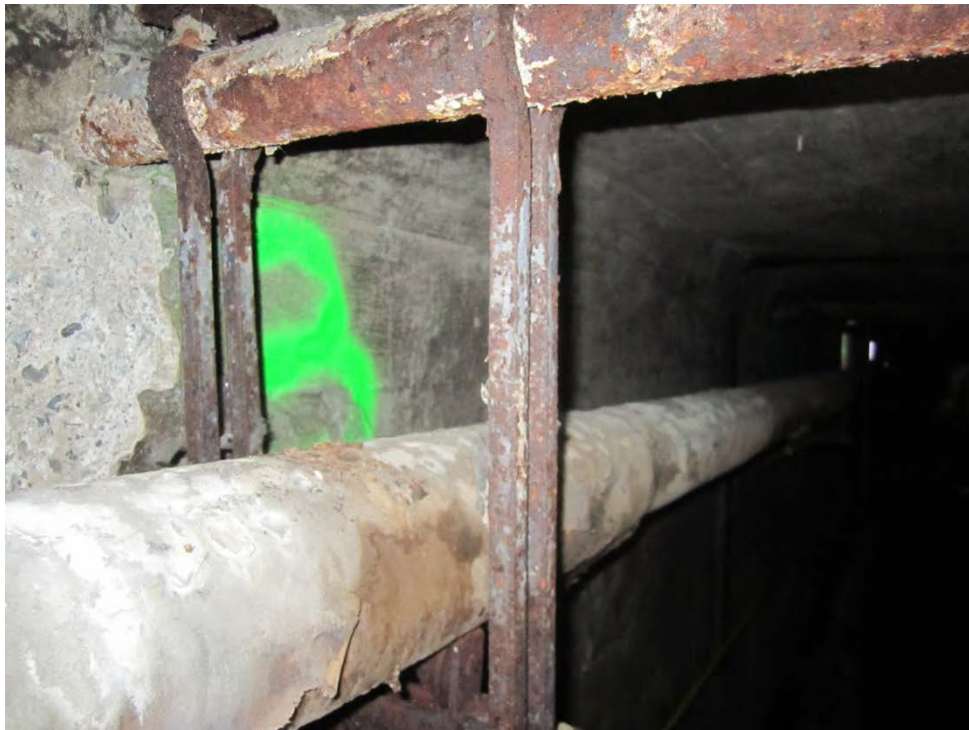
Picture #20- Soft Concrete Section 3-4

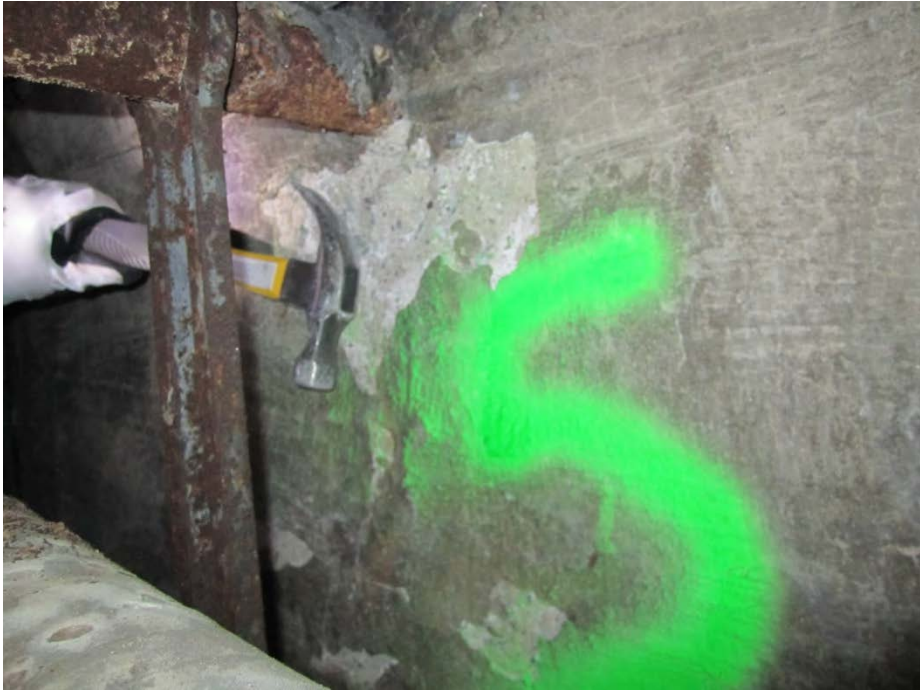
Picture #21- Soft concrete Section 5-6

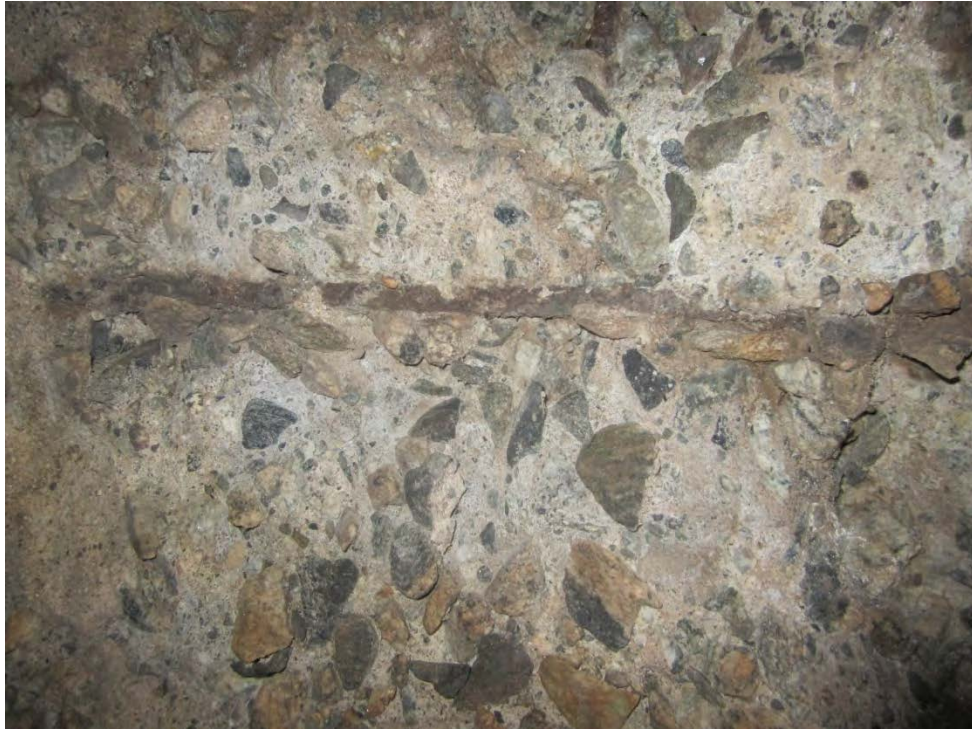
Picture #28- Soft concrete Section 15-16

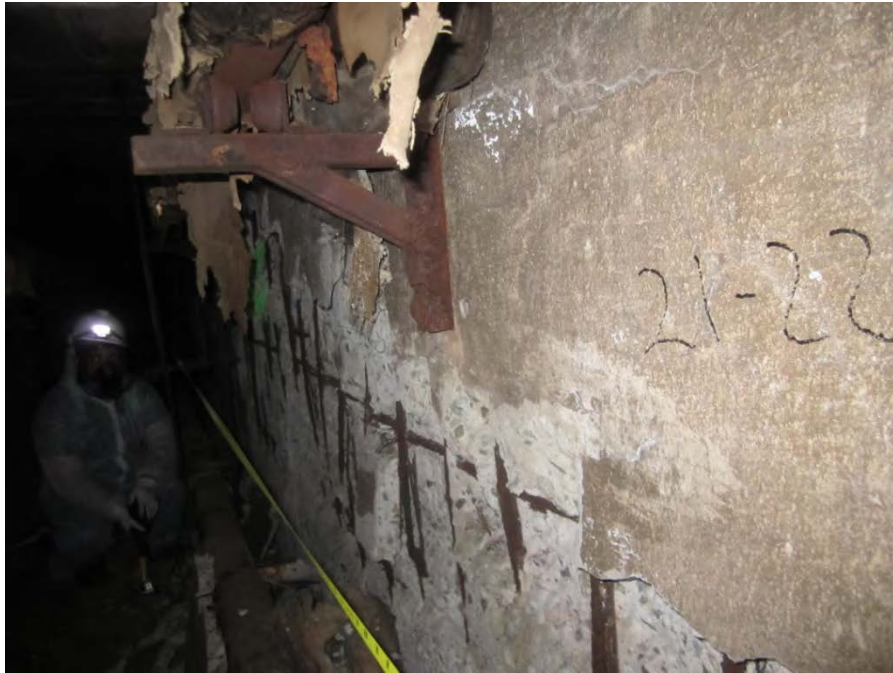
Picture #30- Spall with exposed corroded reinforcing steel Section 21-22

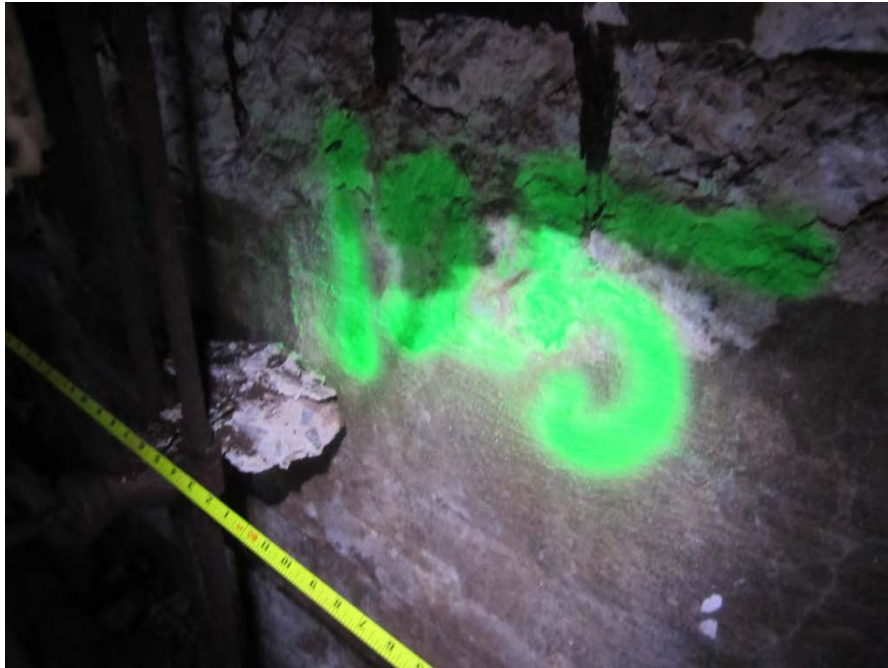
Picture #32- Spall with exposed corroded reinforcing steel Section 21-22

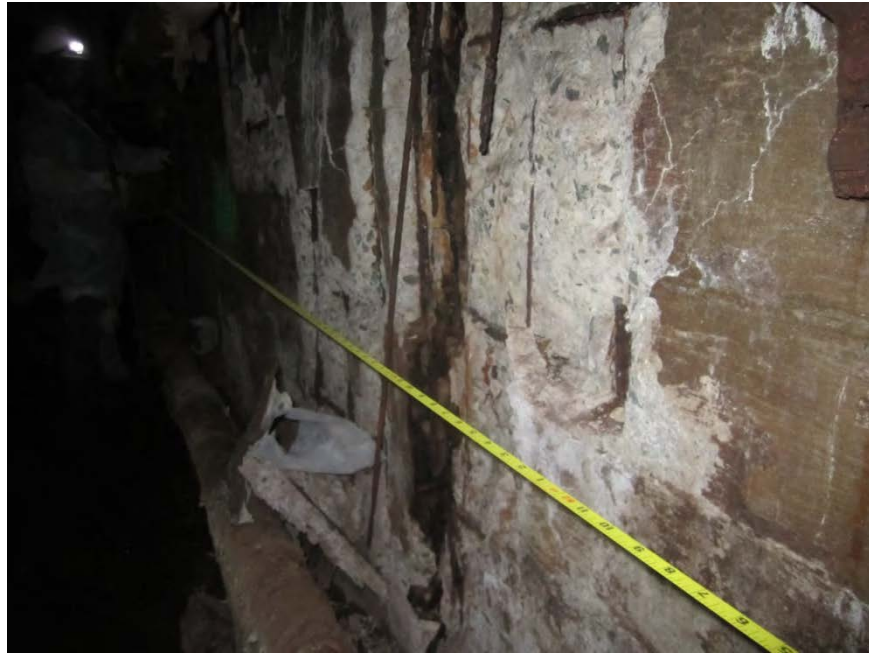
Picture #34- Damage tunnel section with spalling and heavy corrosion near Station 26

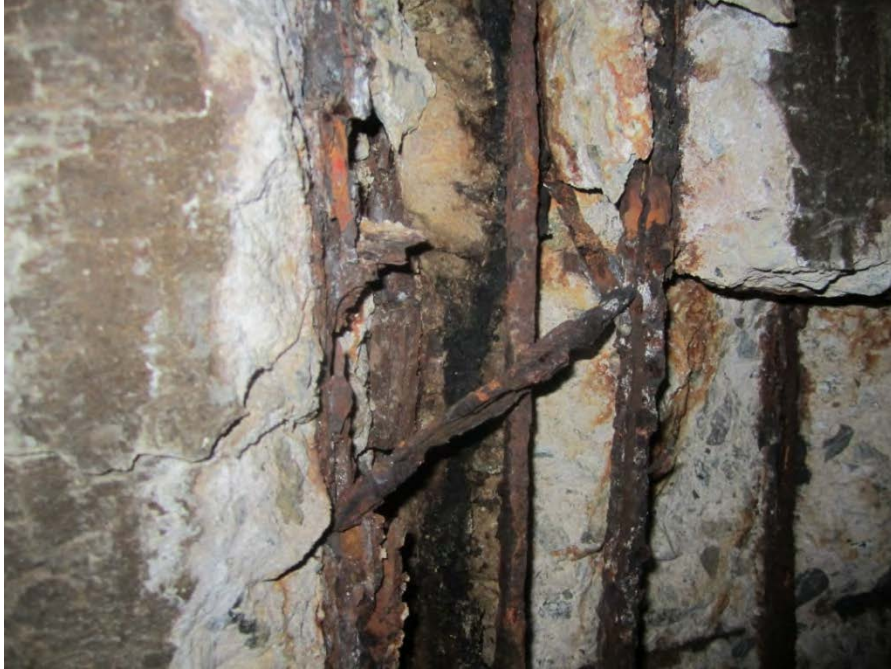
Picture #36- Ceiling delamination with corroded pipe, conduit, and reinforcing steel near Station 26

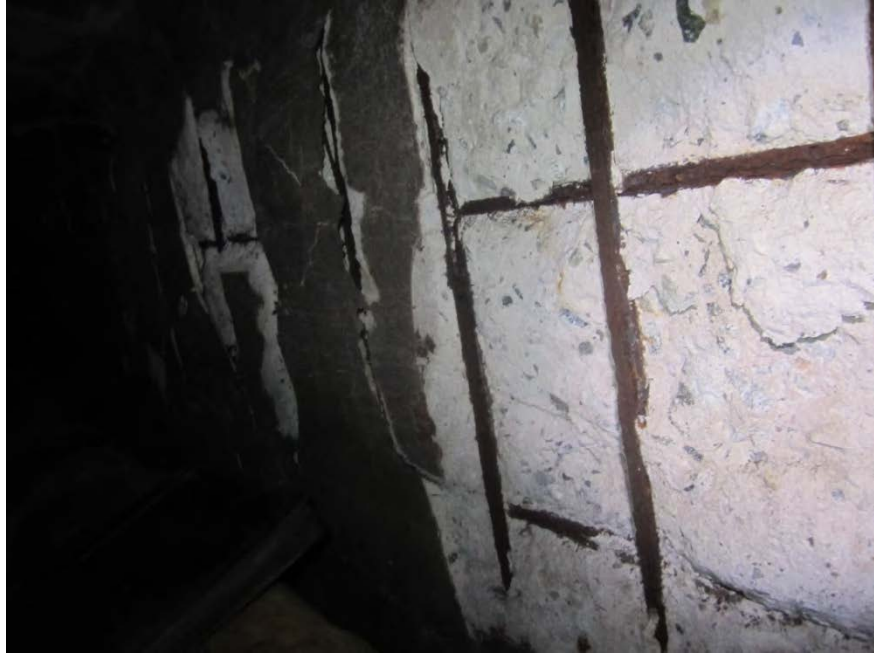
Picture #38- Deep spalling and extensive corrosion near Station 26

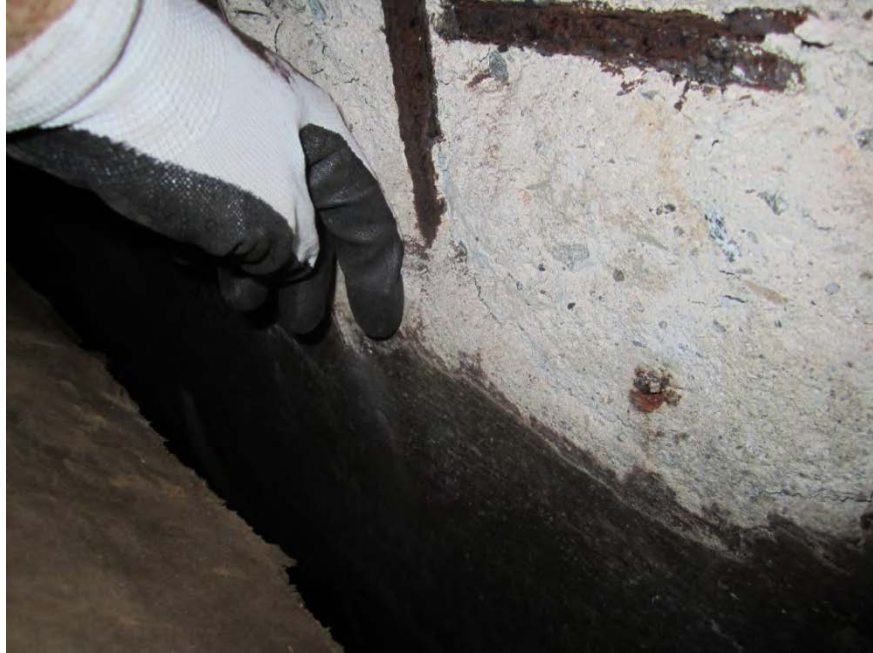
*Picture #40- Spalling and soft concrete Section 35-36*

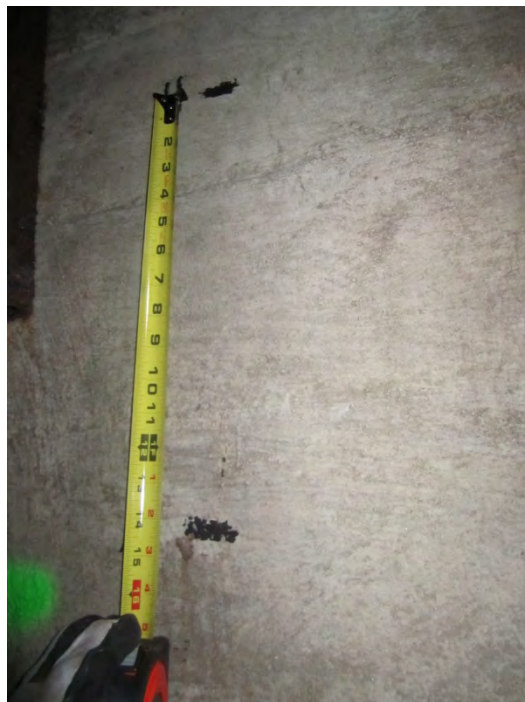
*Picture #47- Spacing of vertical reinforcement in Test Area 1*

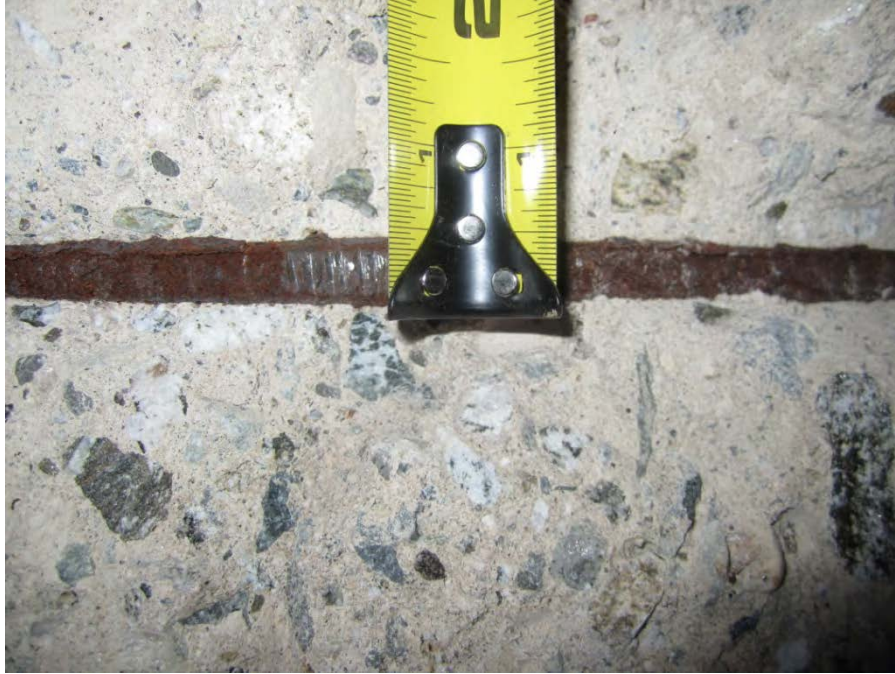
*Picture #48- Spacing of horizontal reinforcement in Test Area 1*

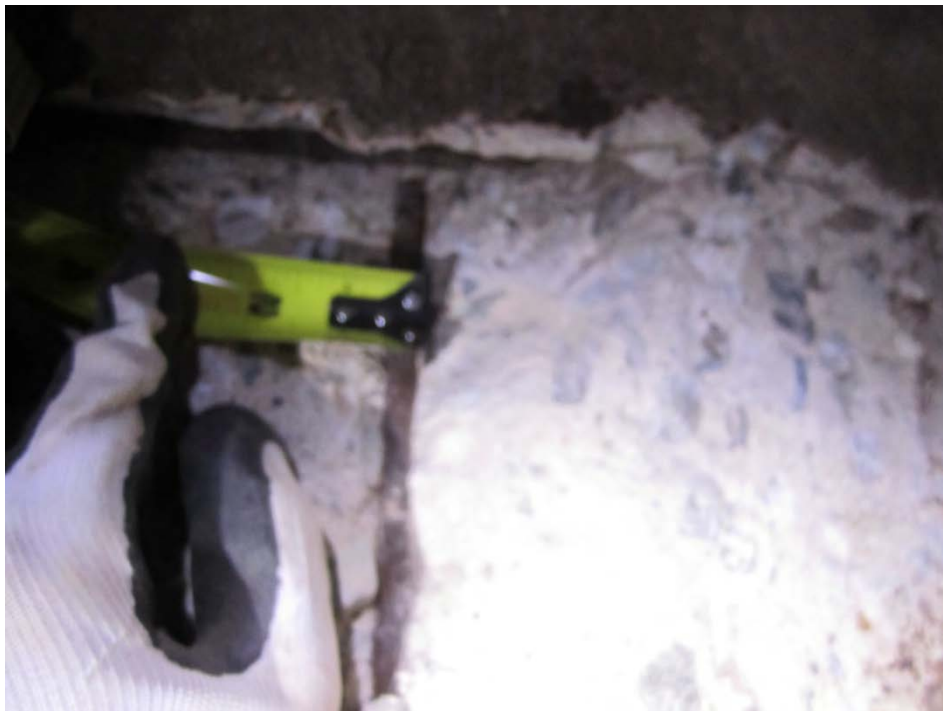
*Picture #49- Exposed square Reinforcing bar 3/8"*

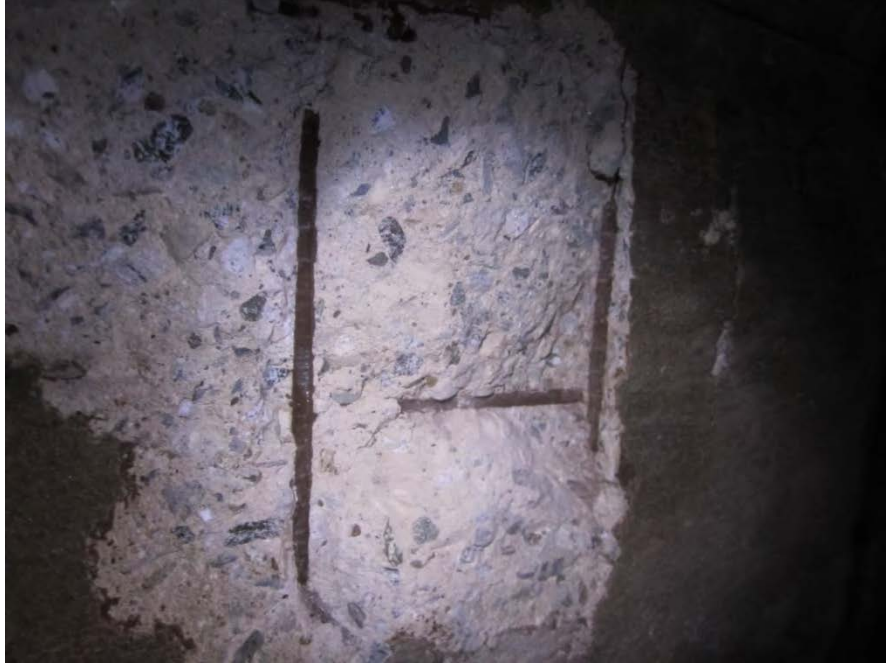
*Picture #50- Measurement of exposed reinforcing bar 3/8"*

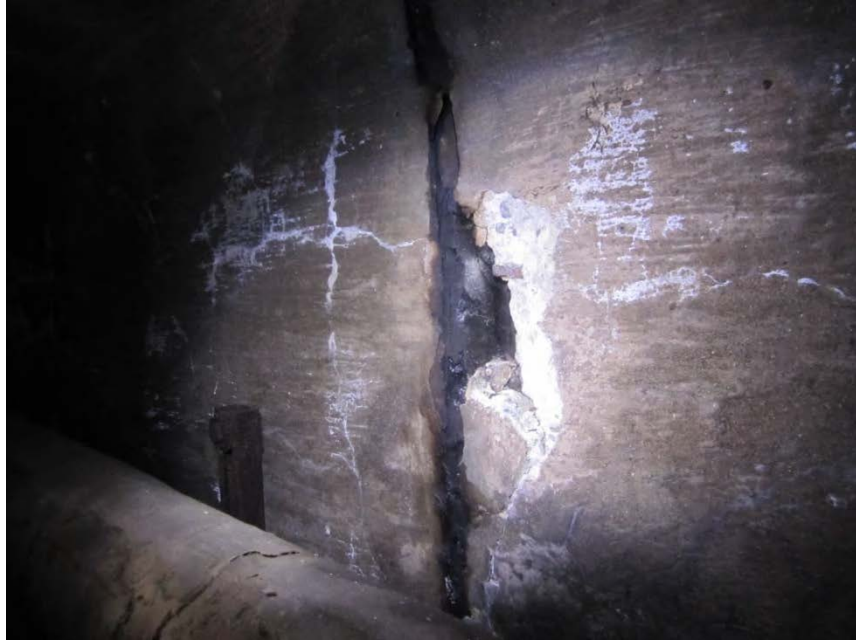
*Picture #52- Spall depth approximately 1-3/4" near Station 19*

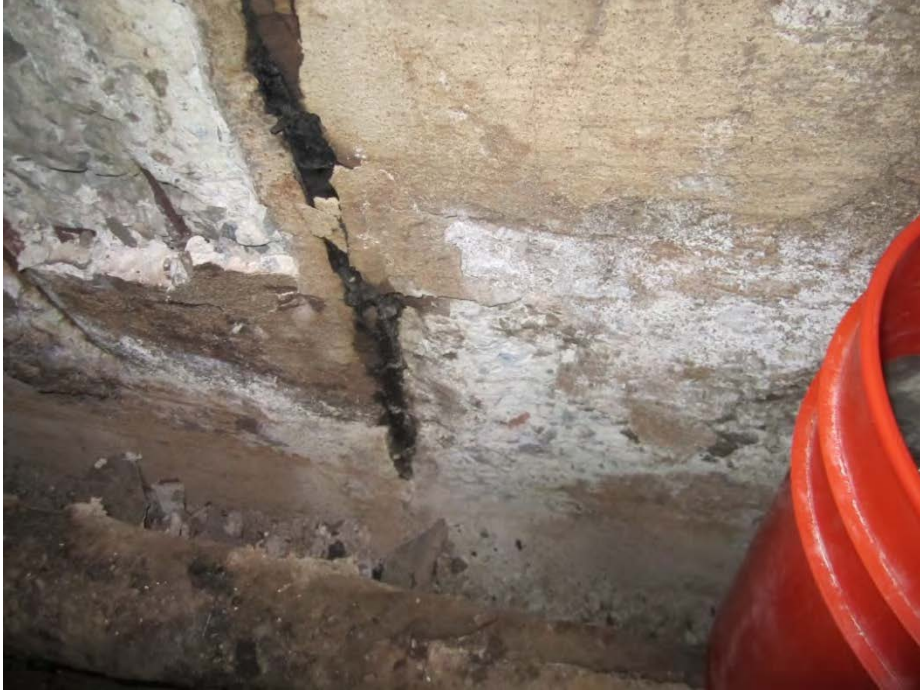
*Picture #54- Spalling near joint Section 19-20*
