LAC+USC TUNNEL STRUCTURAL AND MECHANICAL ASSESSMENT  
AND ASBESTOS SURVEY,  
1200 NORTH STATE STREET, LOS ANGELES, CALIFORNIA

LAC USC TUNNEL  
Structural and Mechanical  
Assessment and Asbestos Survey

January 30, 2013

**Structural Assessment & Corrosion Evaluation Of  
LAC+USC Medical Center/Utility Tunnel (Juvenile Hall)  
Los Angeles, California**

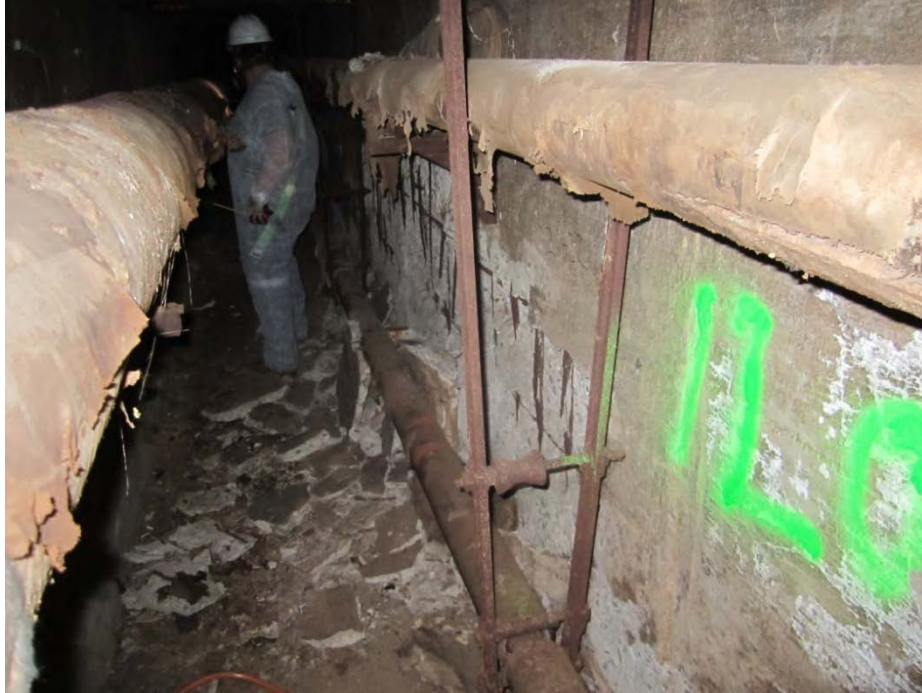
*Picture #56- Ceiling spall Section 19-20*

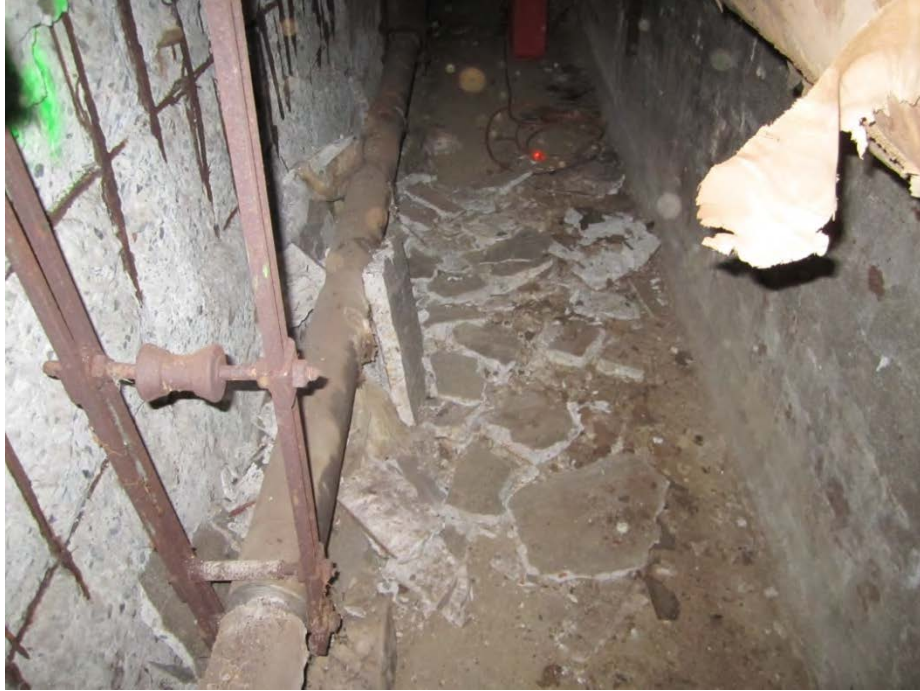
*Picture #60- Spalling Section 20-21*

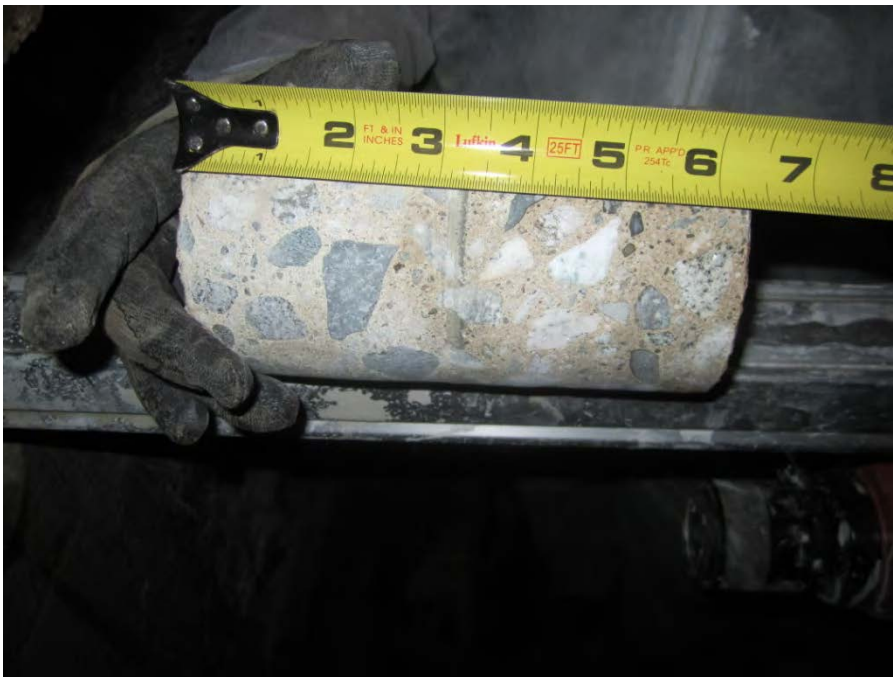
Picture #71- Core CS19-20-S

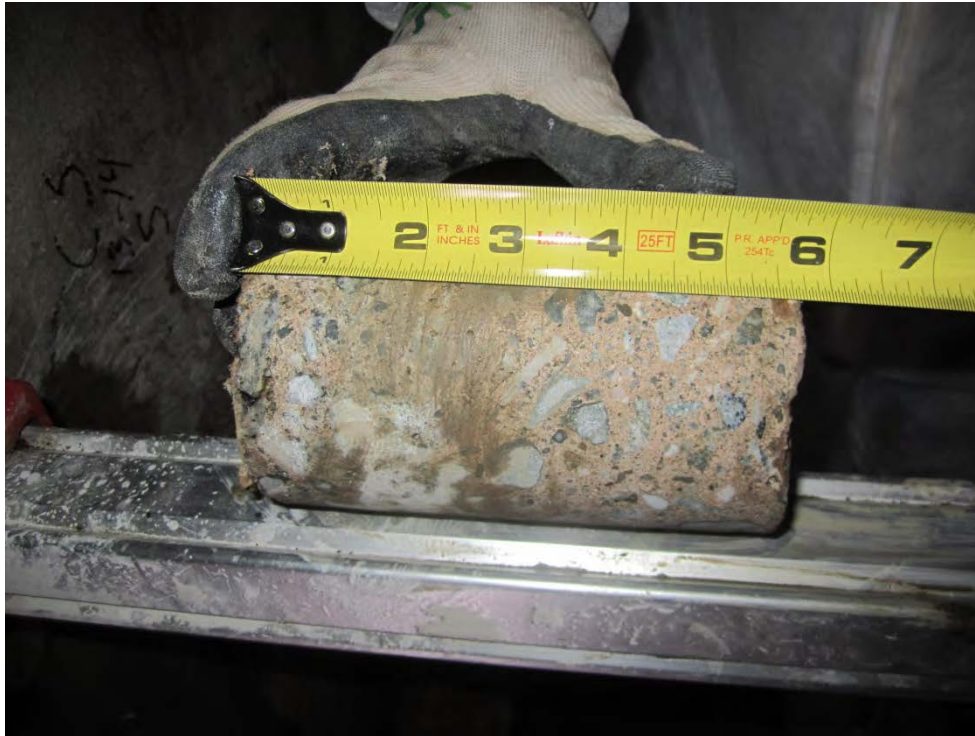
*Picture #75- Core CS13-14S taken to full depth approximately 5-3/4" thick*

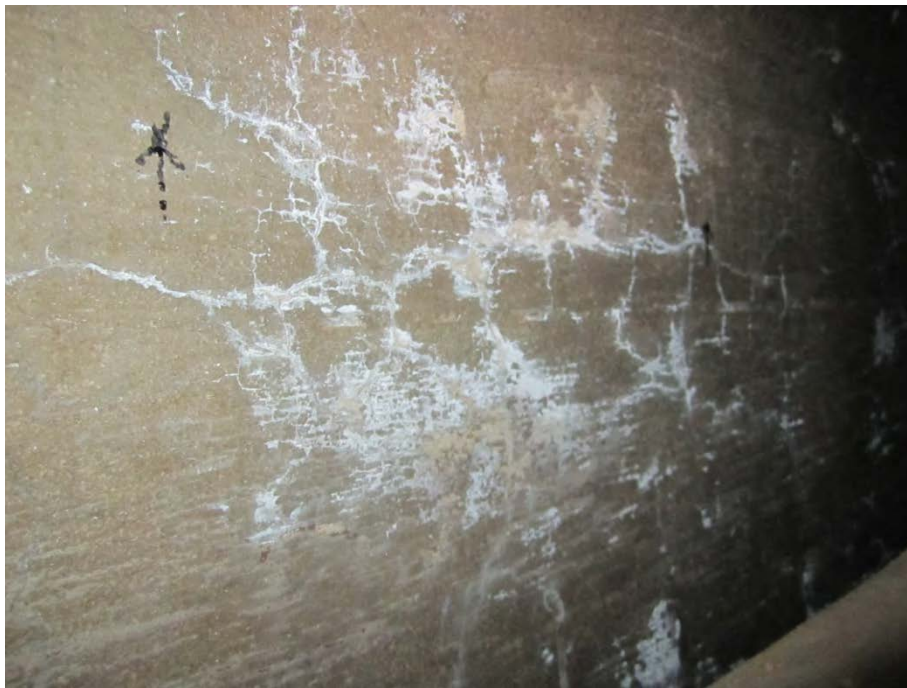
*Picture #84- Many small cracks*

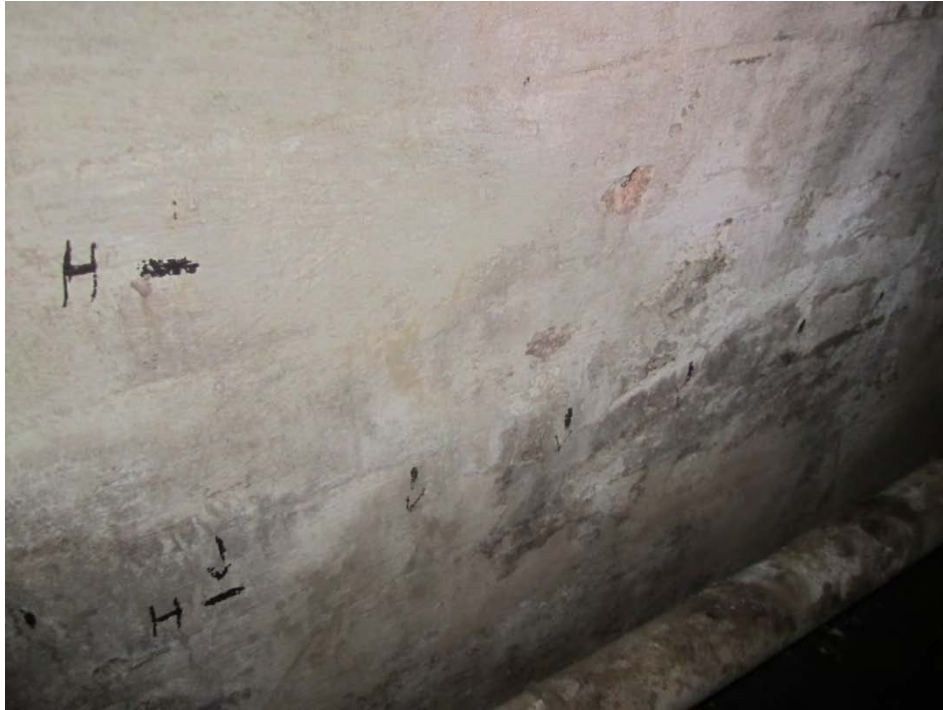
*Picture #89- Steel lay-out Test Area 1*

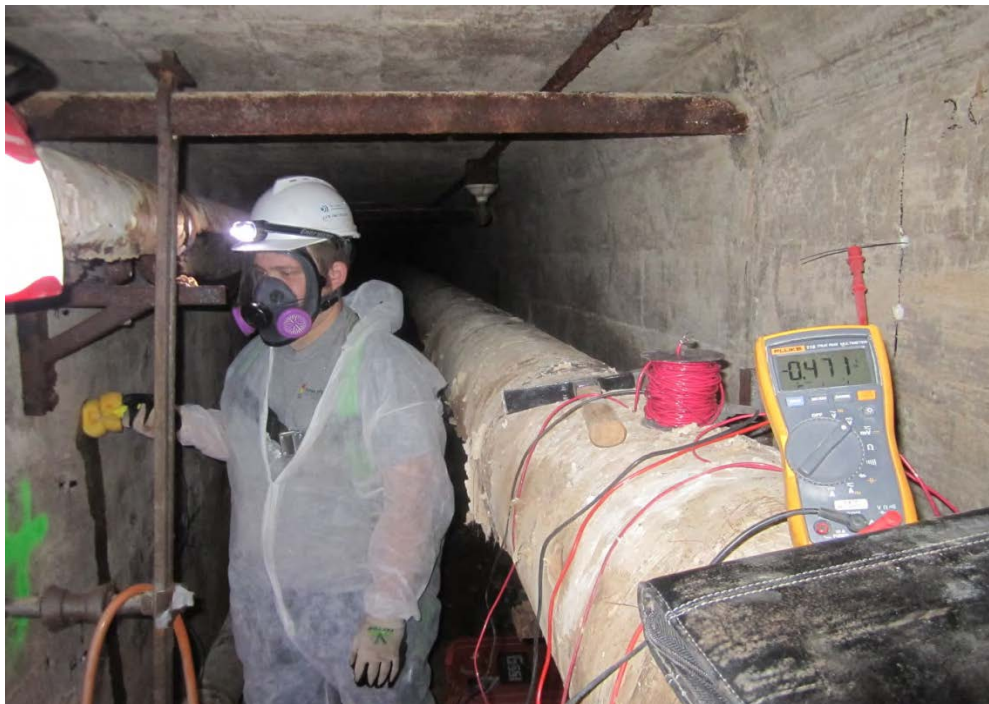
*Picture #90- Corrosion potential testing in progress*

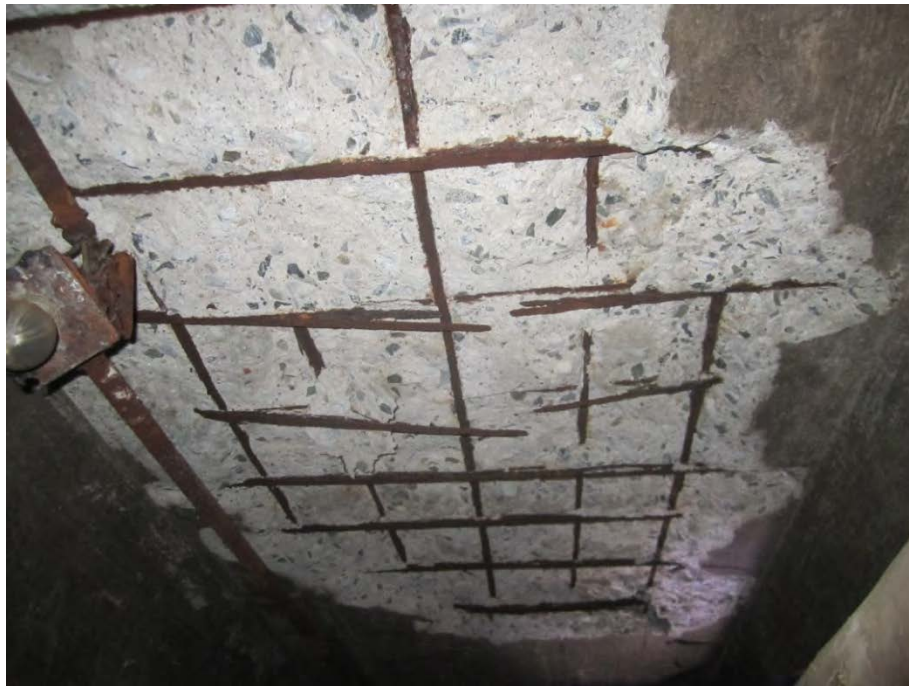
*Picture #92- Ceiling Spall near Station 20*

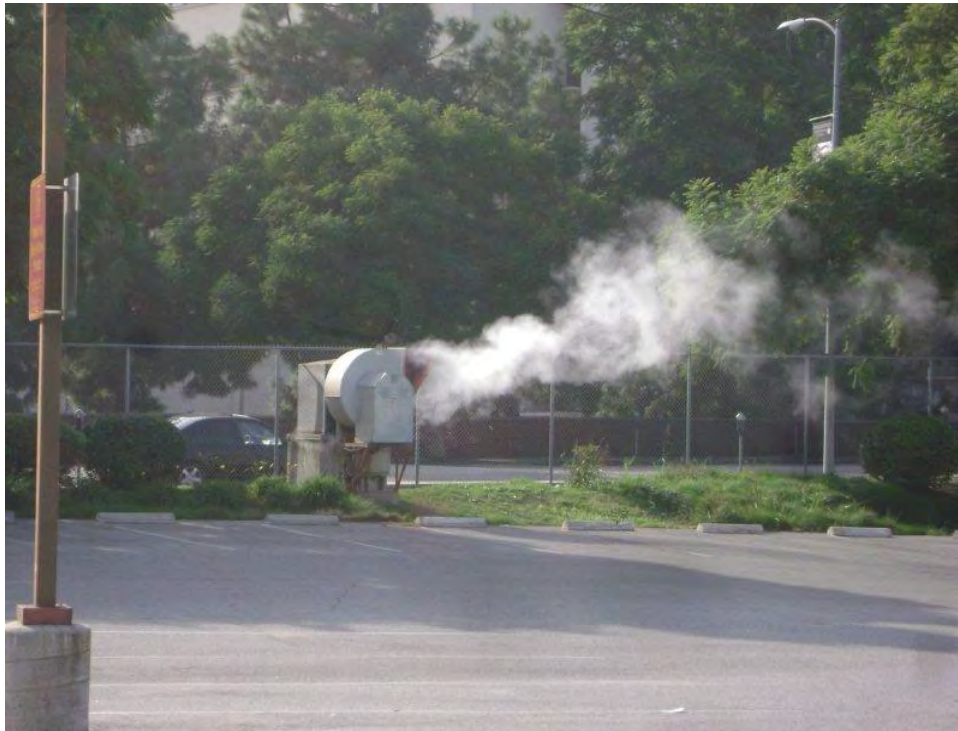
3. Working Conditions: The steam supply and steam condensate return piping are black steel and in poor working condition; leaking steam and water in many locations (See Photos #1 thru 7). Steam piping are insulated with fiberglass on the South Side and insulated with asbestos (See Photo #8) on the North Side of the utility tunnel. The fiberglass insulation is in poor working condition and there is no insulation in many locations (See Photos #9 thru 11). Steam supports are rusted and not properly anchored or secured to the concrete wall due to the wall being spalled (See Photos #12 thru 14). The electrical conduit is completely corroded (See Photos #15 and 16).

PHOTO 7: STEAM ESCAPING (EASILY OBSERVABLE) THRU EXHAUST FAN ON TOP OF MANHOLE AT ZONAL AVENUE

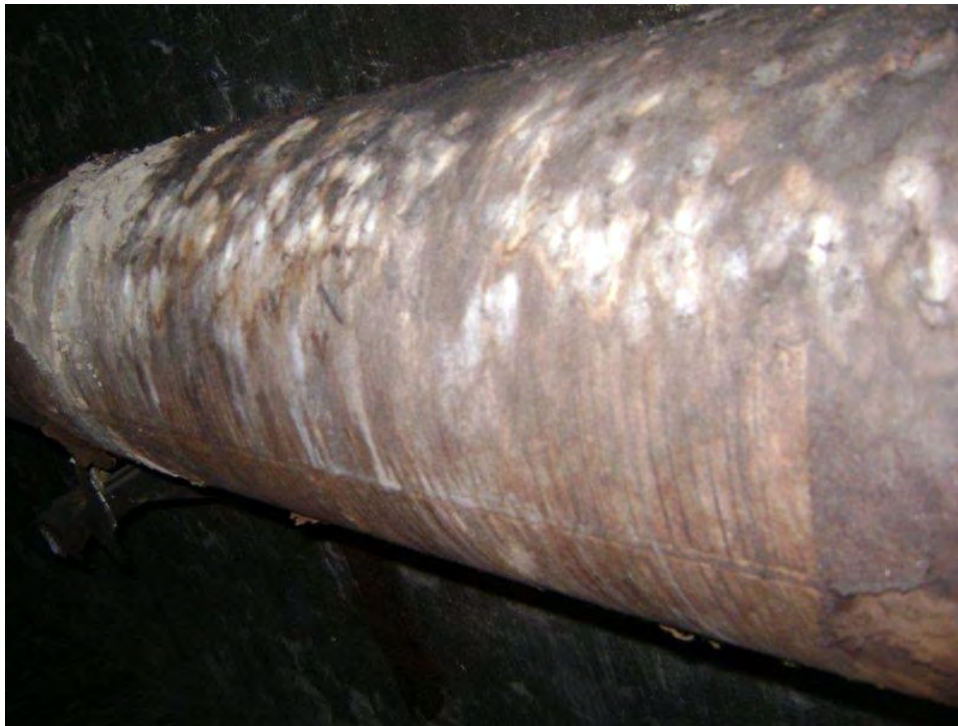
PHOTO 8: STEAM PIPE INSULATED WITH ASBESTOS

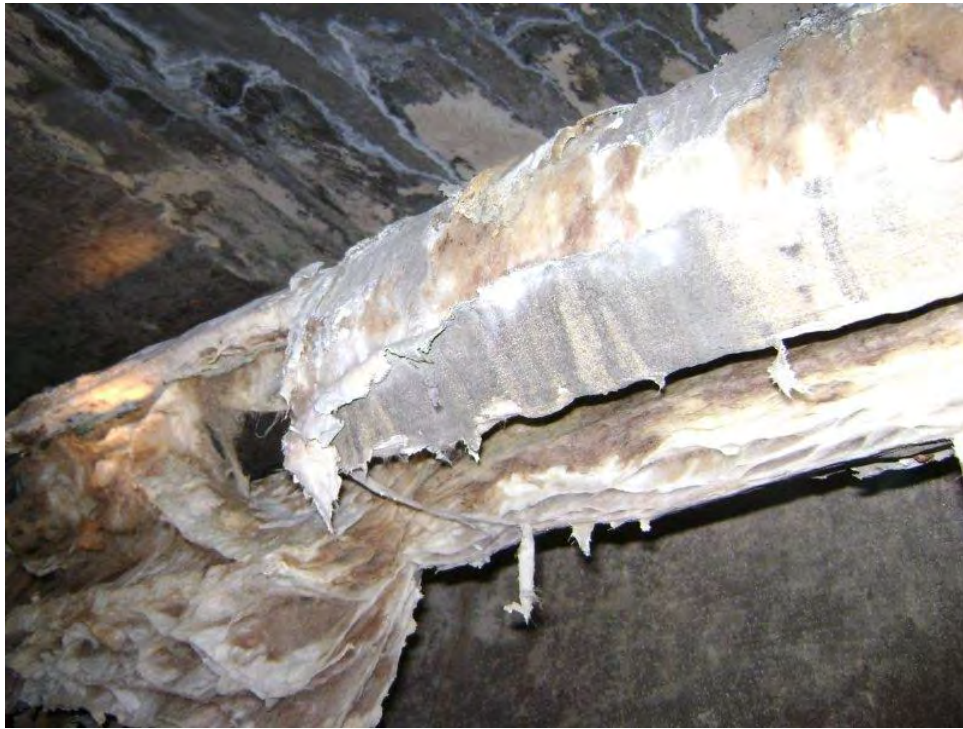
PHOTO 9: INSULATION IS FALLING APART

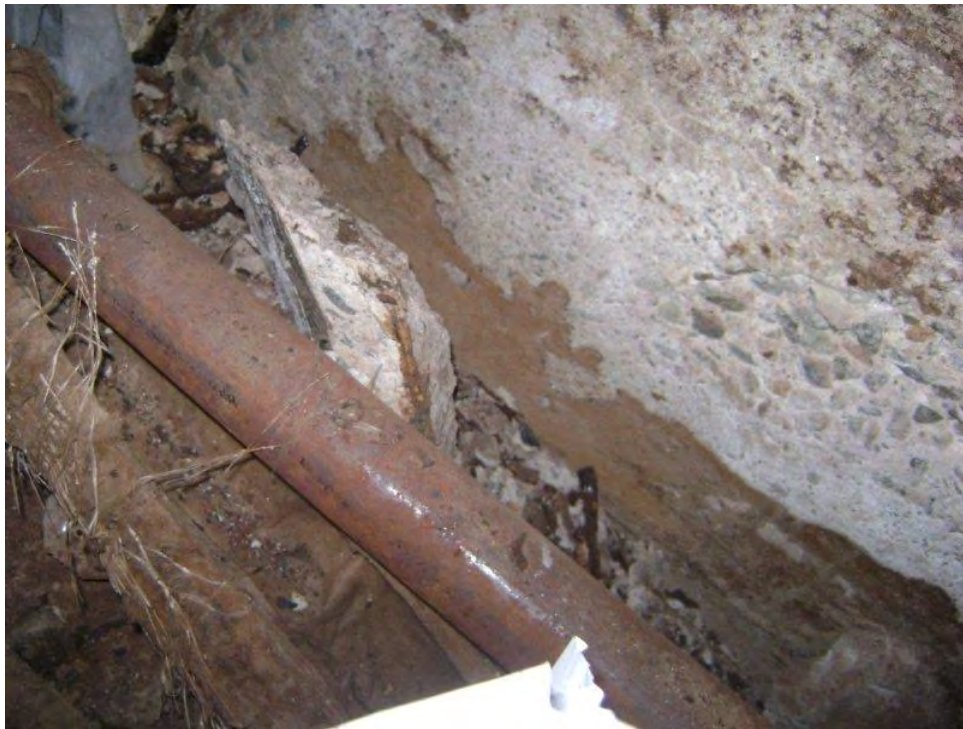
PHOTO 10: INSULATION IS FALLING APART
