LAC+USC TUNNEL STRUCTURAL AND MECHANICAL ASSESSMENT  
AND ASBESTOS SURVEY,  
1200 NORTH STATE STREET, LOS ANGELES, CALIFORNIA

LAC USC TUNNEL  
Structural and Mechanical  
Assessment and Asbestos Survey

January 30, 2013

**Structural Assessment & Corrosion Evaluation Of  
LAC+USC Medical Center/Utility Tunnel (Juvenile Hall)  
Los Angeles, California**

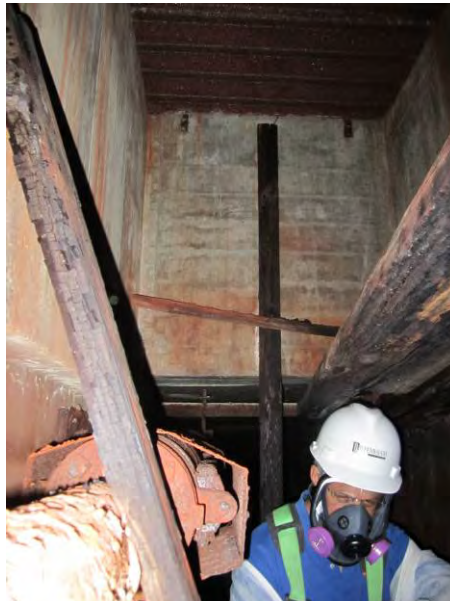
- Structural visual assessment and delimitation survey of the entire accessible portion of the tunnel by Juan Carlos Esquivel, M.S., S.E., Principal of JCE Structural Engineering Group and Andrew Broecker and Clarence Zimmel from Vector Corrosion Technologies. The tunnel was NOT accessible beyond Zonal Avenue (See Photo 1) up to about 100 feet into the Juvenile hall (See Photos 2 & 3).

**3. No Access Beyond this Point (100 FT Inside Juvenile Hall)**

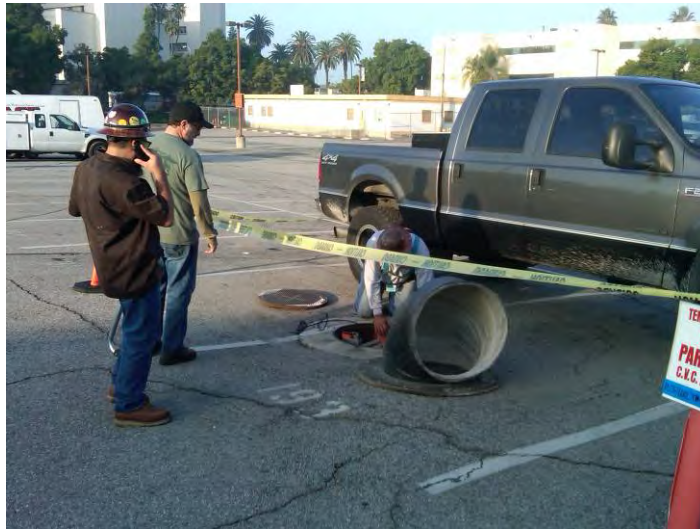
**5. Ventilation Preparations at Second Manhole**

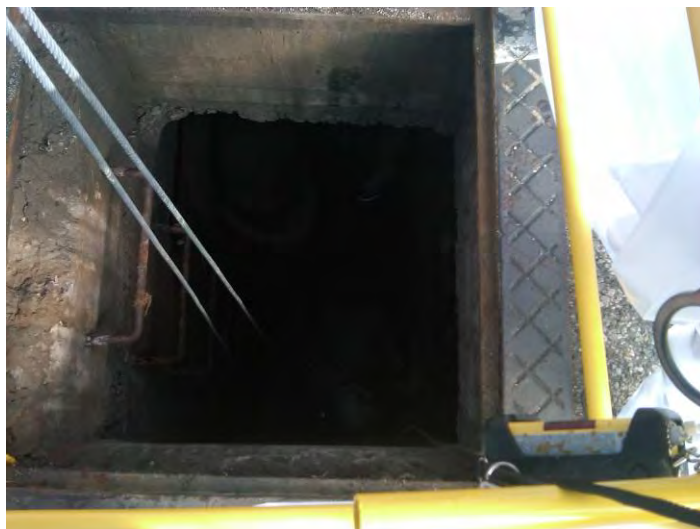
**6. Tunnel View from Entry**

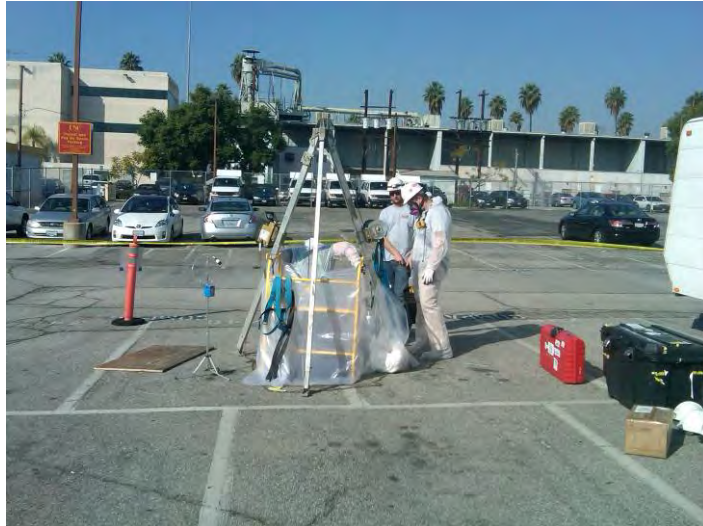
**7. Vector Corrosions Technology Entry**

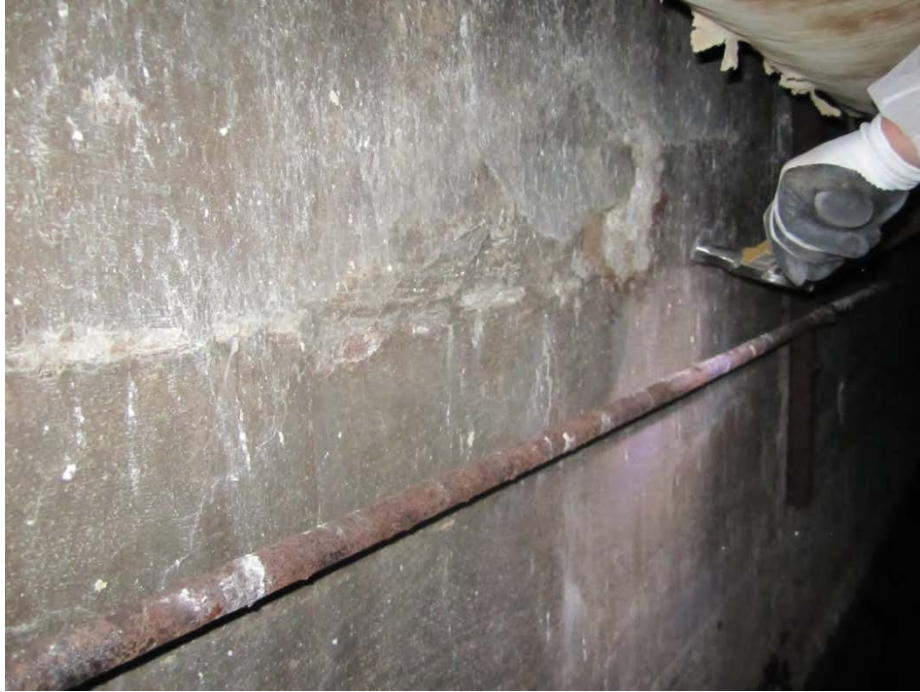
Picture #19- Sounding survey Section 3-4

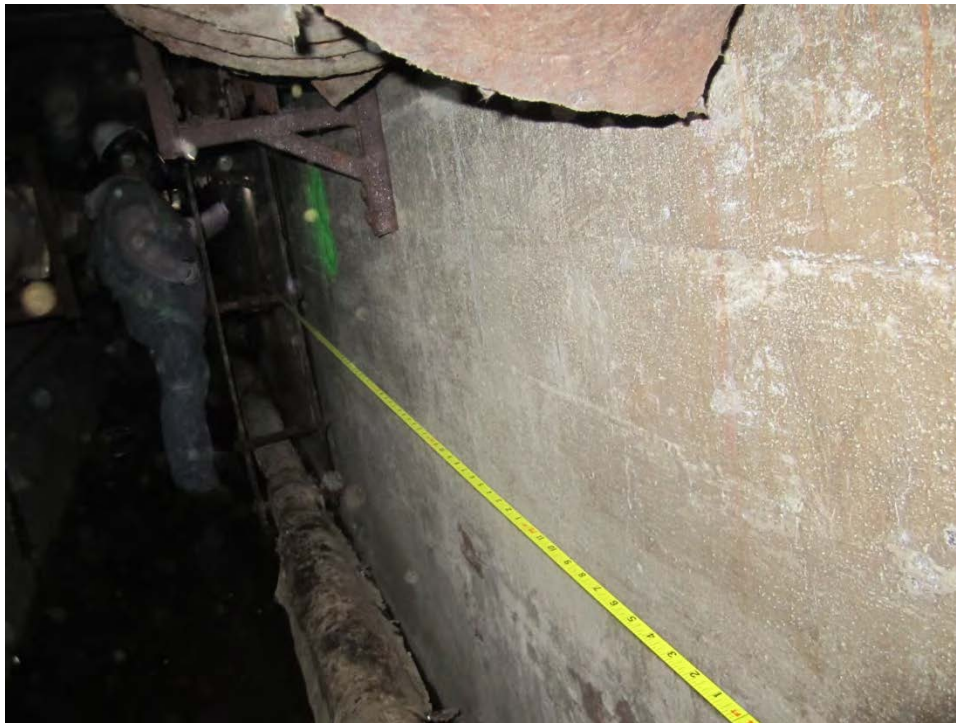
Picture #23- Deteriorated joint near Station 6

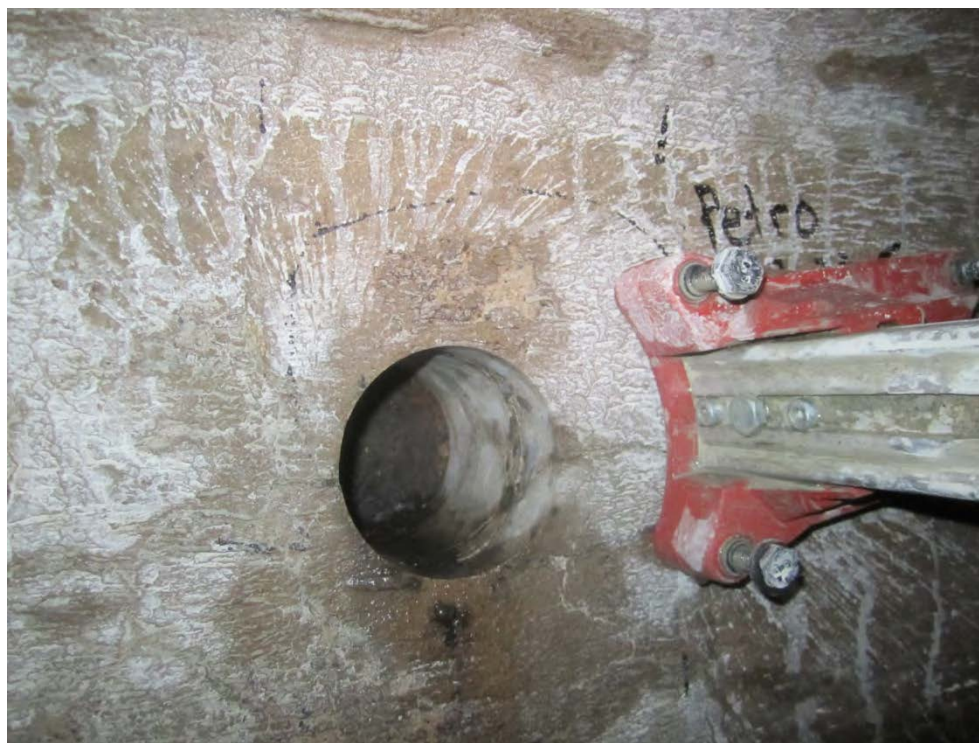
*Picture #65- Area of petrographic analysis core Petro19-20-S*

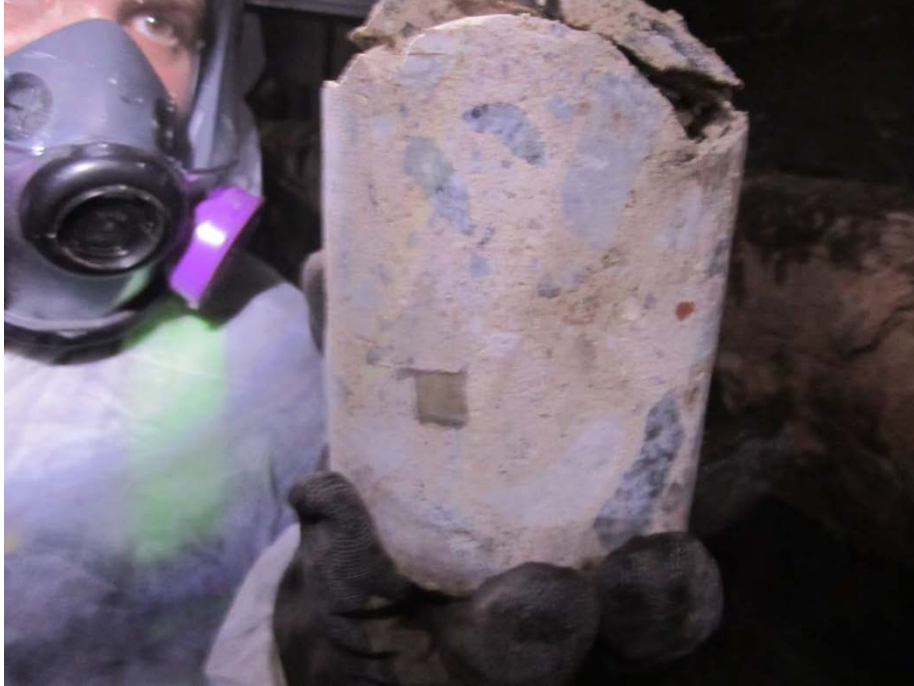
*Picture #66- Core hole for Petro19-20-S*

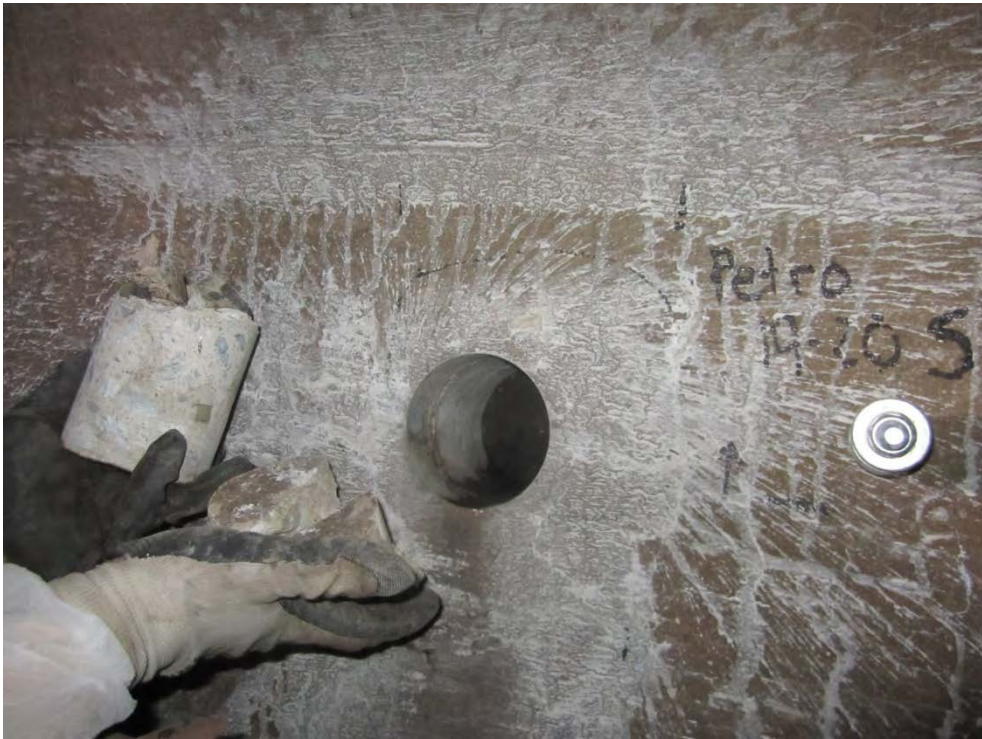
*Picture #67- Core Petro19-20-S*

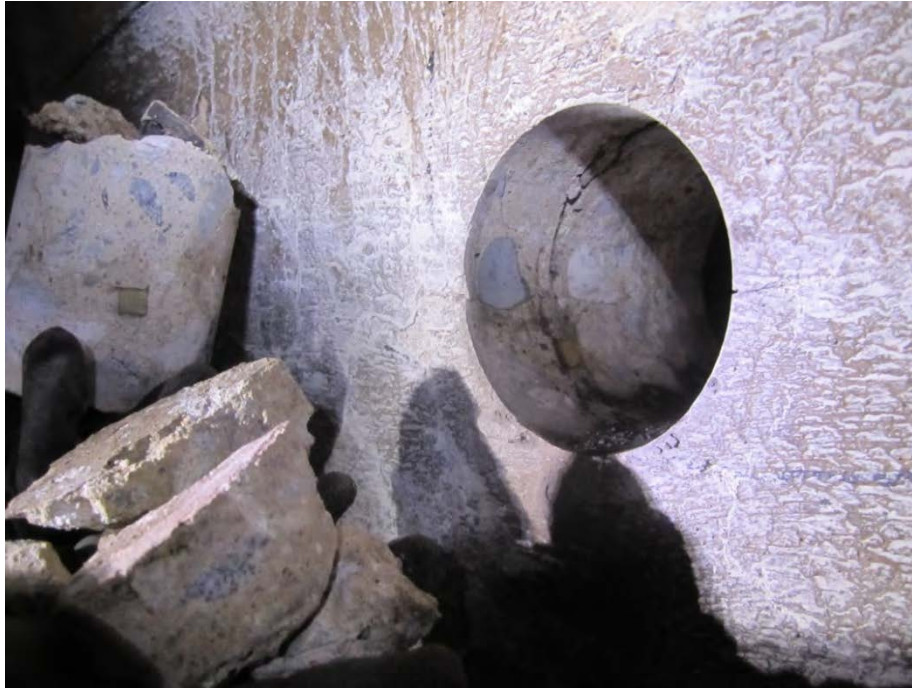
*Picture #68- Core Petro19-20-S taken to full depth*

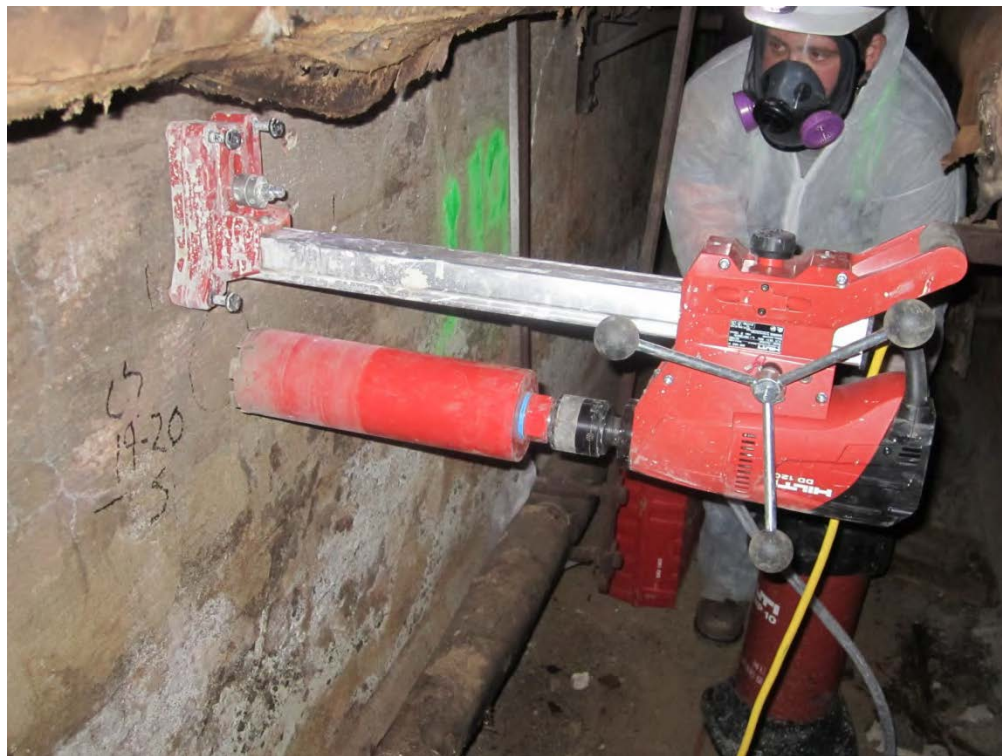
*Picture #69- Visible delaminated layer in core hole Petro19-20-S*

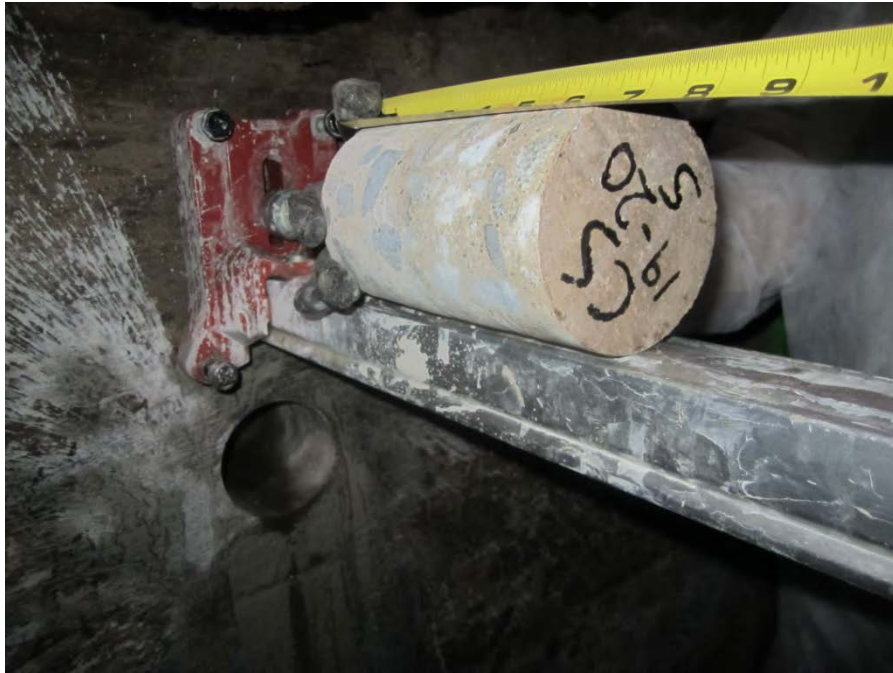
*Picture #70- Area of Core CS19-20-S*

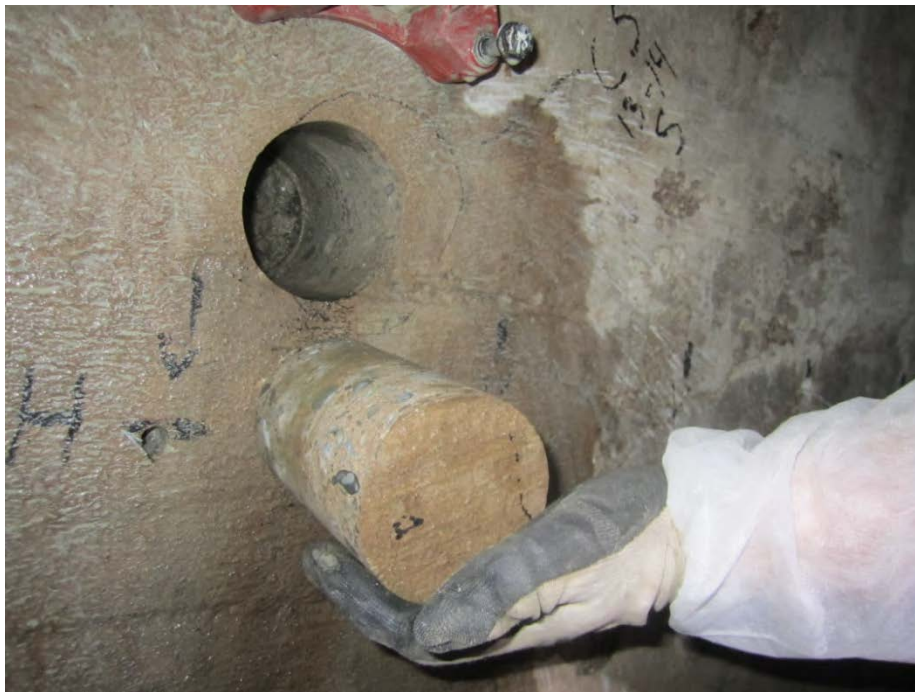
*Picture #73- Area of core Petro13-14-S taken on a crack*

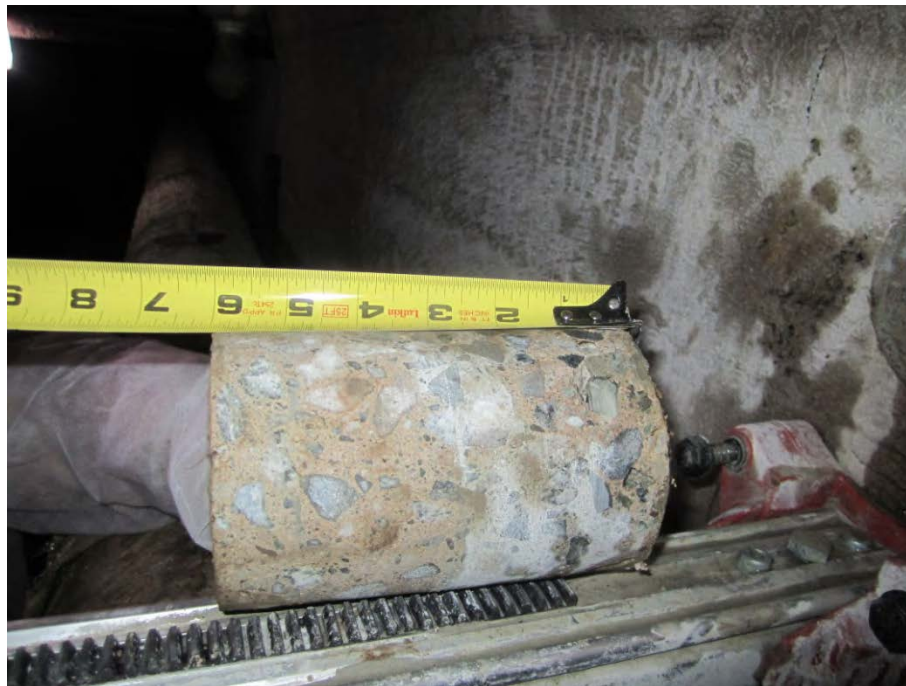
*Picture #76- Full depth core CS13-14N approximately 6" thick*

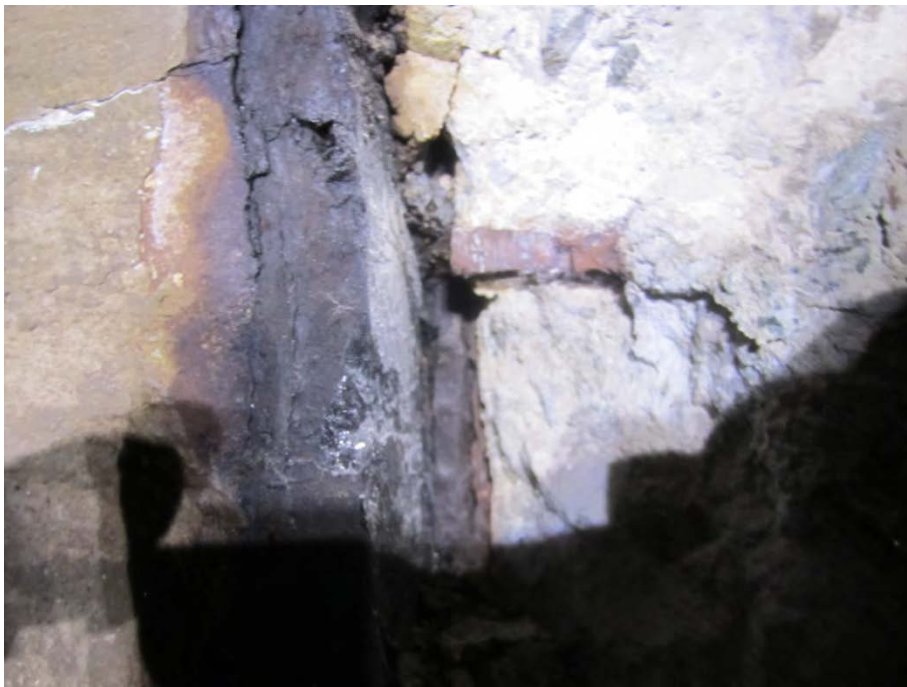
*Picture #88- Steel does not cross joint*

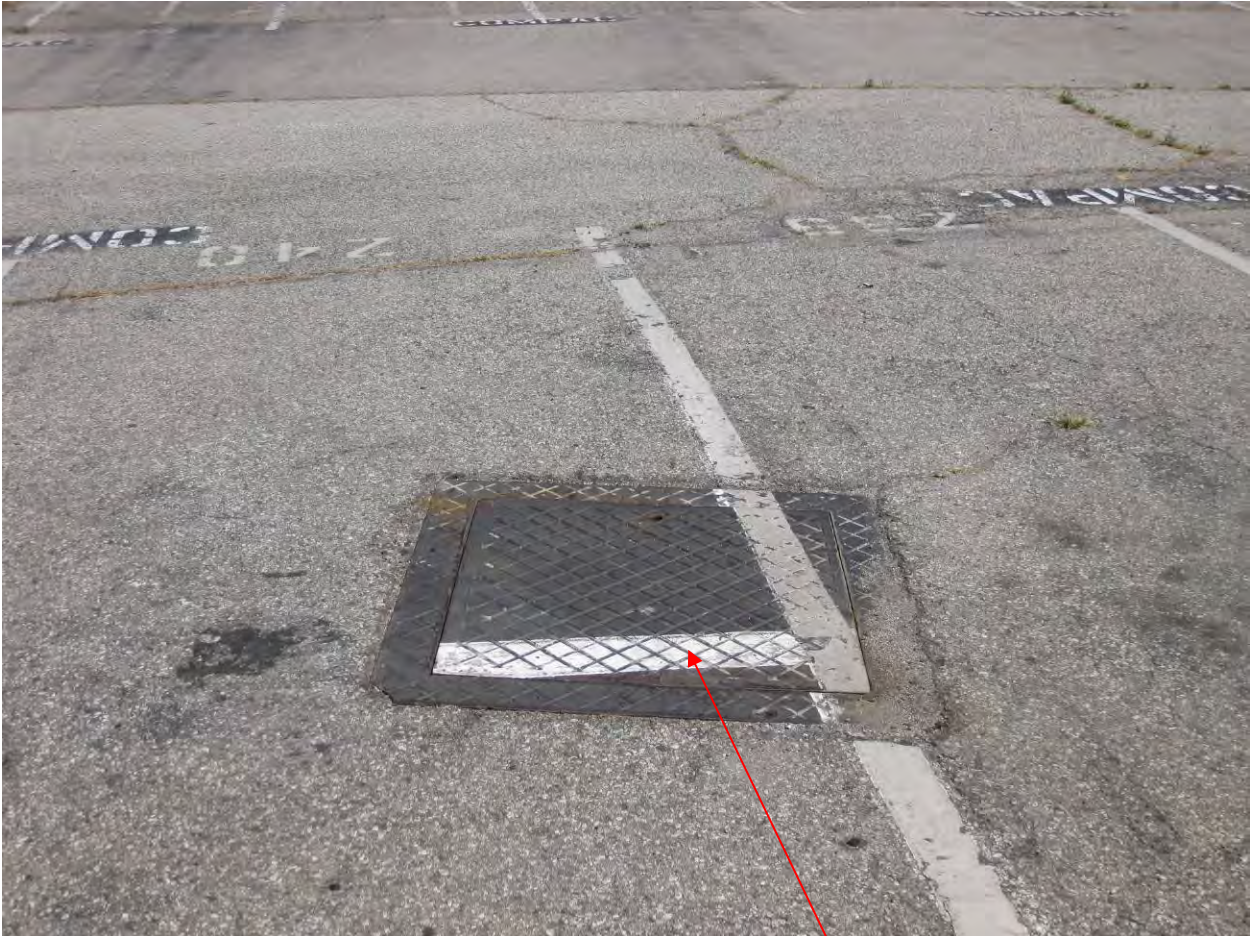
**PHOTO 1: MANHOLE ENTRANCE TO JUVENILE HALL TUNNEL.**

**MANHOLE ENTRANCE  
LOCATED AT MIDDLE OF  
PARKING LOT ABOVE  
JUVENILE HALL TUNNEL**
